CLAM PASS

2019 Review of Inlet Management

Prepared for
Pelican Bay Services Division
Collier County, Florida

Prepared by
Humiston & Moore Engineers
md@humistonandmoore.com

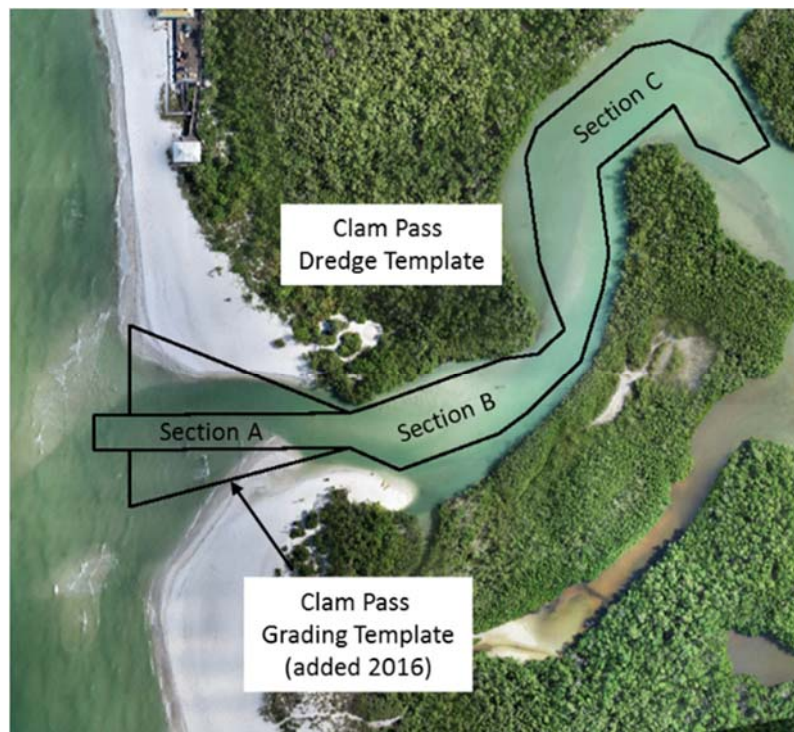
Figure 5 . Clam Pass maintenance dredging template (aerial photo July 2019)

The above information was compiled and reviewed. Key findings and recommendations are discussed in the following sections. Supporting information in the form of charts and tables are also provided in the Appendices sections. **Figure 5** shows a plan view of the authorized dredging template established in the 2014 updated NRPA management plan. The dredging area included the inlet channel (section A) and flood shoal dredging areas (sections B and C). The 2014 updated plan and subsequent permits also included grading areas along the inlet channel banks to allow post dredging conditions to mimic natural inlet conditions following construction.

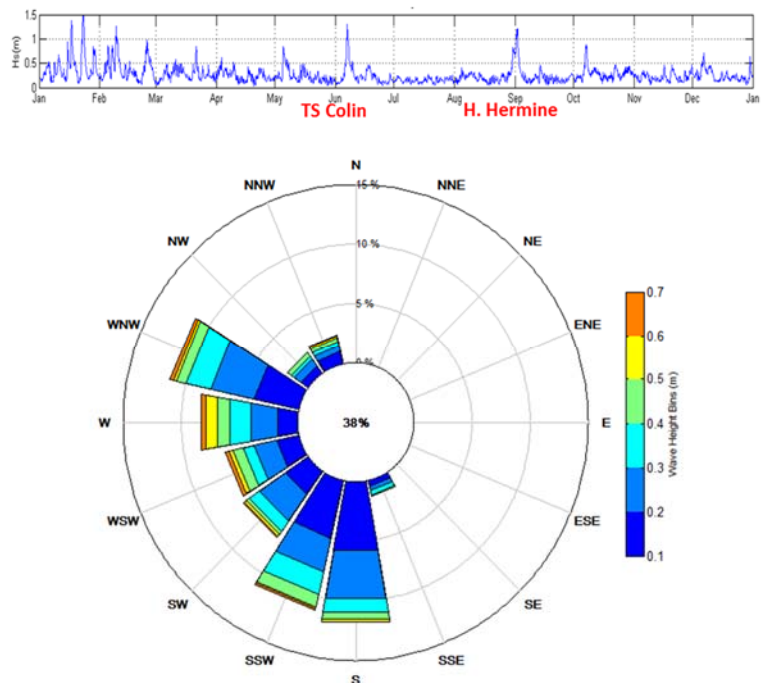
Figure 8 . 2016 wave record and wave rose showing effect of tropical storms on wave climate at Clam Pass

tropical storm activities. **Figure 8** shows wave record and wave rose of 2016 indicating the effects of the tropical storms on wave energy and direction. The figure indicates that during 2016, calm waves conditions represented only 38% compared to over 60% of the time typically. The 2016 wave events included significant wave energy from south and southwest directions in addition to the northwest waves during winter months.

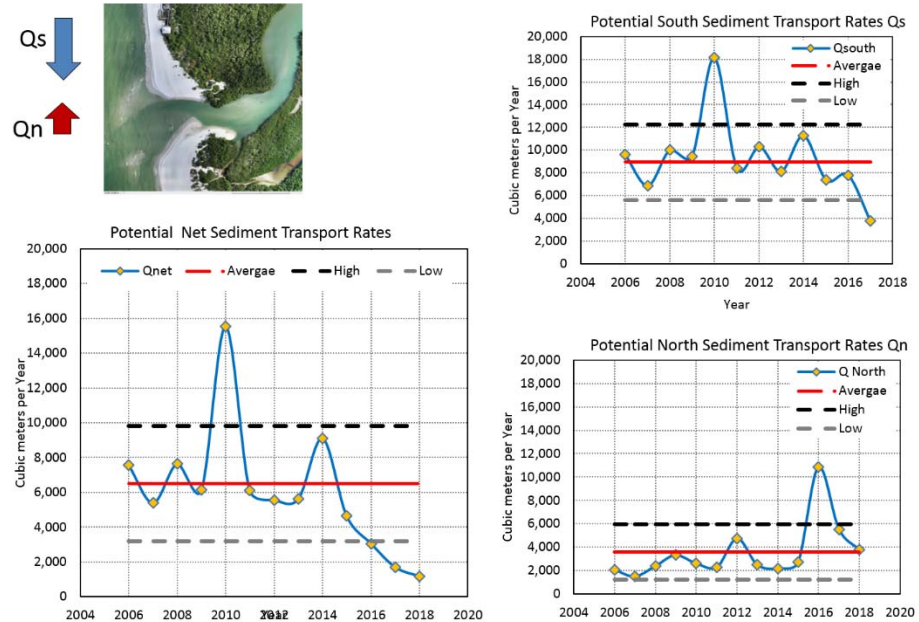
Figure 9 . Calculated net, north and south annual sediment transport rates at Clam Pass based on wave driven sediment transport modeling for wave record of 2006 to 2018

Figure 9 shows the calculated annual north, south and net sediment transport rates. The figure shows the model computation for each year of the 13-year record and indicates the potential average, high and low expected yearly range based on the modeled period. **Figure 10** shows the calculated annual gross sediment transport which is the magnitude total of both north and south transport, and indication of total energy regardless of direction. While the net transport is commonly used to evaluate sediment budgets for open coasts, the gross sediment transport is an important measure of wave energy and sediment transport in areas near inlets where the inlet channel or dredged areas act as a sink for sand transported from both directions. The sediment transport figures show the yearly variations in sediment transport magnitudes and breakdown between north and south sediment transport components.

Wave events and tropical storms in 2010, 2012, 2016 and 2017 influenced the overall sediment transport magnitudes and directions. In 2012 the Passage of Tropical Storms Debby and Isaac caused significant shoaling at the inlet mouth and the pass was eventually closed in the fall of 2012. In 2016 and 2017 the net sediment transport was to the north which is opposite to the typical yearly trend.

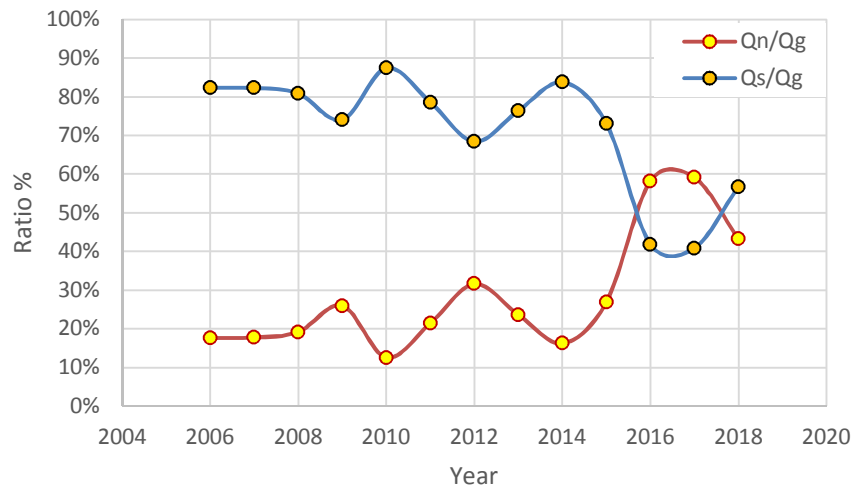
Figure 11. Ratios of north transport 'Qn' and south transport 'Qs' to total 'Qgross' transport

Figure 11 shows the yearly ratios of north and south bound transport relative to total yearly sand transport. Long-term averages indicate that in most years the majority (~80%) of wave energy drives sand transport alongshore from north to south. In 2016 and 2017 the majority of wave energy came from the southwest driving sand transport towards the north which is opposite of the predominant trend.

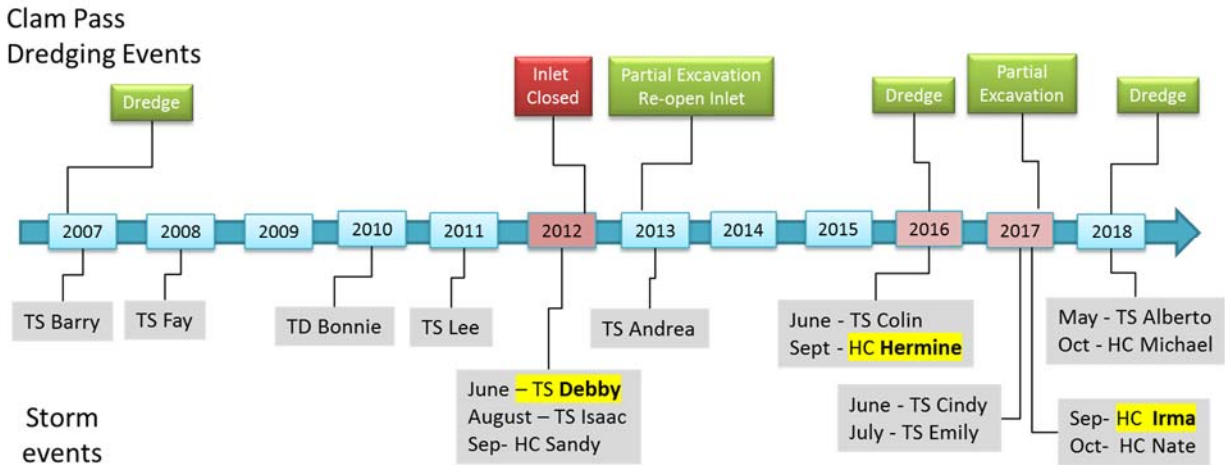
Figure 14 . Timeline of tropical storms and dredging events (2007-2018)

The analysis of the wave record and storm events indicates the correlation between increased storm activities and dredging events. Storm activity affected southwest Florida in 2012, 2016 and 2017. The inlet closed in the fall of 2012 following sequence of tropical storms Debby, Isaac and Sandy. Emergency maintenance in 2017 and maintenance dredging in 2018 helped avoid inlet closure during the active years of 2016/2017 and restored the inlet to stable conditions.

This illustrates the importance of the monitoring program and the ability to conduct emergency responses in a timely manner following major storm events to avoid potential for inlet closure. The wave analysis also provided assessment of the variability in long-term wave climate and the inlet response to prevailing sediment transport in both directions. Typically the beach and inlet geometry adjusts to near equilibrium following long-term trends. This includes the predominant trends of sand transport from north to south. Sustained wave energy from the south over two consecutive years represented atypical conditions that impacted inlet stability and required maintenance dredging to restore the inlet stability.

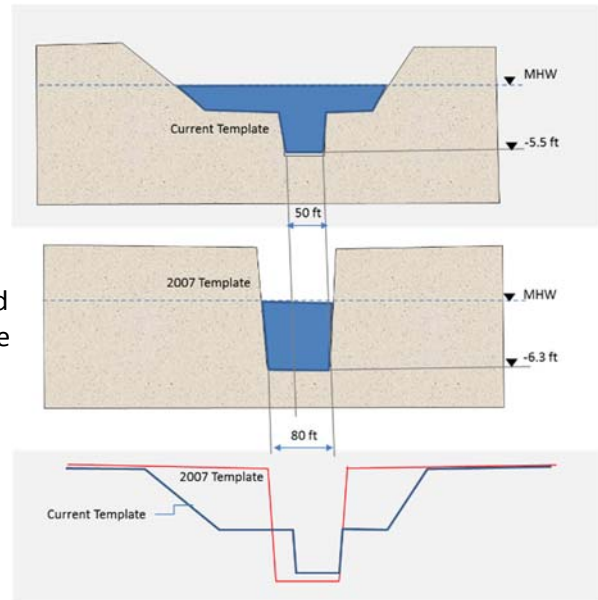
Figure 17 . Typical maintenance dredging cross section in the 2007 template and current permitted template.

- Modification of the inlet channel cross section to reduce channel bottom width and include large tidal flats and gradual grading of inlet banks to mimic natural conditions while maintaining equilibrium area of flow. **Figure 17** shows illustration of the typical channel cross section used in the current dredging template compared to the 2007 dredging template.
- Slight reduction of dredging depth to avoid and minimize potential of dredging cohesive sediment or non-beach compatible sediment.
- Provide small buffer between the active dredging areas and mangrove shoreline to minimize potential impacts to mangroves.

The above minor modifications were designed to promote inlet stability and address environmental concerns. The overall change in the capacity of the dredging template was less than 10% of the template capacity used in the 2007 dredging. For example, the total volume for 2007 and 2016 dredging was approximately 21,000 and 19,000 respectively.
