**PELICAN BAY SERVICES DIVISION**  
**Municipal Services Taxing & Benefit Unit**

**NOTICE OF PUBLIC MEETING**

# PELICAN BAY

# Lake 4-1 Analysis

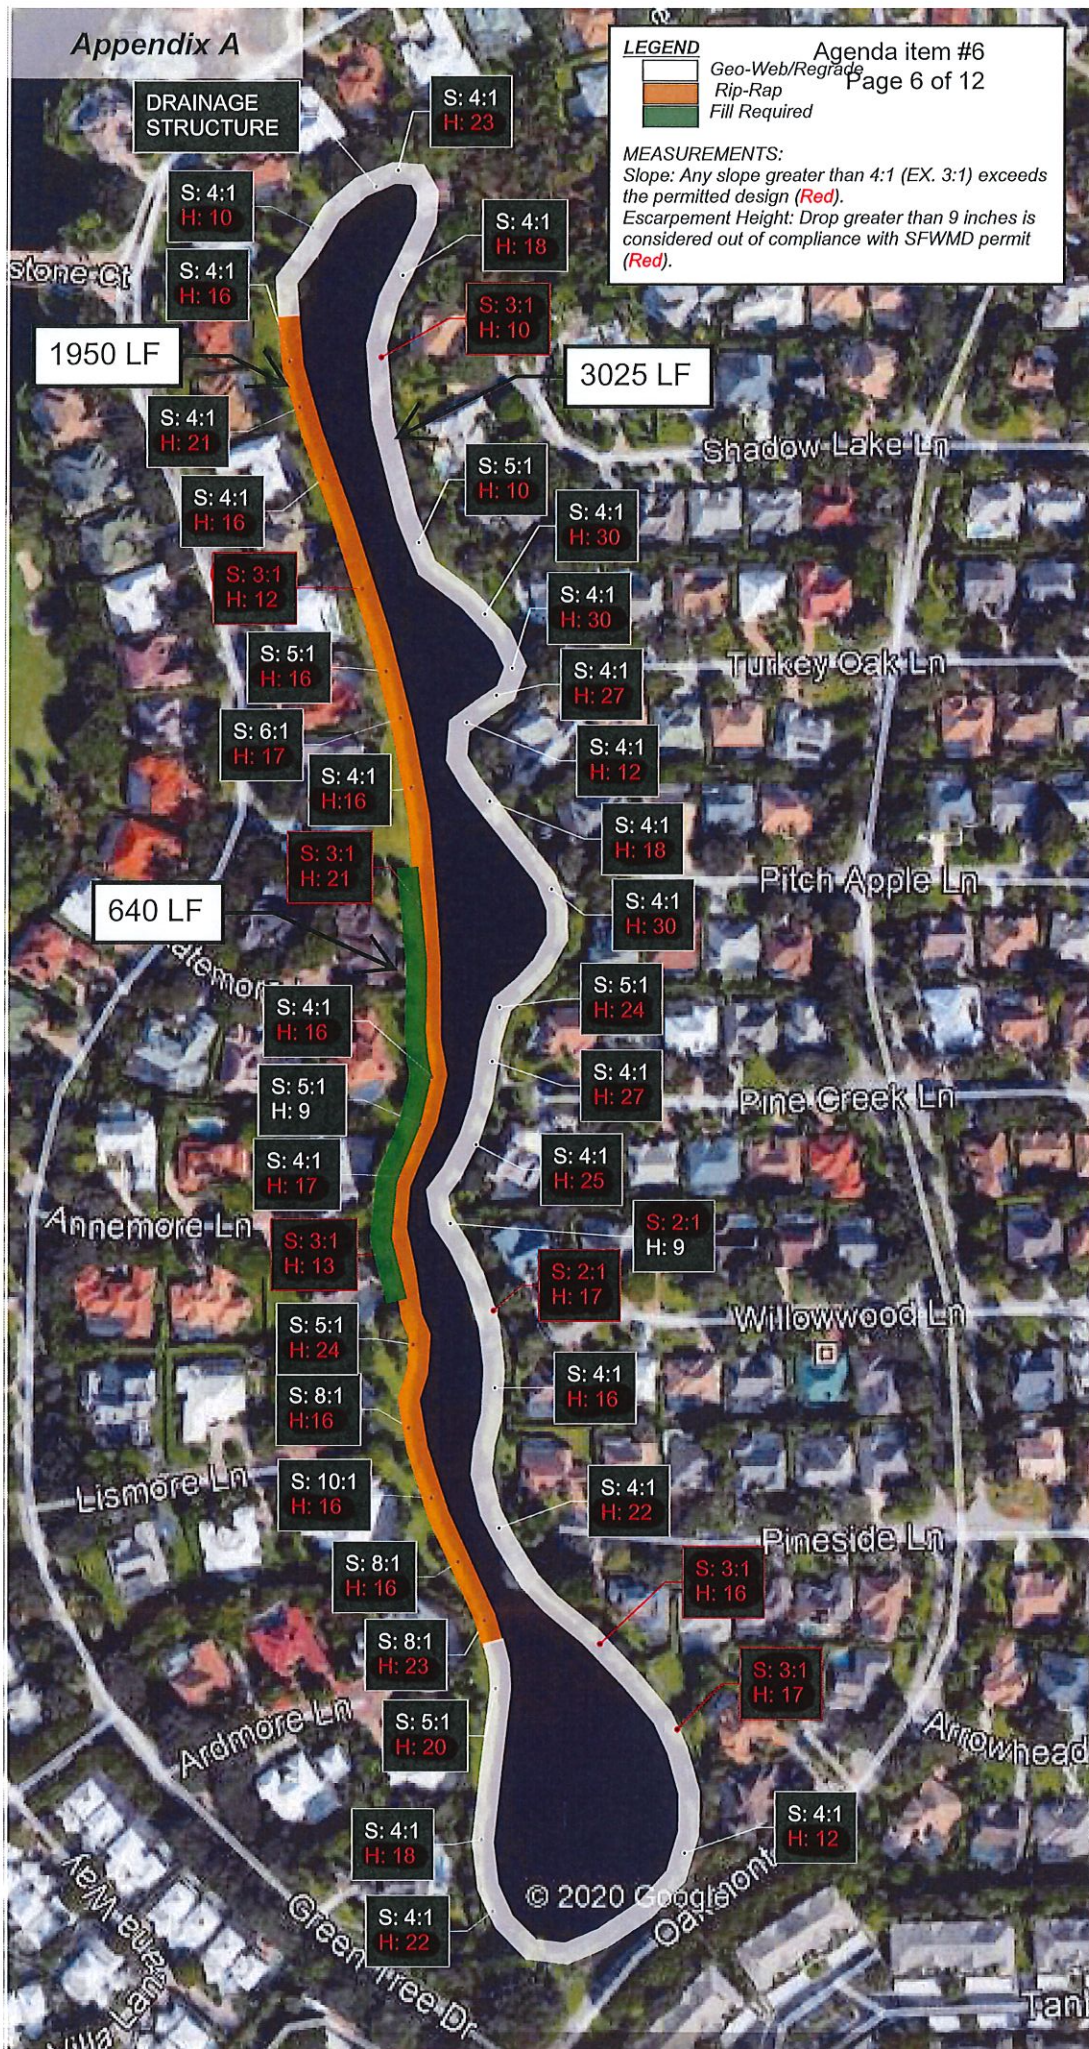
Slope: Any slope greater than 4:1 (EX. 3:1) exceeds the permitted design (Red).

Escarpement Height: Drop greater than 9 inches is considered out of compliance with SFWMD permit (Red).

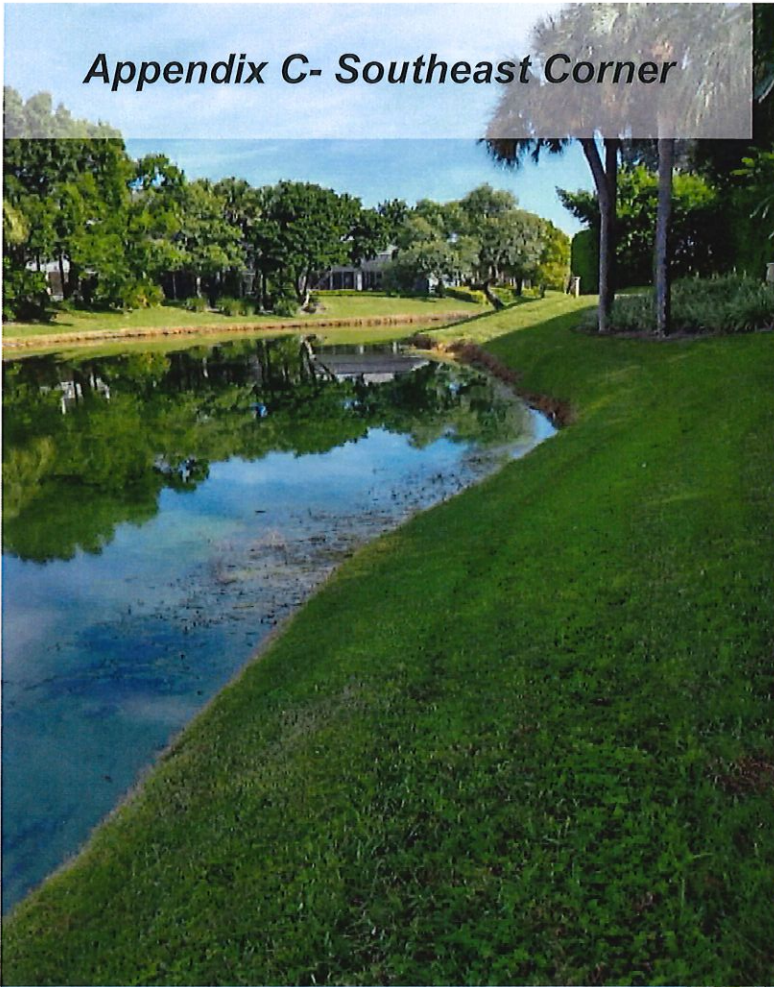
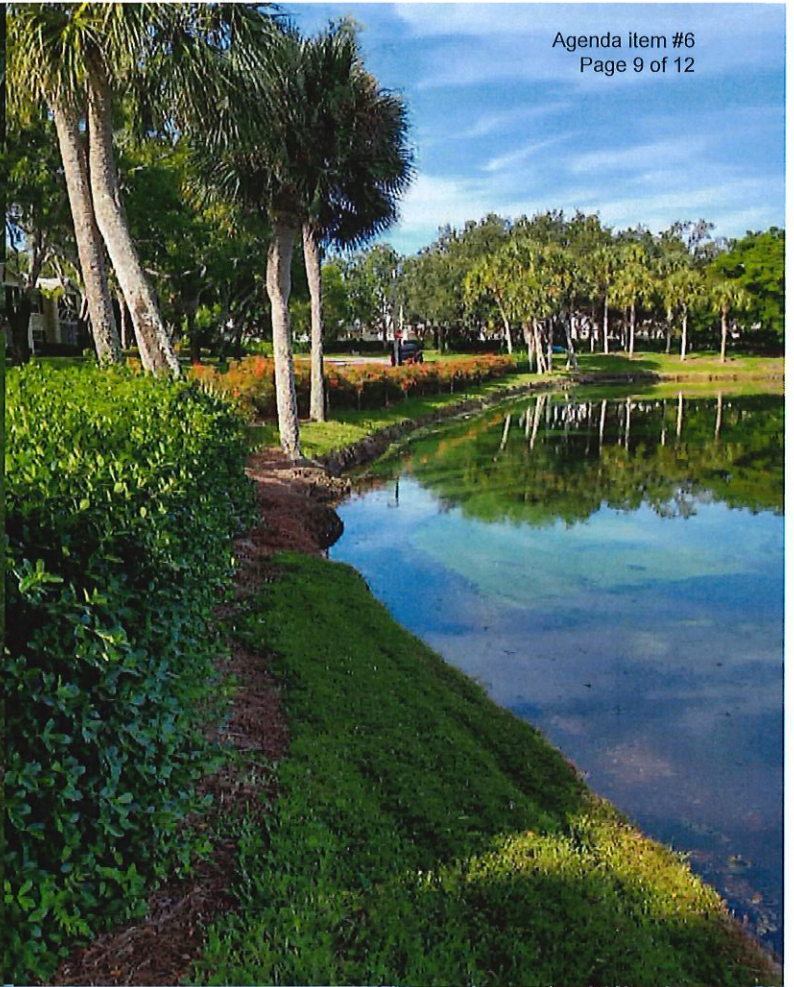
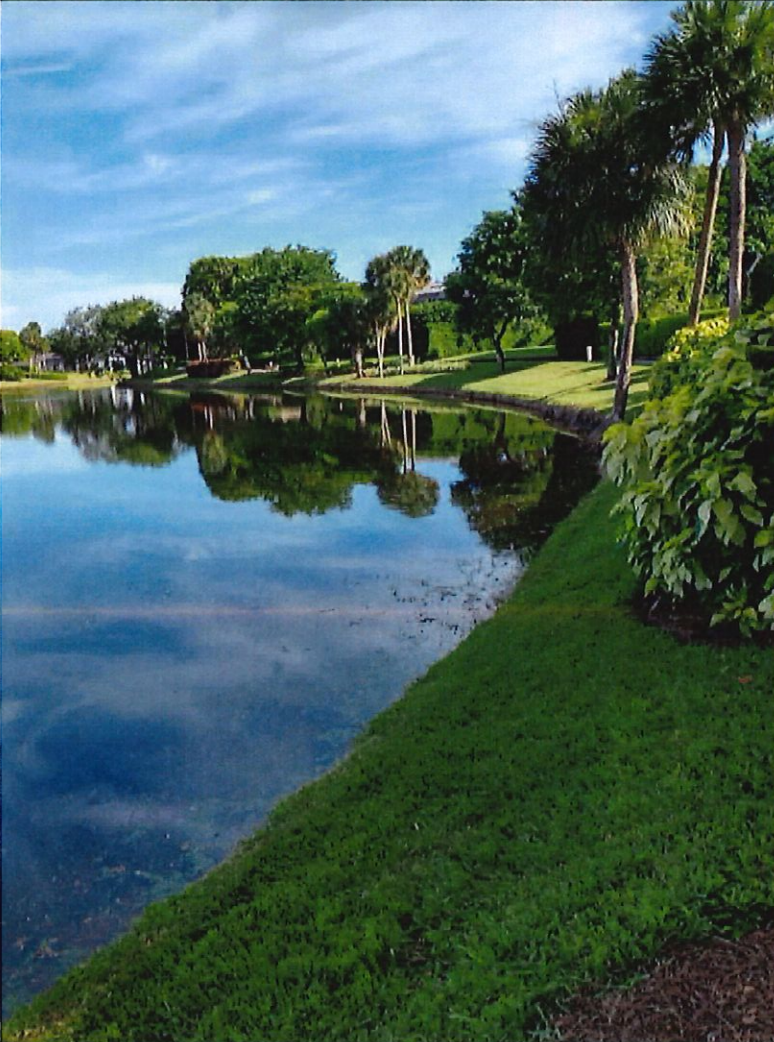
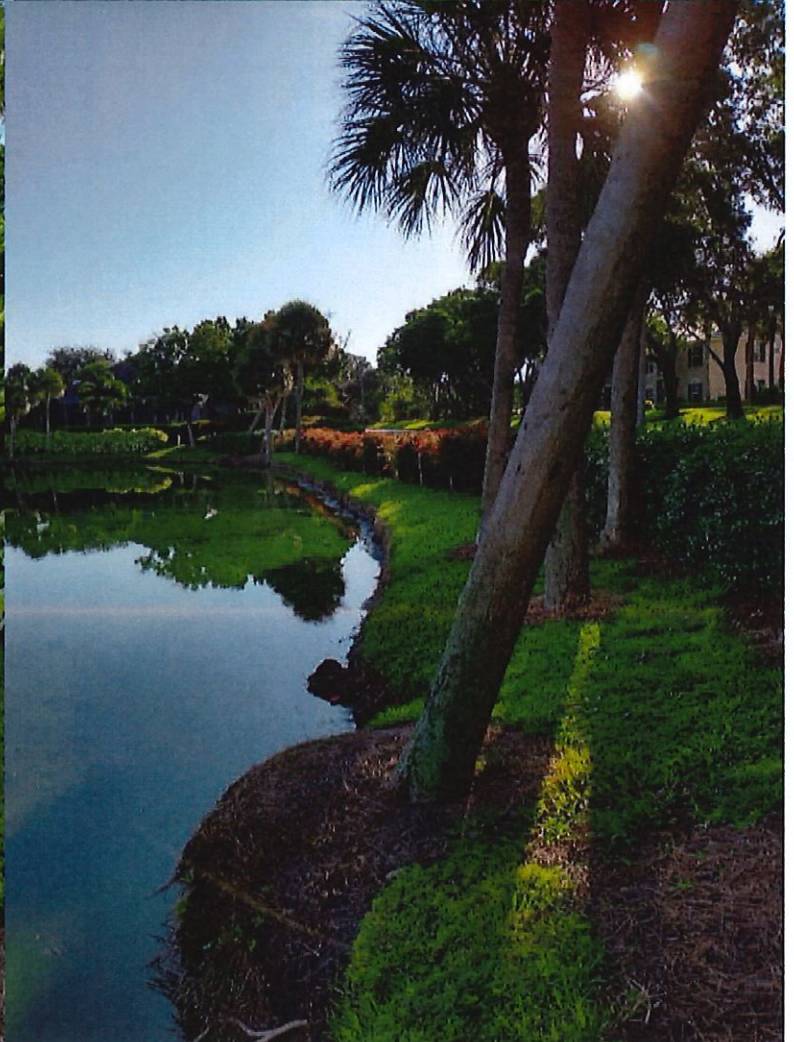
*Appendix C- Southeast Corner*

The escarpment height around much of the lake reaches depths of up to 30 inches in some places, falling out of compliance with the SFWMD permit. It was most critical along the east side of the lake where you can see exposed geo-tube from previous erosion prevention efforts. However, this fabric has begun to fail and is now sliding into the water no longer preventing erosion along the bank.
