Clam Pass Physical and Tidal Monitoring Report 2020

March, 2021

Prepared for
Pelican Bay Services Division

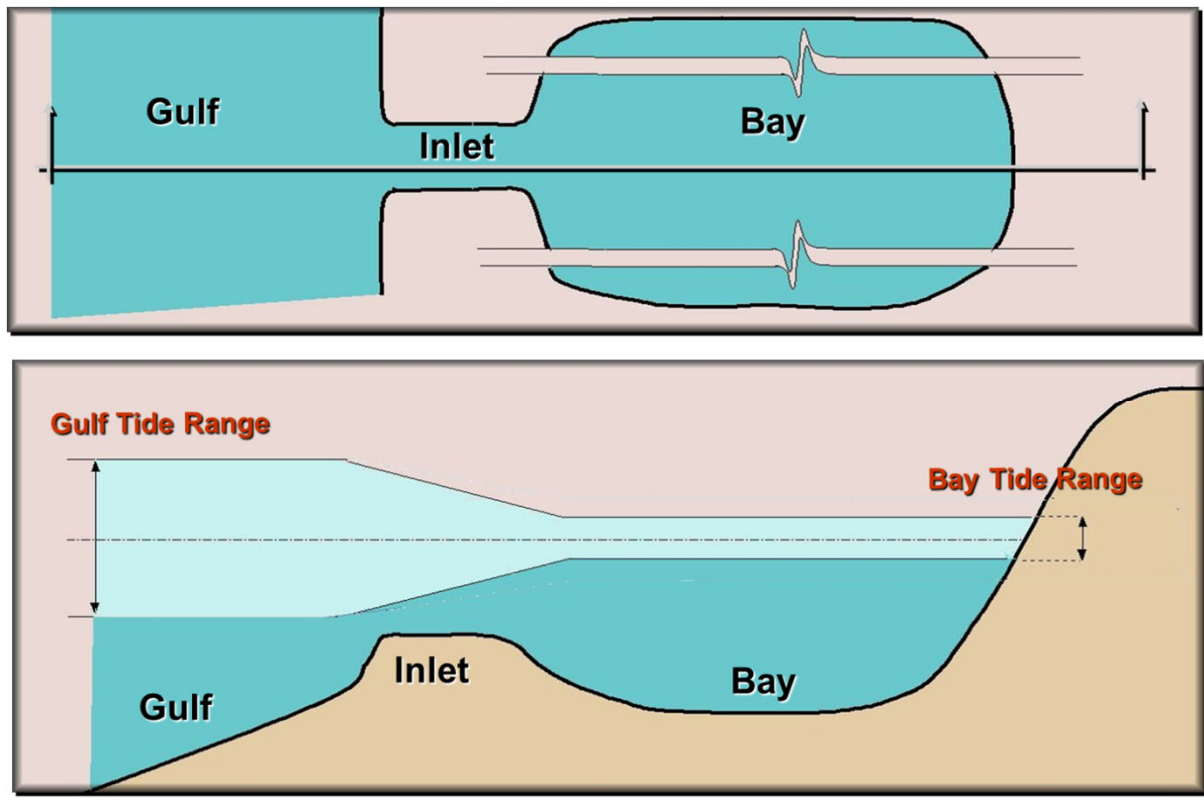
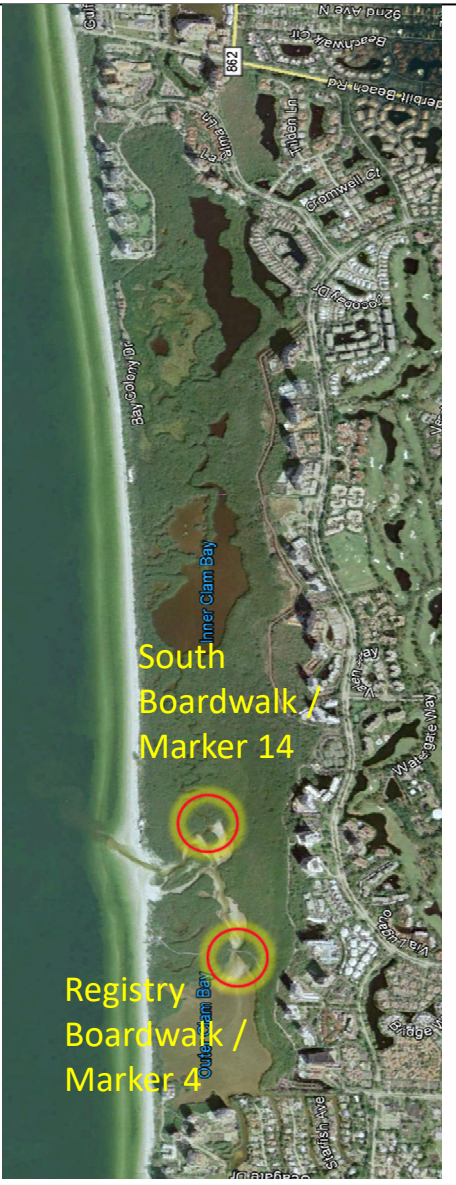
Figure 6. Gulf and Bay Tide Range Illustration

The tide range is also an important indicator of the flushing of Clam Bay and shoaling within the inlet. The tide range is the difference in elevation between high water and low water for a given tidal cycle which is an indicator of the tidal prism or volume of water flowing through the inlet at each tidal cycle. The bay tide range will always be smaller than the gulf tide range, however, a reduced bay tide range is an indicator of flow restriction through the inlet channel and shoal features (**Figure 6**).
