Above the Flood: Elevating Your Floodprone House

FEMA 347/ May 2000

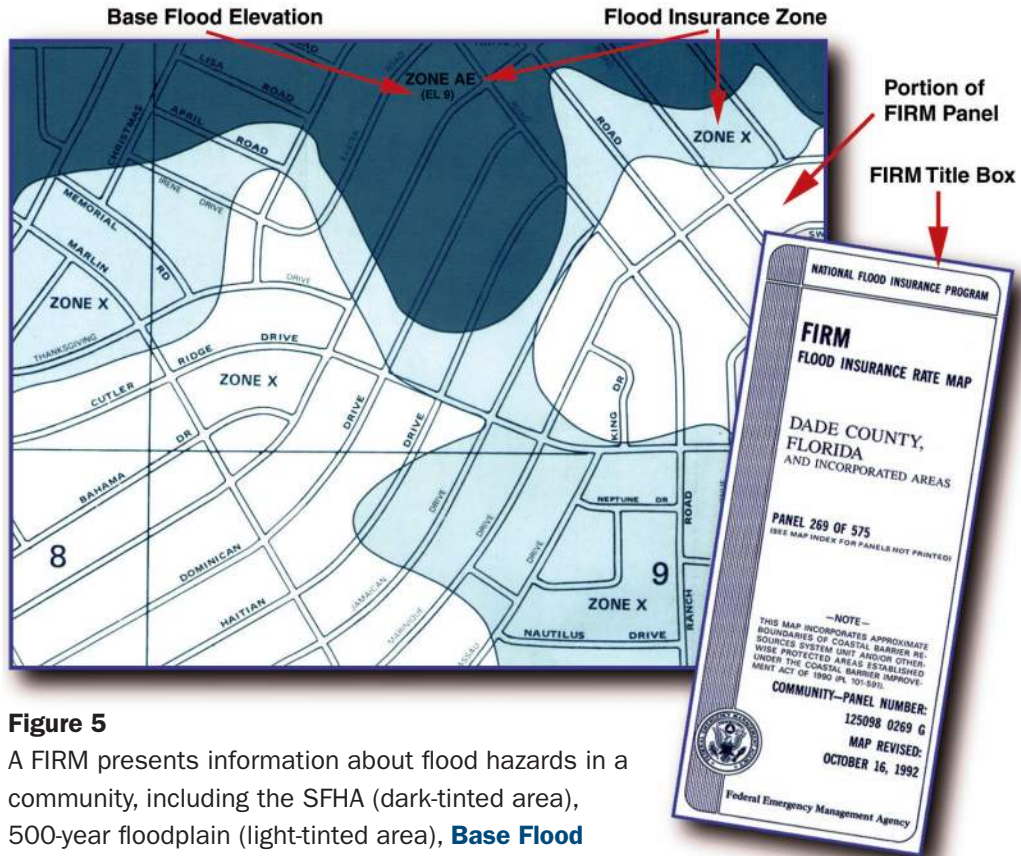
Figure 5
A FIRM presents information about flood hazards in a community, including the SFHA (dark-tinted area), 500-year floodplain (light-tinted area), **Base Flood Elevations**, (BFEs) (number in parentheses), and flood insurance zones (AE and X in this example).

Communities participate in the NFIP by enacting and enforcing floodplain management regulations to reduce future flood risks. At a minimum, these regulations govern construction in the **Special Flood Hazard Areas (SFHAs)** shown on Flood Insurance Rate Maps (FIRMs) issued by FEMA (Figure 5).

Note that the SFHA in the example in Figure 5 is designated Zone AE. This zone is only one of several applied to SFHAs under the NFIP, including V, VE, V1-V30, A, AE, A1-A30, AO, and AH. These zones indicate differences in the types and severity of flood hazards in SFHAs. For the purposes of this publication, it is sufficient to focus on the basic differences between the two main types of SFHA zones—V zones and A zones. The distinction is important because regulatory requirements associated with V zones and A zones differ significantly. As explained later in this chapter, these requirements affect the types of building elevation techniques that may be used under the NFIP.

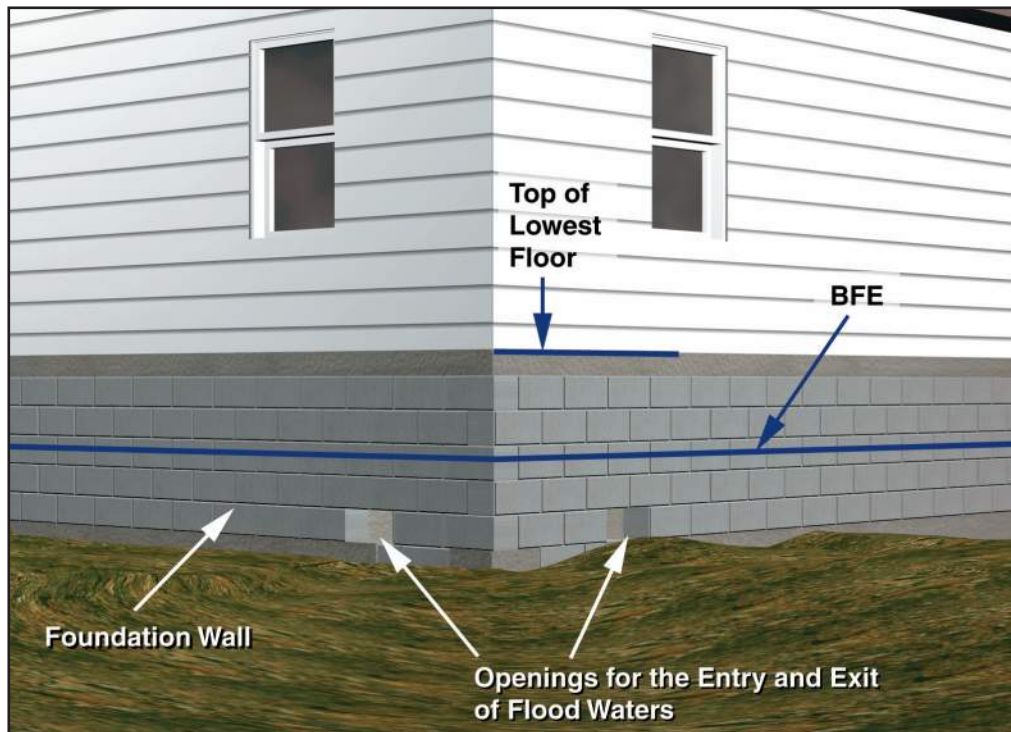
**Figure 6**

In a new, substantially improved, or substantially damaged building in an A zone, the elevation of the lowest floor must be at or above the BFE.

In A zones, where flood hazards are less severe, buildings may be elevated either on an open foundation or on continuous foundation walls below the BFE (Figure 6). Regardless of the type of foundation used, A-zone buildings must be elevated so that the **lowest floor** is at or above the BFE, as shown in Figure 6. If continuous walls are used below the BFE, they must be equipped with openings that allow flood waters to flow into and out of the area enclosed by the walls (Figure 6). Allowing the entry and exit of flood waters ensures that water pressures will be the same on both sides of the walls and reduces the likelihood that water pressure will cause the walls to fail.

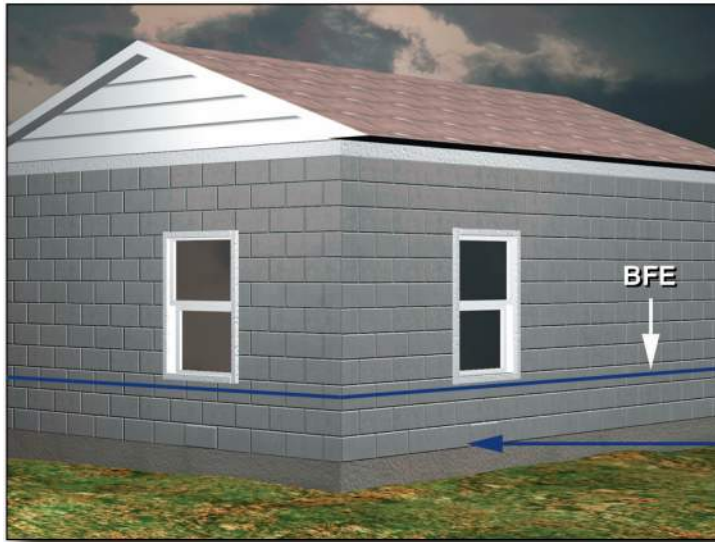
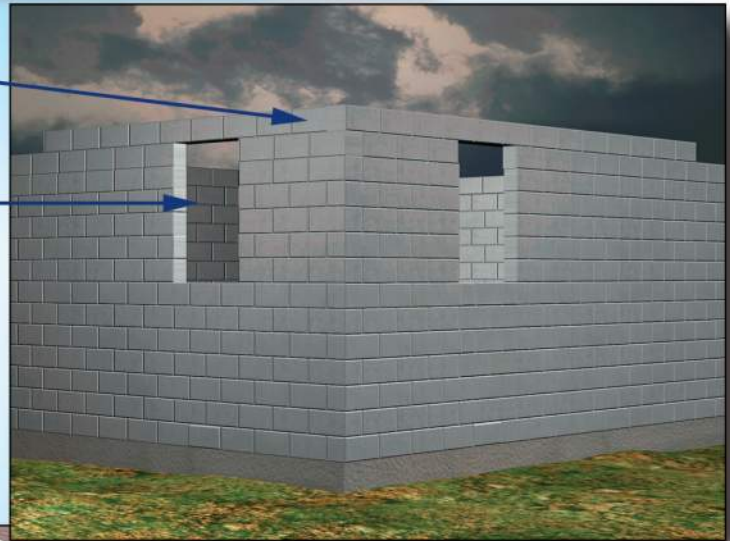
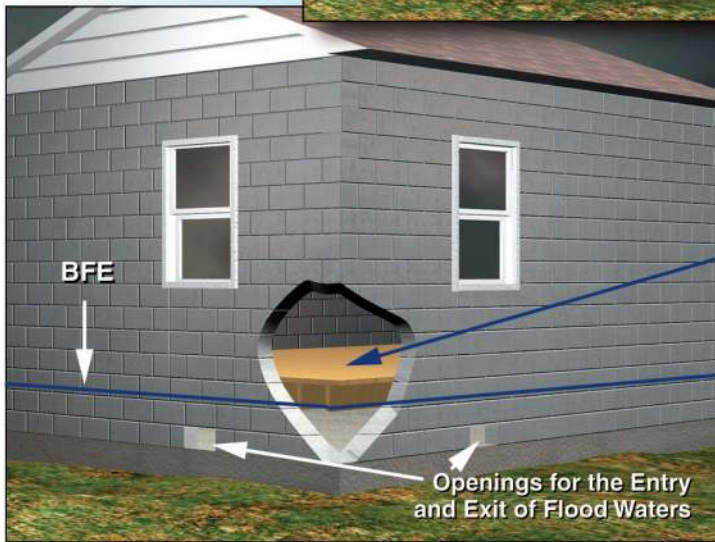
Figure 7
Technique 1 –
Extend the walls of
the house upward and
raise the lowest floor.

**House at the time
Hurricane Andrew
struck**

**Original Level
of the Lowest
Floor**

**Raised Window
Opening**

**Substantially damaged house undergoing
repairs that will bring it into compliance
with Miami-Dade County floodplain
management requirements**

**New,
Raised Floor**

**House after
completion of repairs**

1. Extend the walls of the house upward and raise the lowest floor (Figure 7).
2. Convert the existing lower area of the house to non-habitable space and build a new second story for living space (Figure 8).
3. Lift the entire house, with the floor slab attached, and build a new foundation to elevate the house (Figure 9).

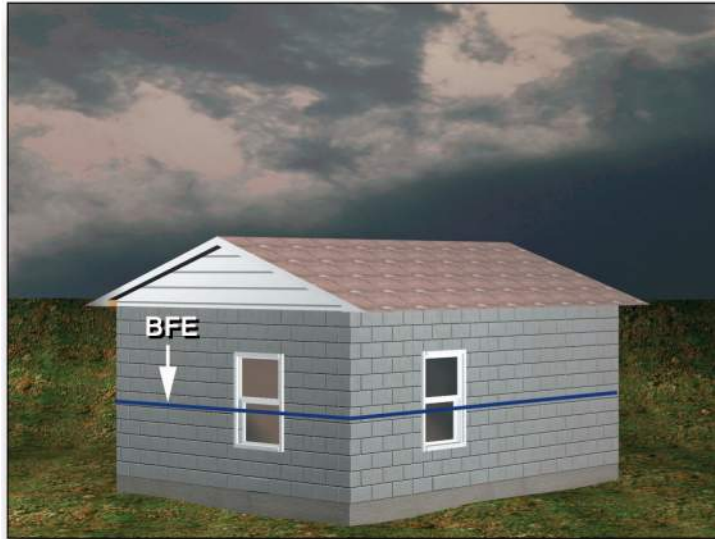
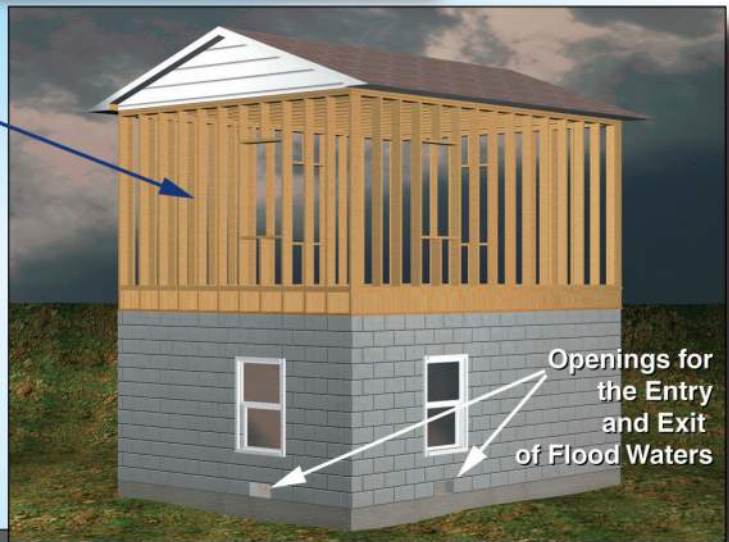
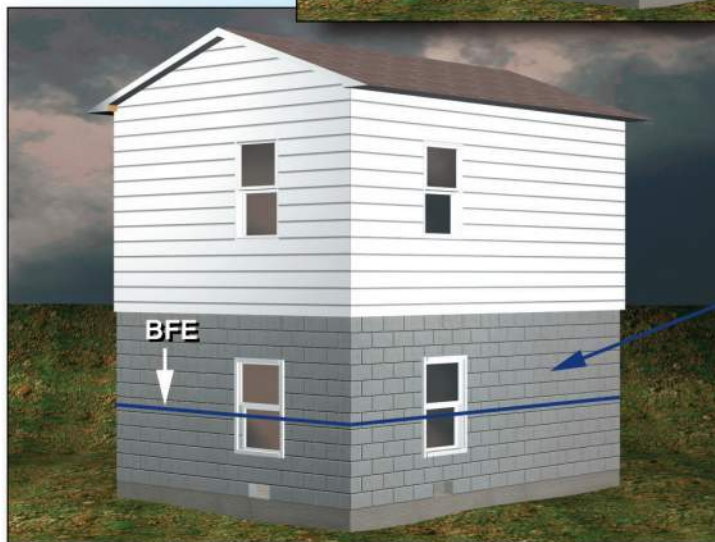
Technique 2 – Convert the existing lower area of the house to non-habitable space and build a new second story for living space.

House at the time Hurricane Andrew struck

New Second Story Above BFE

Substantially damaged house undergoing repairs that will bring it into compliance with Miami-Dade County floodplain management requirements

Openings for the Entry and Exit of Flood Waters

House after completion of repairs

Lower Area Converted to Non-Habitable Space for Storage, Parking, or Building Access

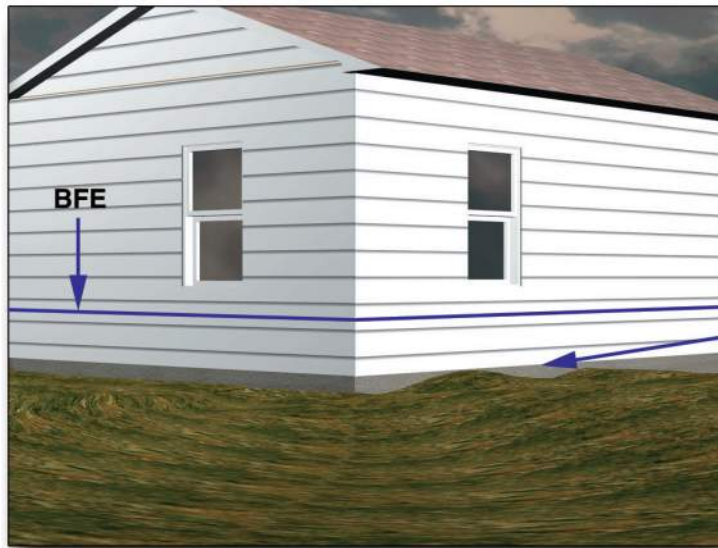
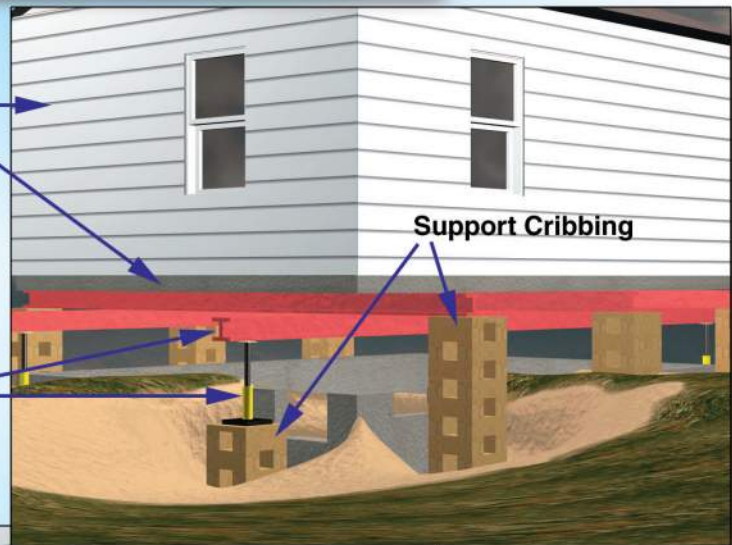
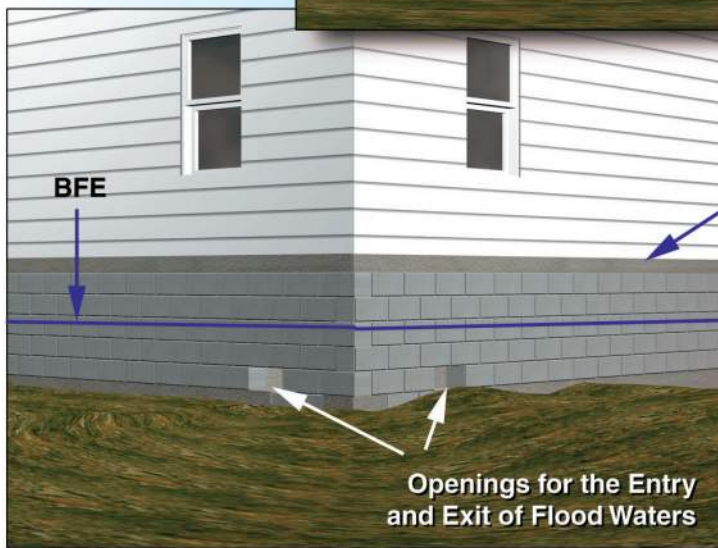
Figure 9
Technique 3 –
Lift the entire house,
with the floor slab
attached, and build
a new foundation to
elevate the house.

House at the time
Hurricane Andrew
struck

Original Level
of the Lowest
Floor

House and
Floor Slab
Lifted
Together

House Lifted
on Jacks and
I-Beams

Support Cribbing

New Level
of the Raised
Lowest Floor

House after
completion of
repairs

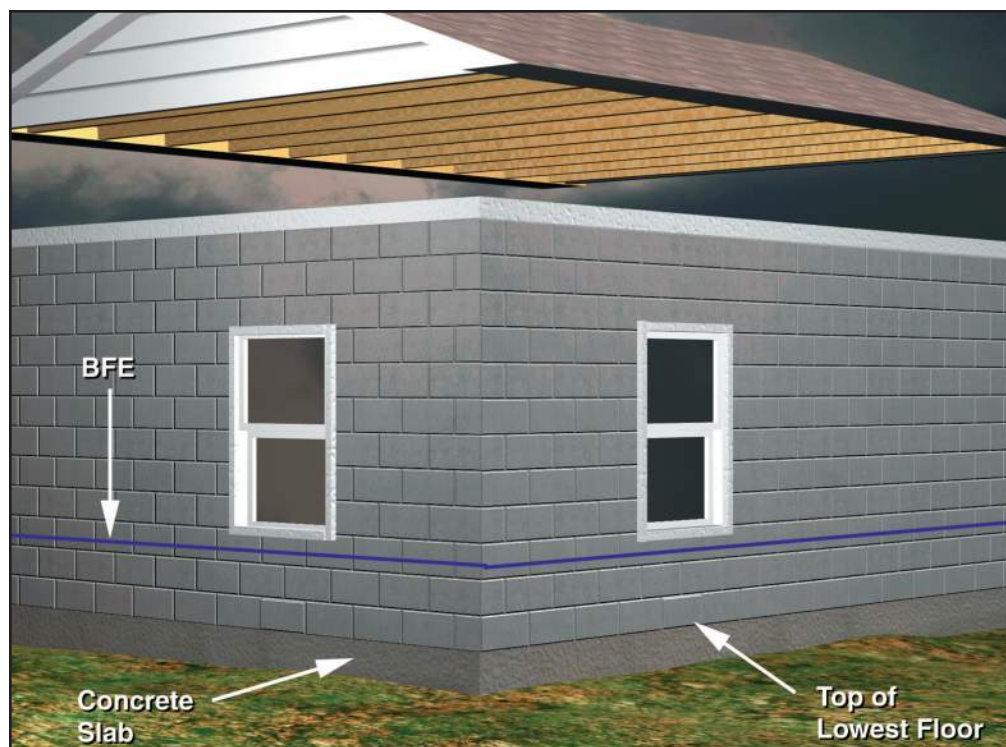
Figure 10
The first step in Technique 1 is removing the roof.

As in Technique 1, the repairs begin with the temporary removal of the roof and roof framing (Figure 10). After the roof is removed, construction of the new second story begins. First, a new wood-frame floor is built on top of the existing lower-story walls. The second-story walls are framed with metal or wood studs and set in place on the floor (Figure 15).

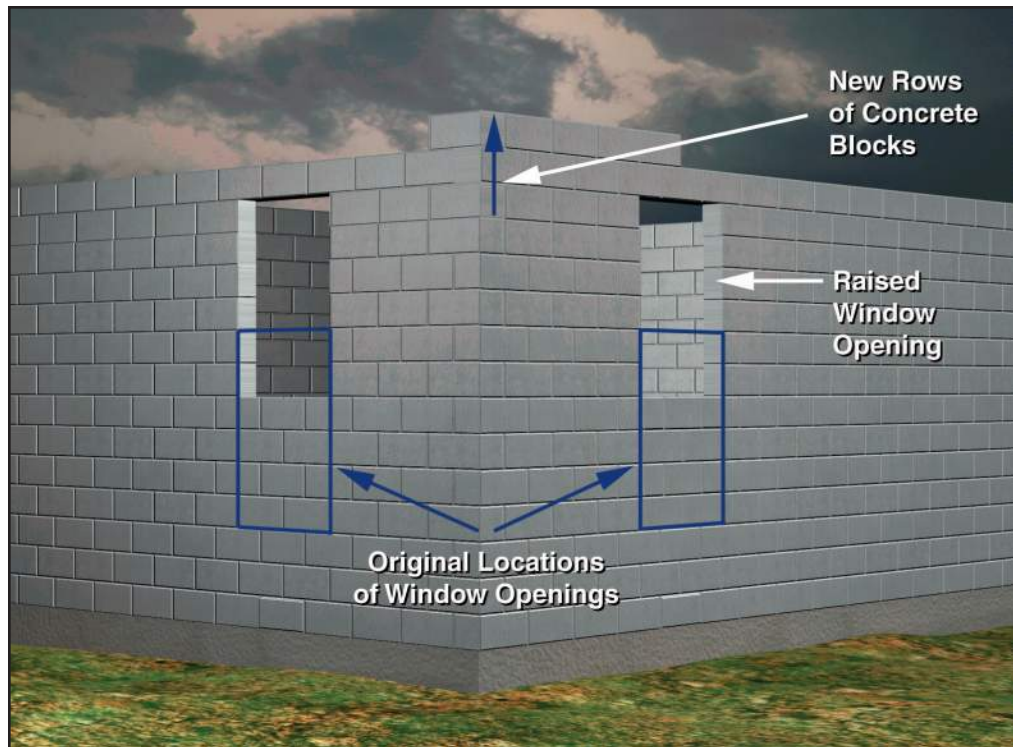
Figure 11

The tops of the walls and bottoms of the window openings are raised with concrete blocks.

After the roof, windows, and doors are removed, several courses of concrete block are added to the tops of the existing walls and to the bottoms of the window openings (Figure 11). A corresponding number of blocks are removed from the tops of the window openings so that the size of the windows will remain the same. In addition, although not shown in Figure 11, concrete bond beams are formed in place at the tops of the extended walls to provide structural reinforcement.

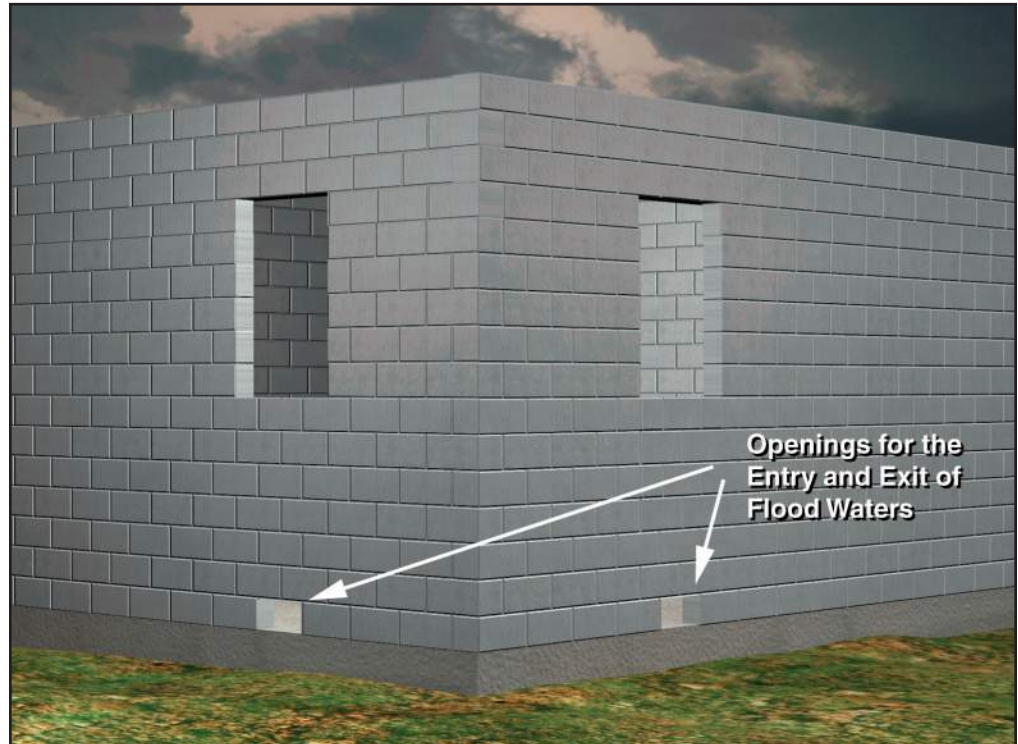
Figure 12
Openings are created in the walls near the ground.

Blocks are removed from the walls of the house at selected locations within 1 foot of the ground (Figure 12). The resulting openings will allow flood waters to flow into and out of the lower area of the house so that the water pressures on both sides of the walls will remain the same. The roof and windows are then replaced, and a new wood-frame floor is constructed above the flood level (Figure 13).

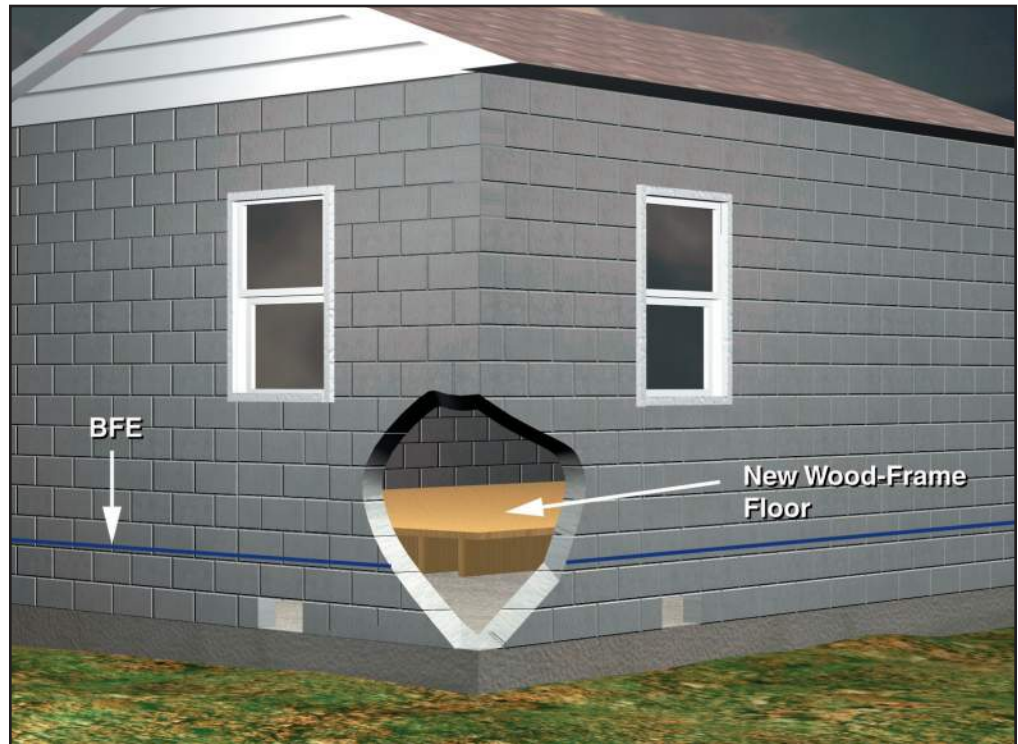
Figure 13
A new wood-frame lowest floor is constructed above the flood level, and the roof, windows, and doors are reinstalled.

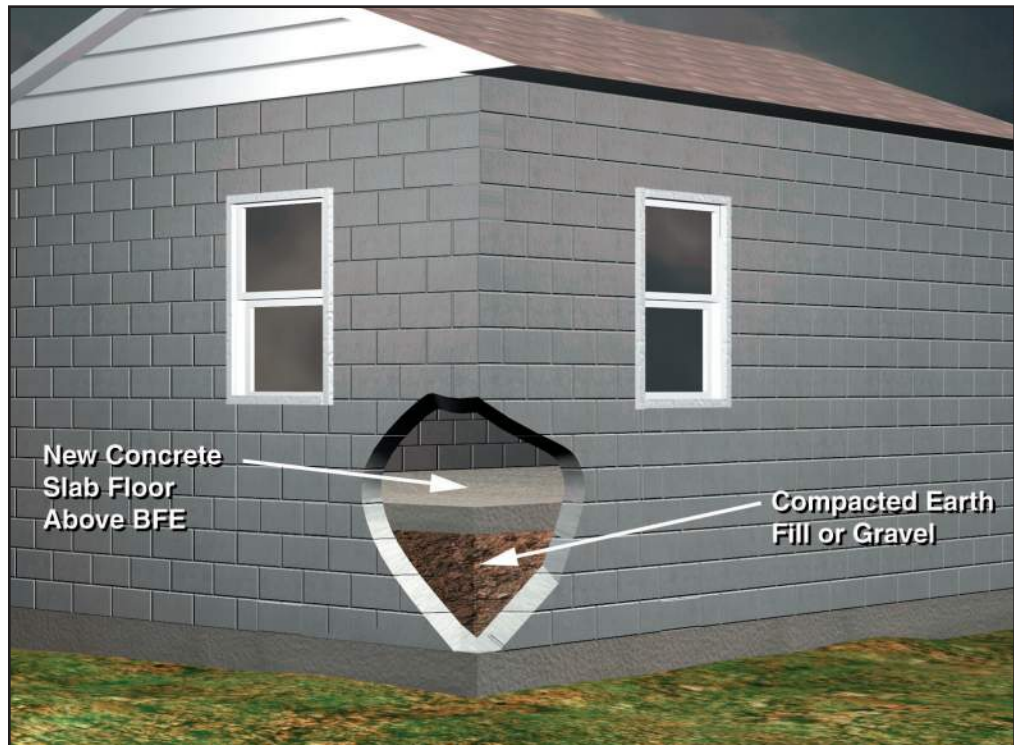
Figure 14
An alternative to building an elevated wood-frame floor is installing a new, elevated concrete slab floor on fill placed over the old slab.

A homeowner who chooses Technique 1 may decide to build a new concrete slab floor instead of a wood floor (Figure 14). When this option is chosen, compacted fill dirt or gravel is placed on top of the old slab and the new slab floor is poured on top. Because the area below the new floor is filled with dirt or gravel, wall openings are not required.

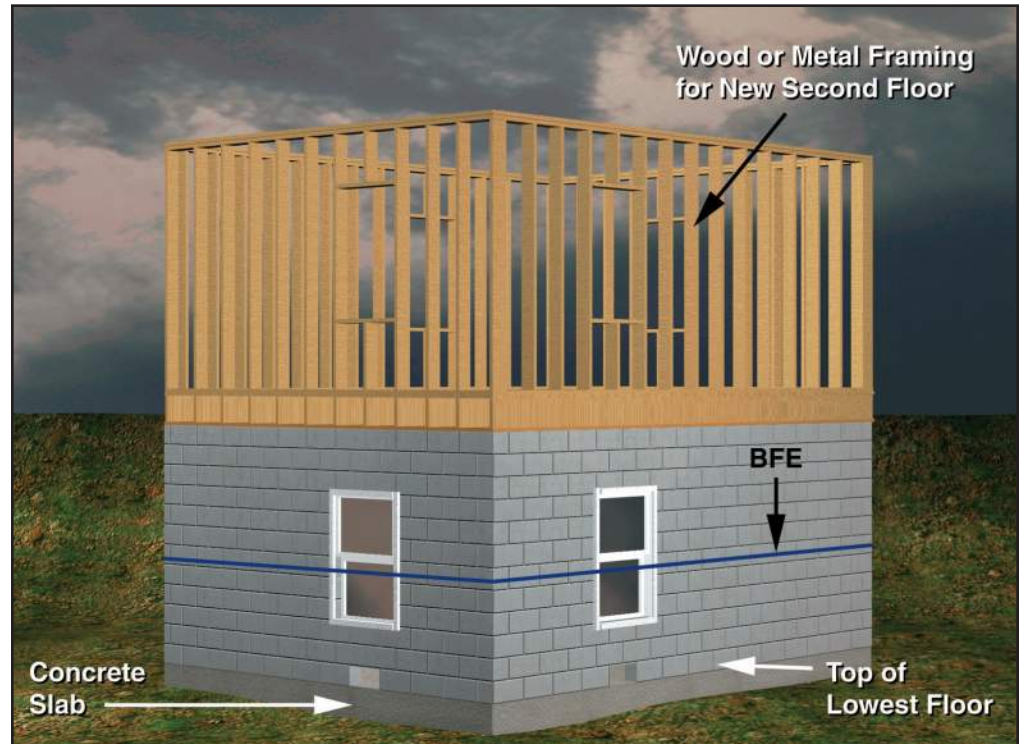
Figure 15
The new second-story floor and walls are built on top of the existing lower story.

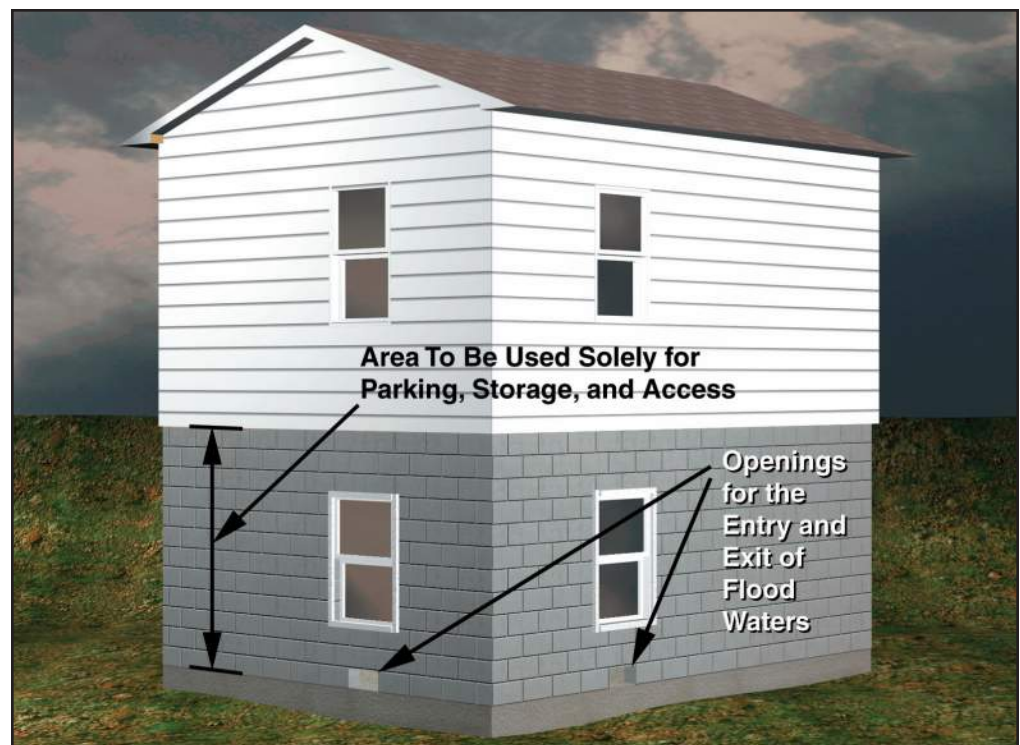
Figure 16
The new second-story walls are covered with siding or stucco.

Some homeowners prefer that the second story be constructed of masonry, but wood- or metal-framing is more common, primarily because it is lighter and less expensive. The roof is replaced, and blocks are removed from the walls to allow flood waters to enter and exit. Exterior sheathing is then added to the framed walls of the second story, the new windows are installed, and siding or stucco is applied to the sheathing (Figure 16).

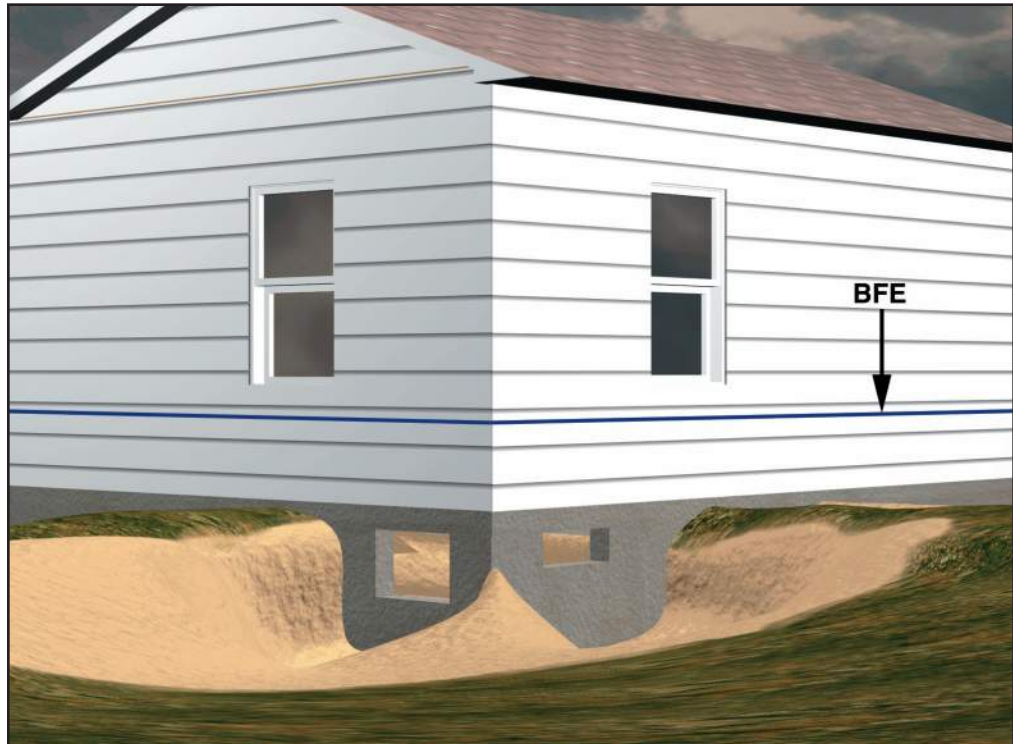
Figure 17
Trenches and tunnels under the slab provide access for the jacks and I-beams that will lift the house.

First, trenches are dug to expose the foundation walls immediately below the slab. Holes are then cut in the foundation walls at intervals around the house, and tunnels are dug under the slab (Figure 17). Jacks are placed in the trenches and large I-beams are inserted through the tunnels and allowed to rest on the jacks. Smaller I-beams are then inserted through the tunnels at right angles to the larger beams and positioned on top of them. The smaller beams support the slab when the house is raised (Figure 18).

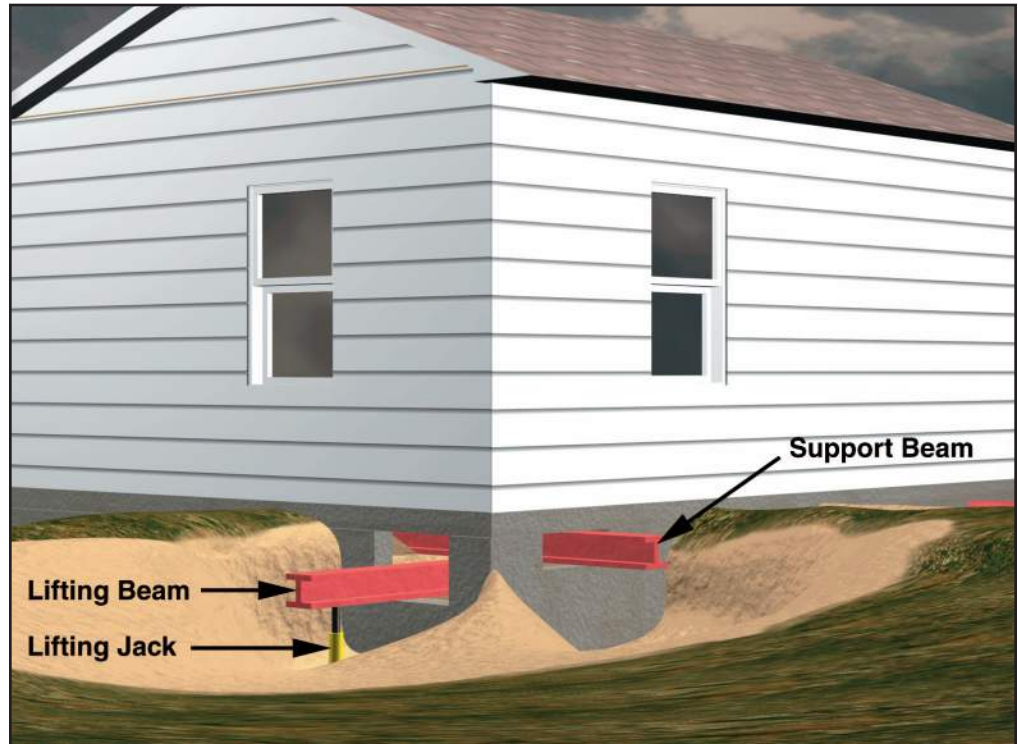
Figure 18
With I-beams and jacks in place, the house is ready to be lifted.

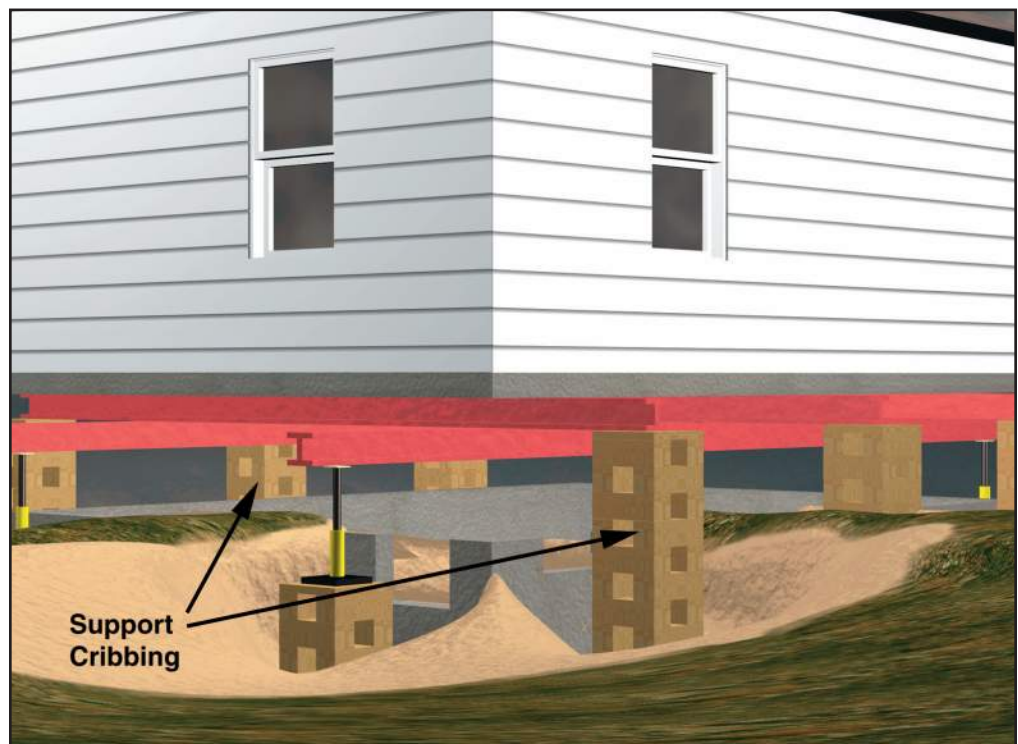
Figure 19
The house is temporarily supported on cribbing.

The house is then jacked up. When the jacks have extended as far as possible, the house must be supported temporarily while the jacks are raised. Both the house and the jacks are usually supported on “cribbing”—temporary piles of crisscrossed timbers (Figure 19). The jacks are then used to raise the house higher.

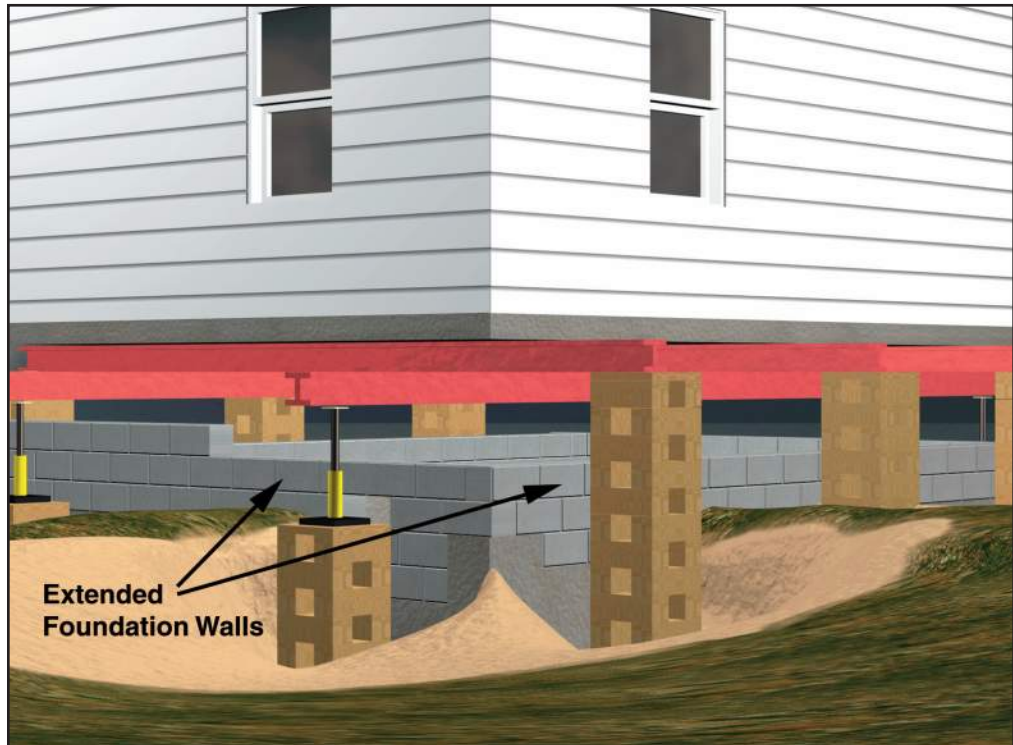
Figure 20
New, extended
foundation walls are
constructed with
concrete blocks.

This process is repeated until the house is raised to the desired height. The foundation walls are then extended upward with additional rows of concrete block (Figure 20). As in the previous techniques, openings are made in the walls within 1 foot of the ground so that flood waters will be able to flow into and out of the area below the elevated floor. The jacks and beams are removed, and the openings left around the beams are filled with blocks (Figure 21).

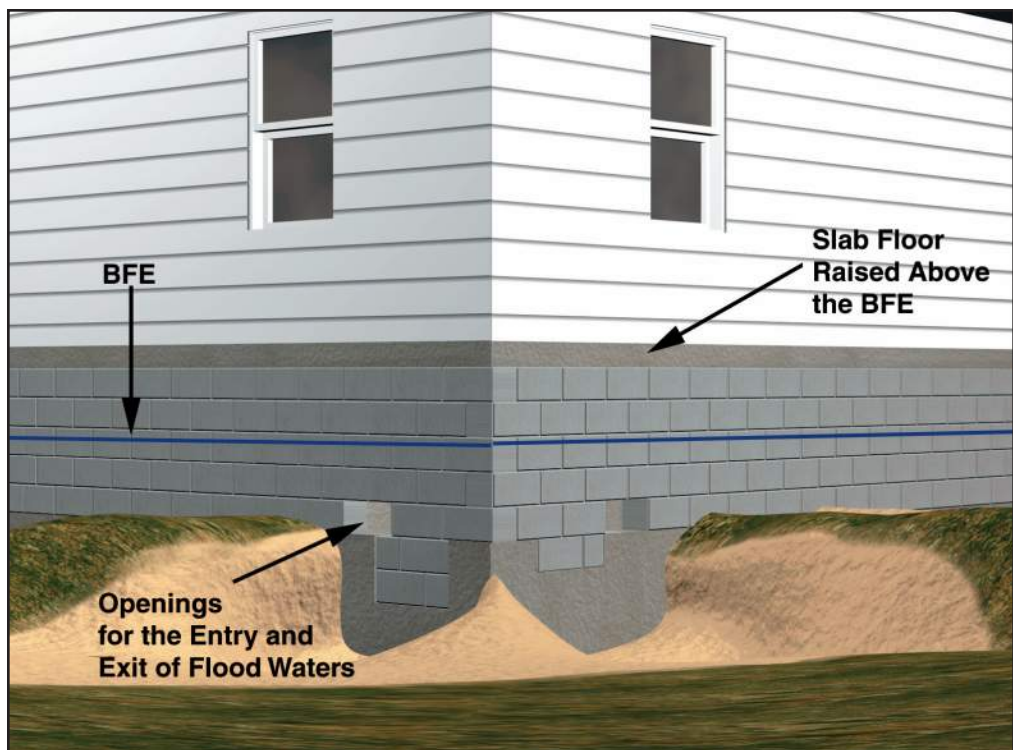
Figure 21
Elevated house and
slab on new, extended
foundation walls.

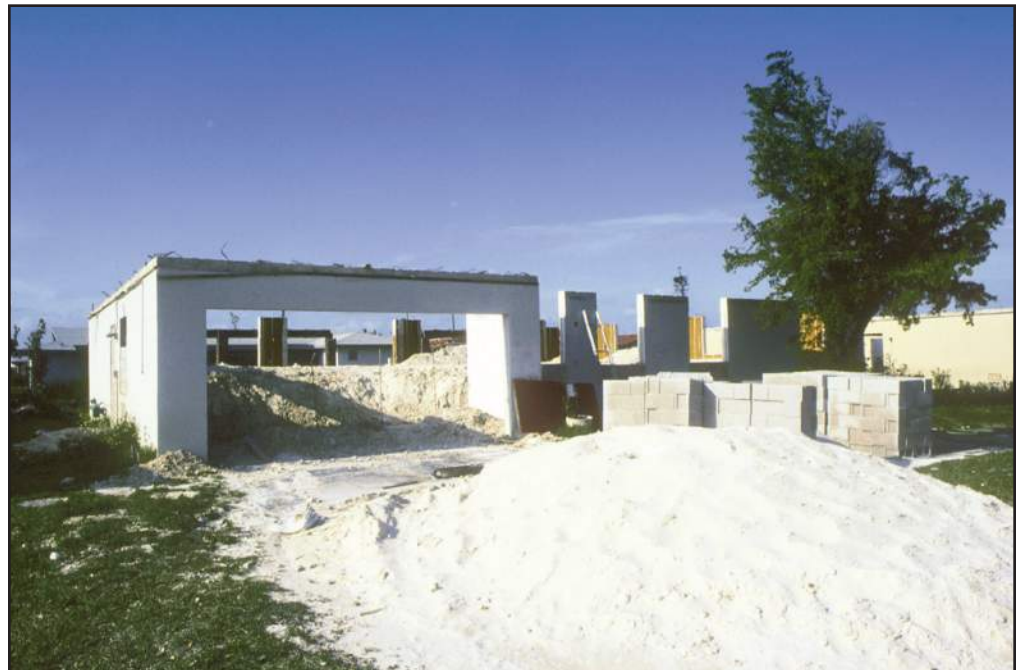
Figure 22

The front of the house at the beginning of the project. The interior walls and contents, which were destroyed or severely damaged by flood waters, wind, and rain, have been removed. Sand has been placed on top of the old slab to provide the base for the elevated lowest floor. The concrete blocks that will be used to extend the walls can be seen stored in the foreground.

The first case study house (Figures 22–32) has masonry walls and a slab-on-grade foundation. The roof of this house was severely damaged by high winds during Hurricane Andrew, and the interior walls suffered extensive damage from flood waters and rain. The owner decided to raise the lowest floor above the BFE by extending the walls upward, placing sand fill on top of the original slab floor, and pouring a new, elevated concrete slab on top.

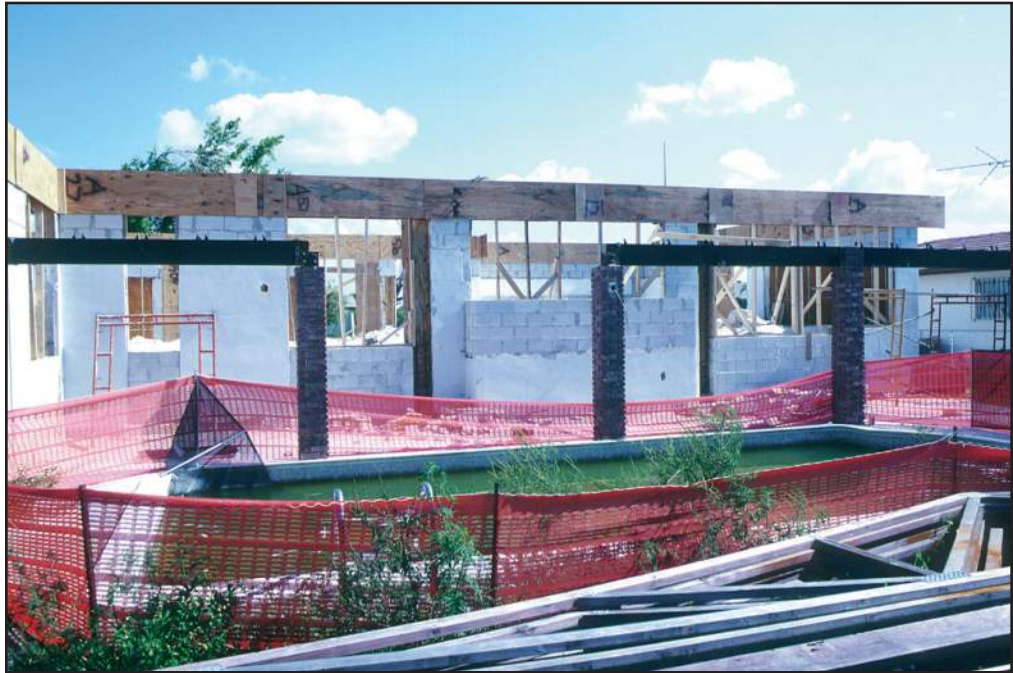
Figure 23
View from the back of the house. The walls have been extended upward with concrete blocks. The plywood visible at the tops of the walls is used to form cast-in-place concrete bond beams that will strengthen the extended walls. The roof trusses shown in the foreground were salvaged for reinstallation. The owner of this house decided to replace the original roof sheathing and shingles with new materials.

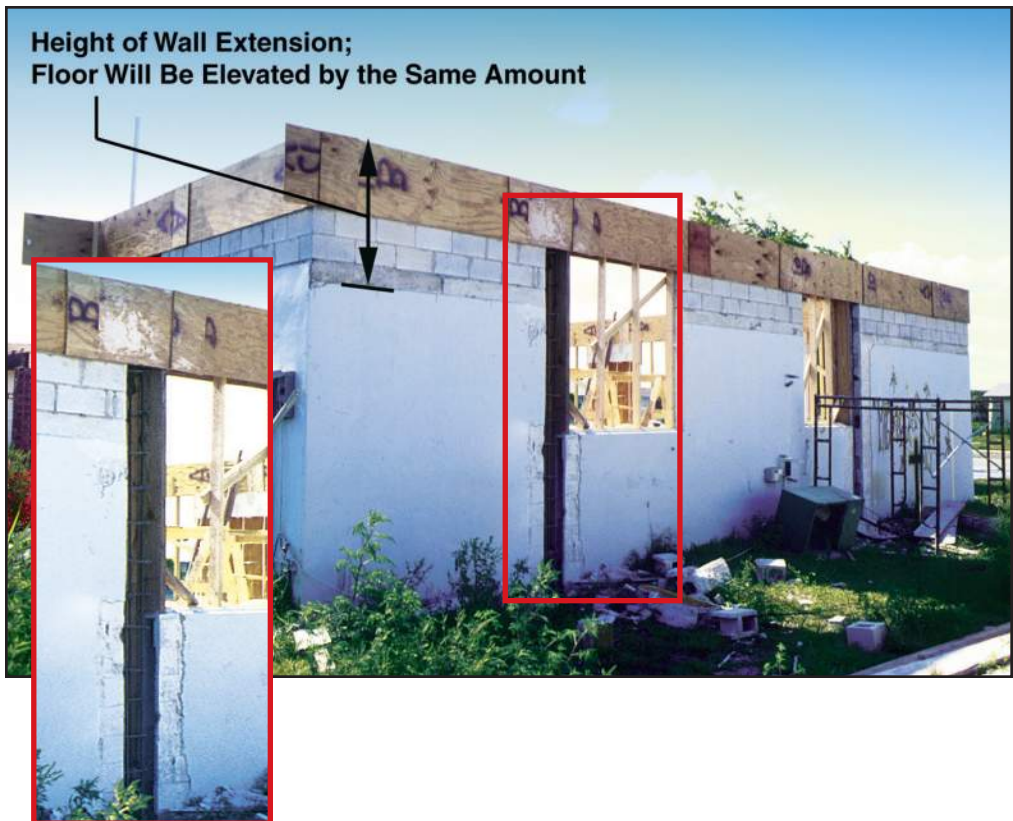
Figure 24
Another view of the extended walls. The vertical cuts in the walls next to the windows are for concrete tiedown columns that will be cast in place to further strengthen the extended walls against wind loads. The owner of this house was able to meet the elevation requirement by raising the floor only a few feet, as indicated by the amount that the walls have been extended.

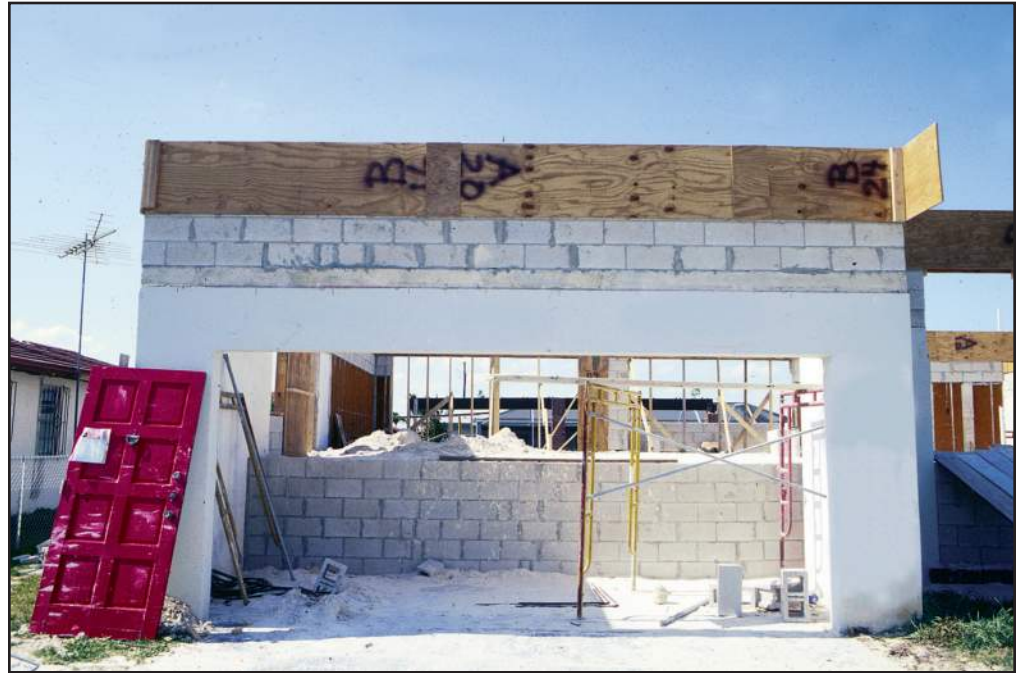
Figure 25

This view through the garage door reveals the different levels of the elevated slab floor, in the background, and the unelevated garage floor.

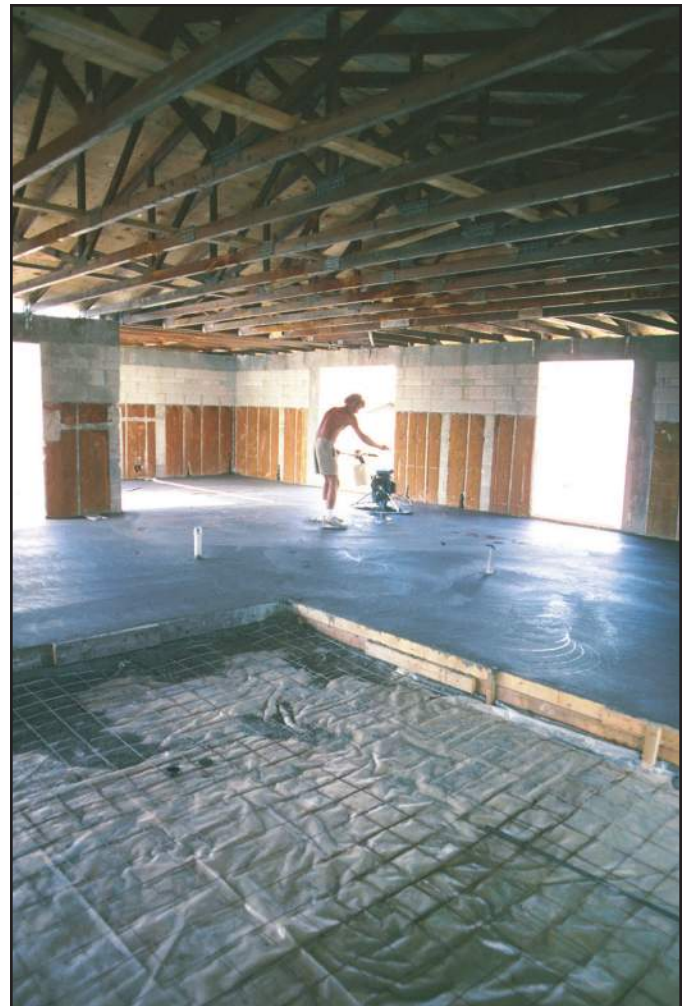
**Figure 26**

The roof has been rebuilt with the salvaged trusses, and most of the new concrete slab has been poured on top of the sand fill. The open area in the foreground, where plastic sheeting and wire reinforcement can be seen on top of the sand fill, is where the remaining part of the slab will be poured.

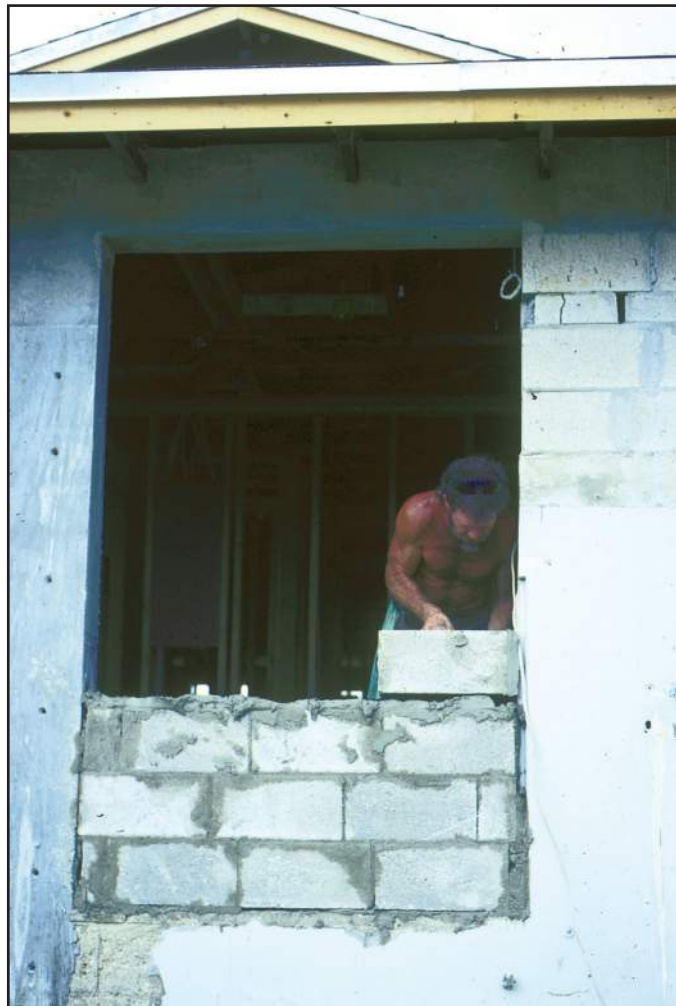
Figure 28
The bottoms of the
original window
openings are raised
with concrete blocks.

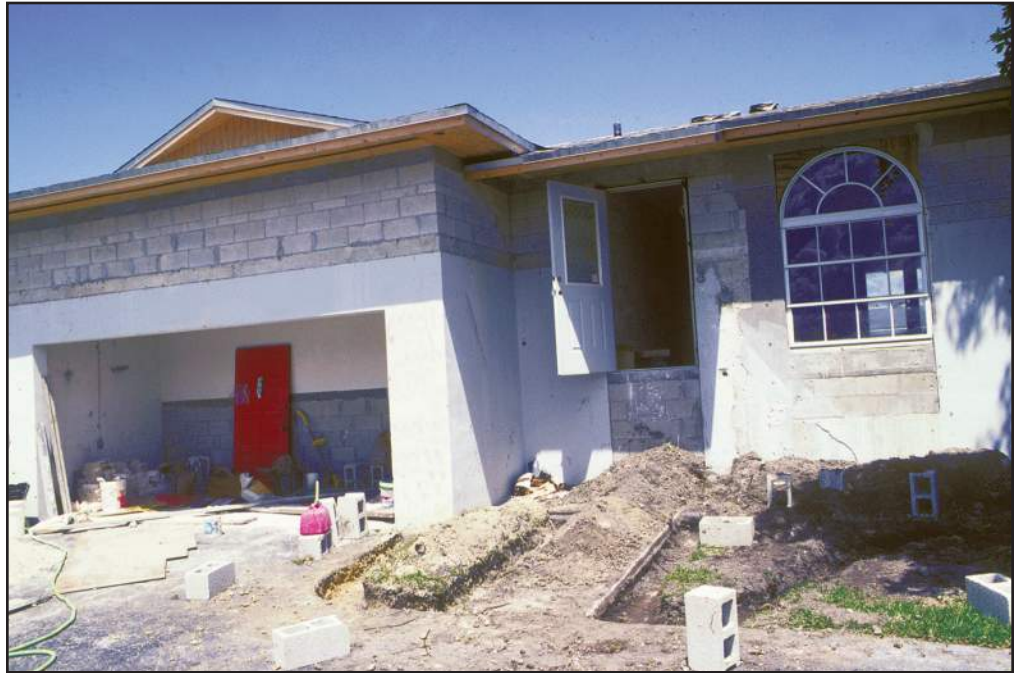
Figure 29
Windows and doors are added. The height of the raised front door shows the amount of elevation.

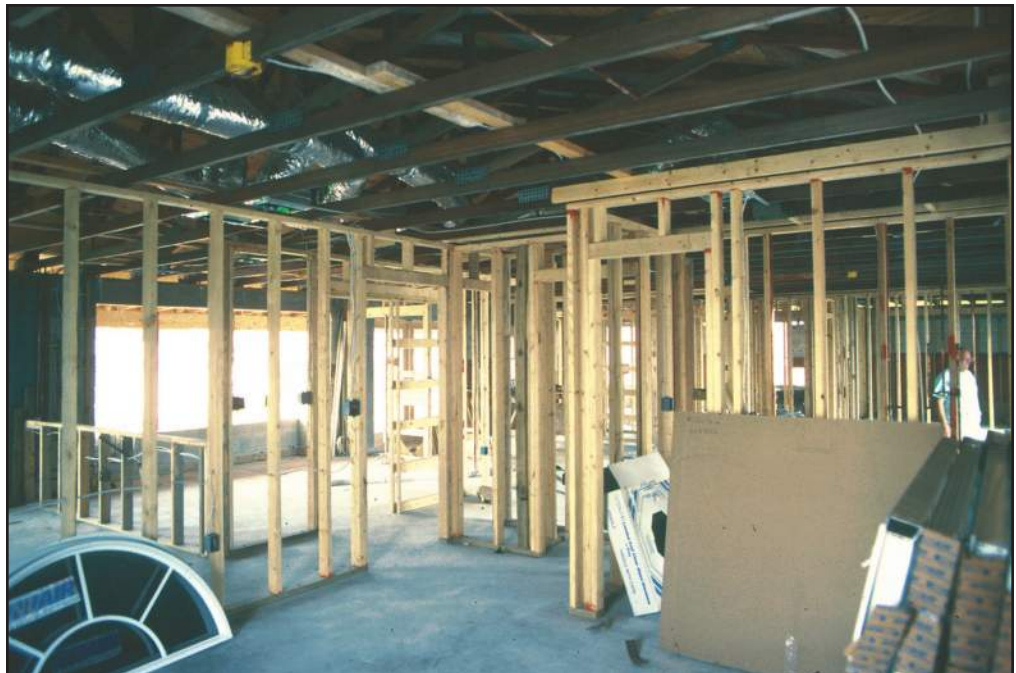
Figure 30
Interior partition walls and utilities are added.
