Above the Flood: Elevating Your Floodprone House

FEMA 347/ May 2000

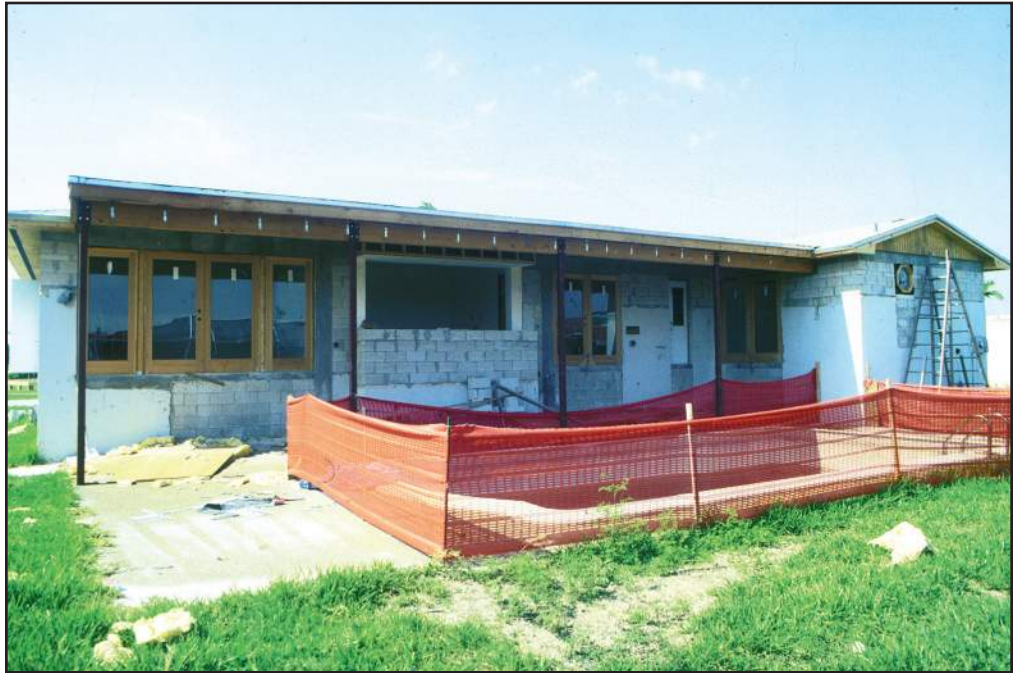
Figure 31

This view from the rear of the house shows that the project is almost complete.

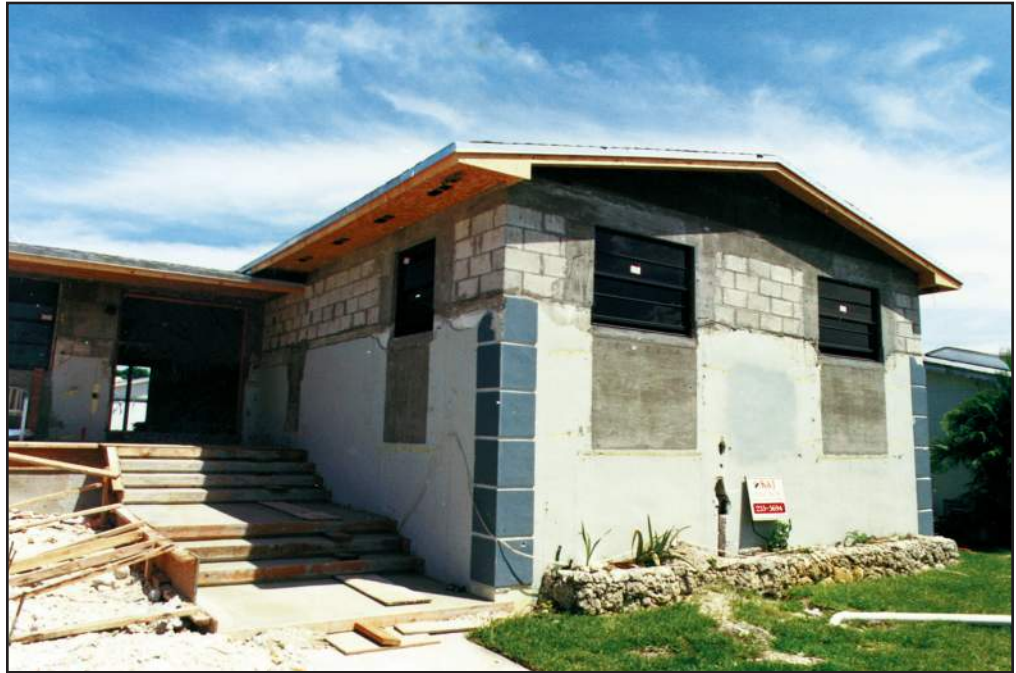
**Figure 37**

The project nears completion. In this house, as in Case Study 1, the level of the garage floor remains unchanged.

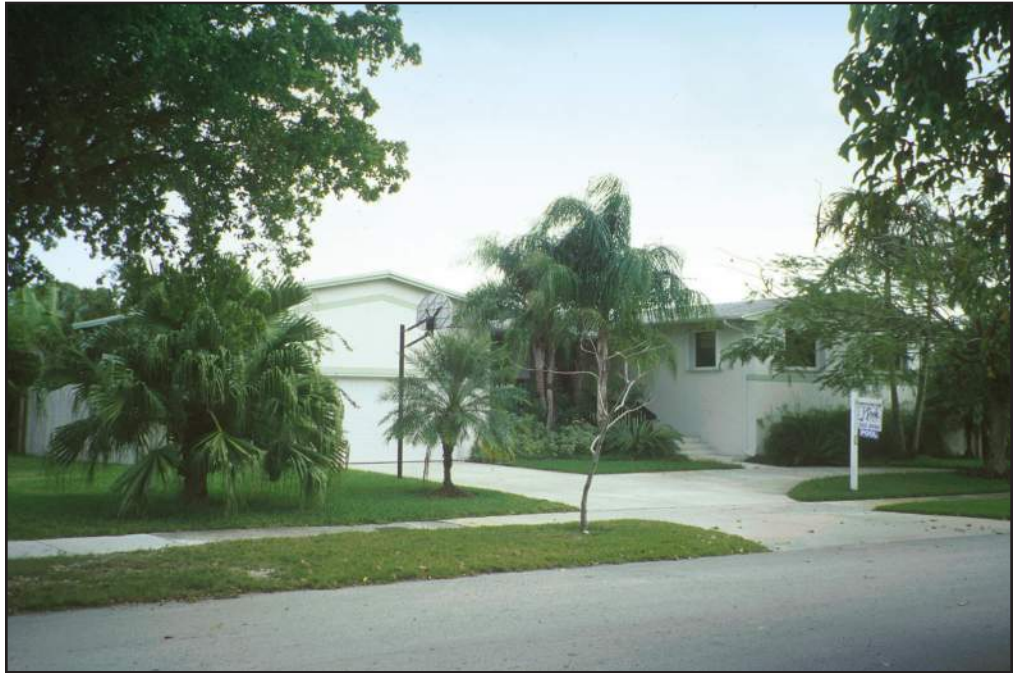
Figure 39

The roof of this house was removed as a single piece; the trusses were held together with bracing and portions of the original roof sheathing. This approach made it easier to reinstall the roof at the end of the project.

In the third house for which Technique 1 was used (Figures 39–44), the lowest floor was raised only about 1 foot. Otherwise, the work performed was essentially the same, with a few minor exceptions.

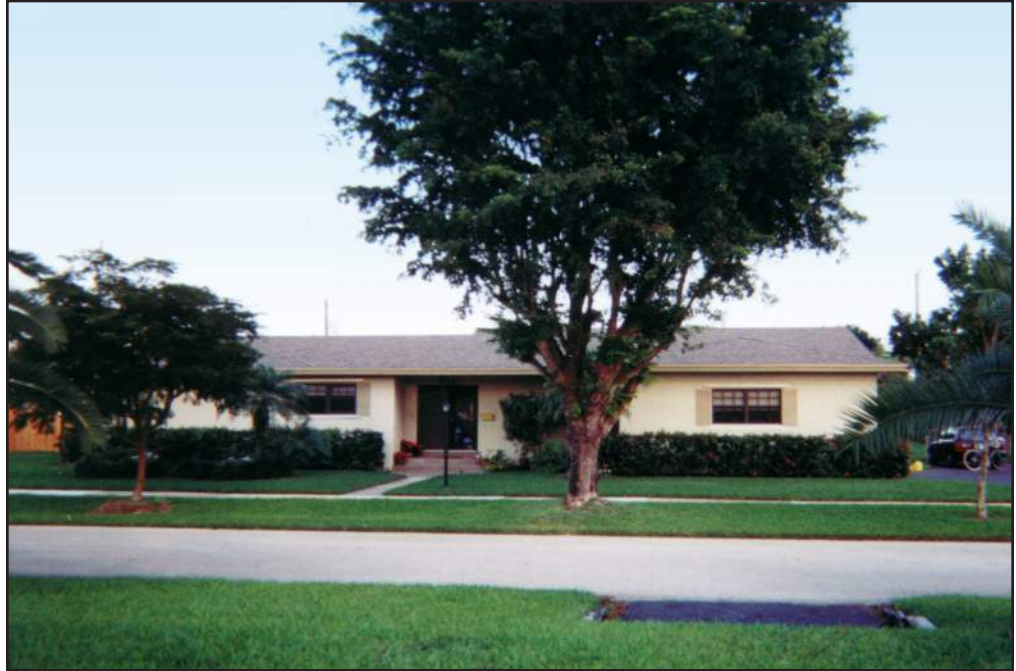
Figure 45

Concrete bond beams similar to those shown earlier were used in this house, but here they were installed on the tops of both the original first-story walls and the new reinforced concrete block second-story walls.

The owner of this house (Figures 45–50) chose to build the new second story with reinforced concrete block.

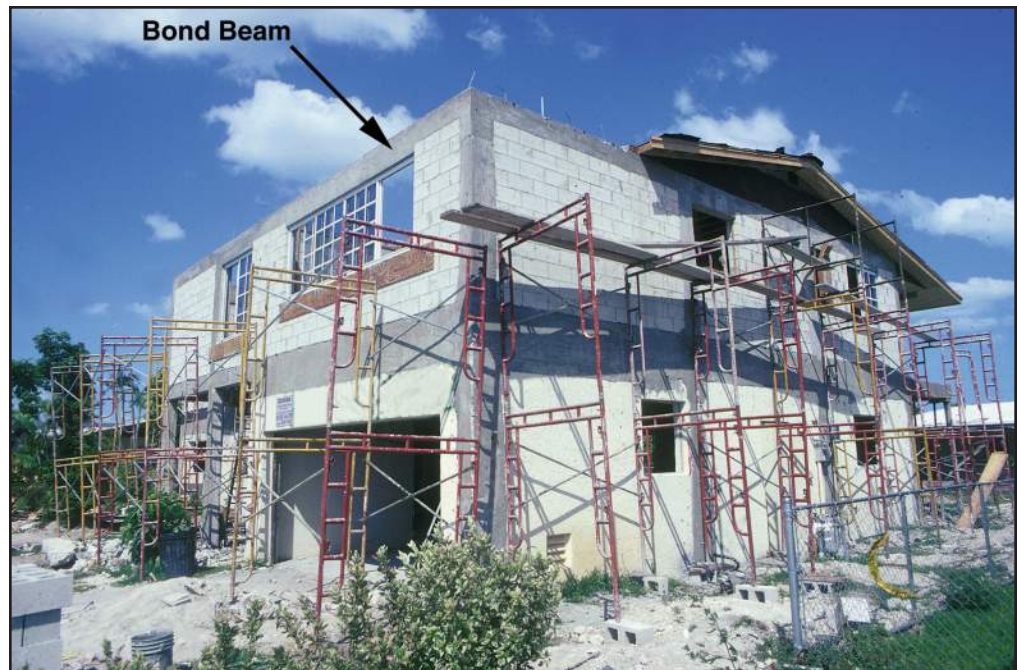
Figure 46
Concrete tiedown columns, such as the one to the left of the window in this photograph, were also used in this house.

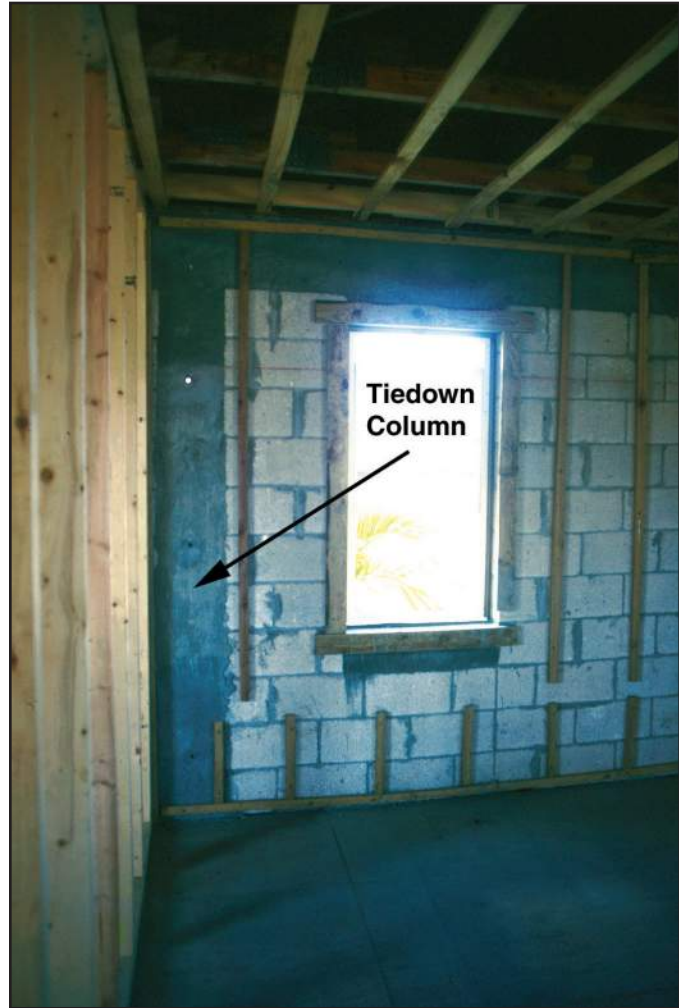
Figure 47
The tiedown columns extend down from the new second-story walls and into the original first-floor walls. The columns tie the first and second stories together and provide a continuous load path that helps the house resist the forces of high winds.

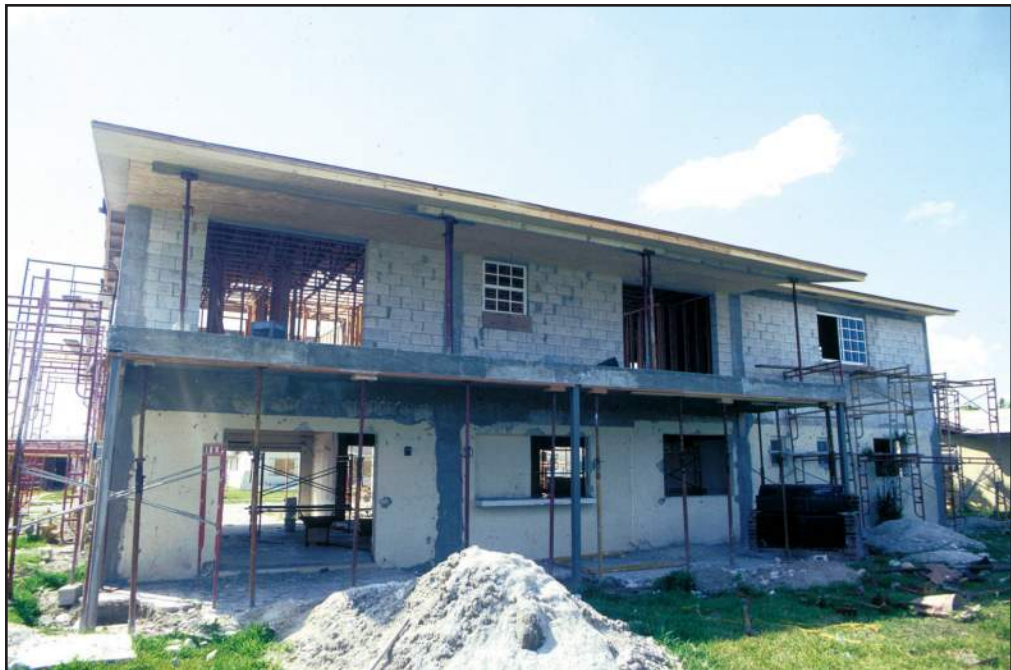
Figure 48
Wood 2 by 4 studs
were used to frame
the interior walls of
the second story.

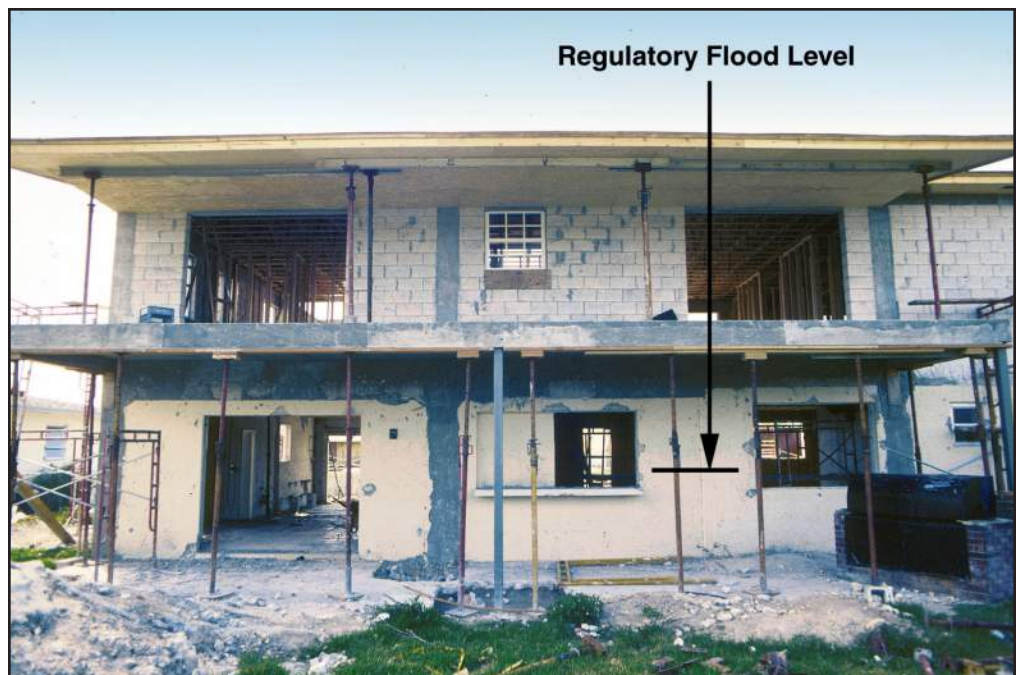
Figure 50

Not only does the completed house meet the requirements of local codes and the NFIP regulations, it now includes a substantial amount of parking and storage space below the new living level. In addition, because the lowest floor is now over 4 feet above the regulatory flood elevation, the house is eligible for NFIP flood insurance at a greatly reduced rate of coverage.

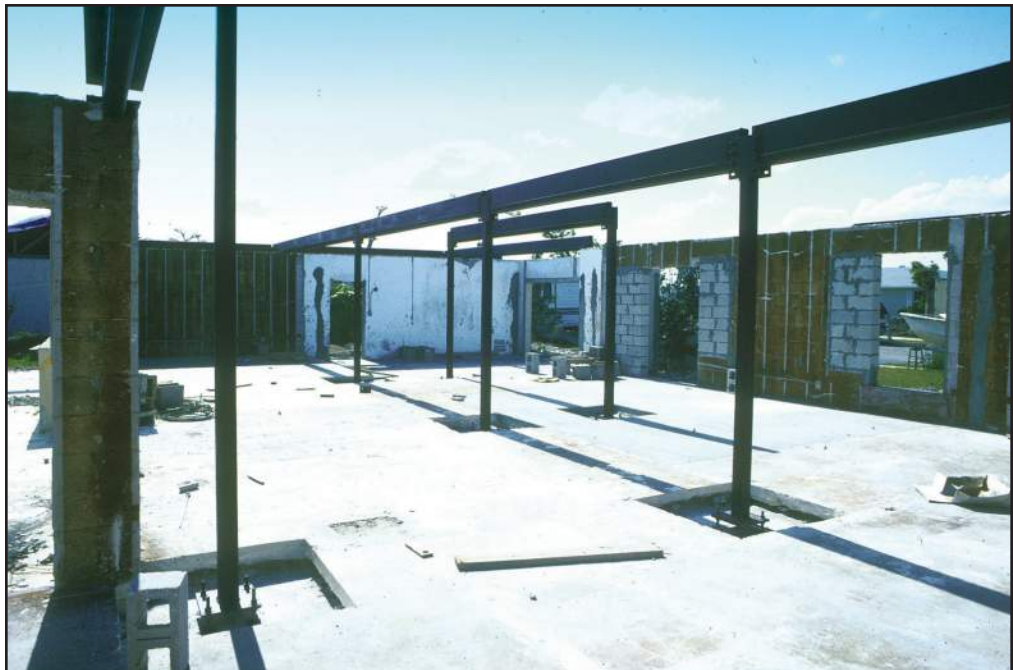
Figure 52

The existing first-story walls have been strengthened by the addition of concrete block. Metal columns and beams have been added to help support the new second story.

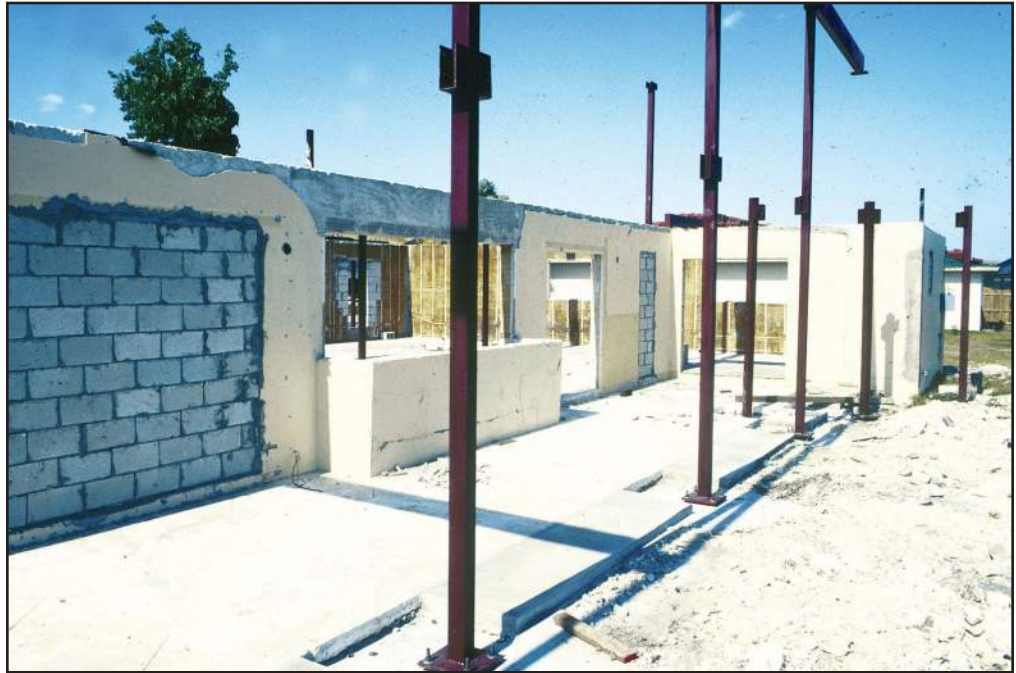
**Figure 53**

As the second story takes shape, its size in relation to the size of the original house becomes apparent.

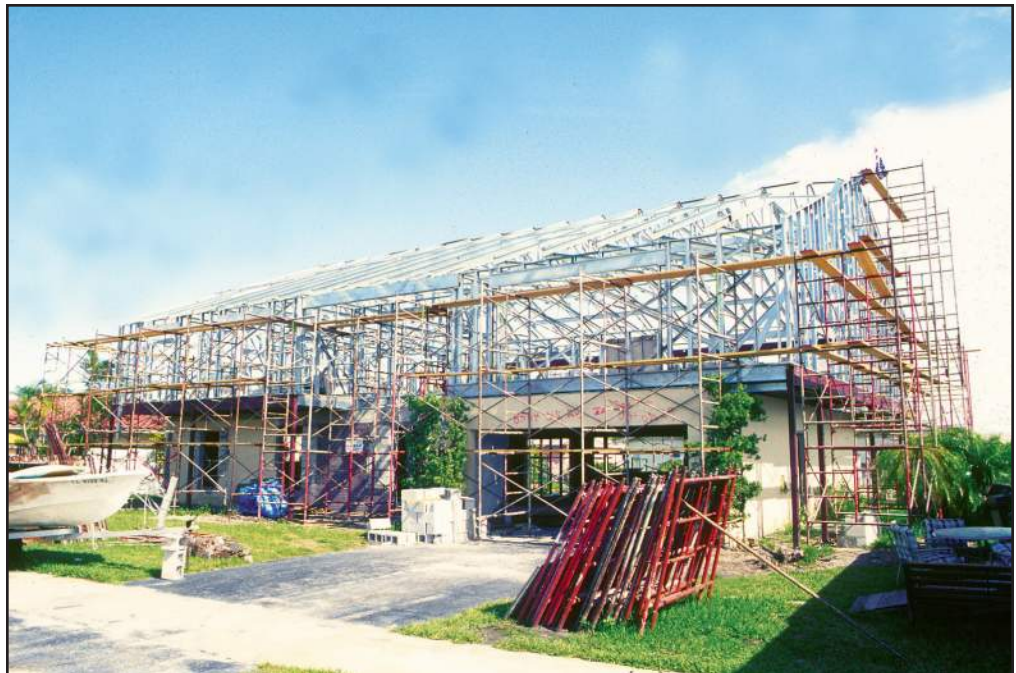
Figure 54
Metal framing is used for the new second story, including the walls and roof support system.

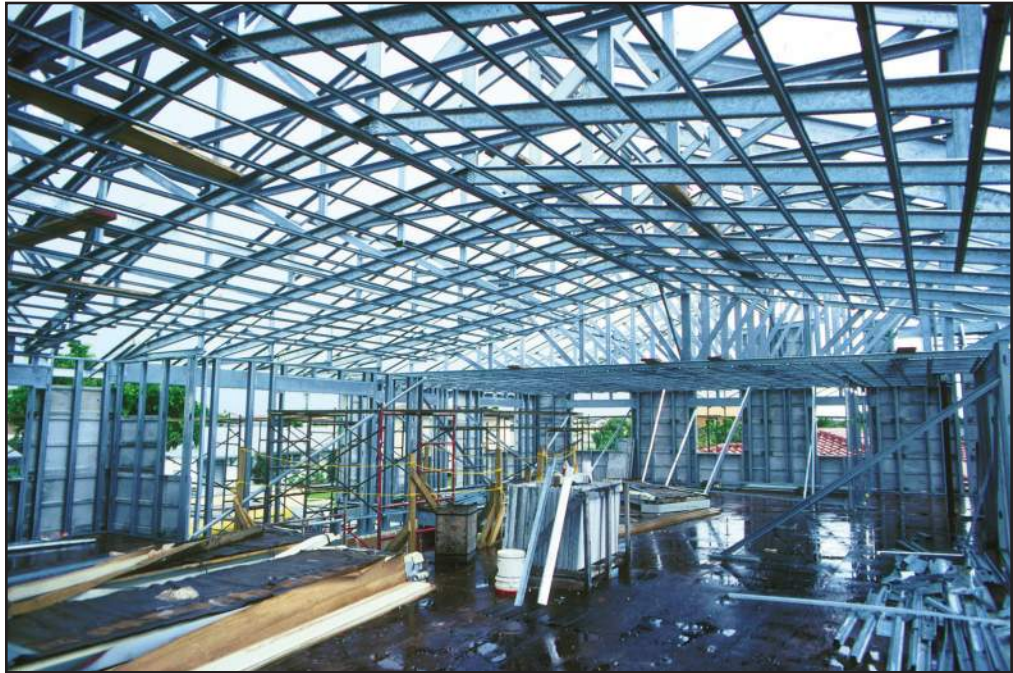
Figure 55
Metal framing also supports the floor of the new second story.

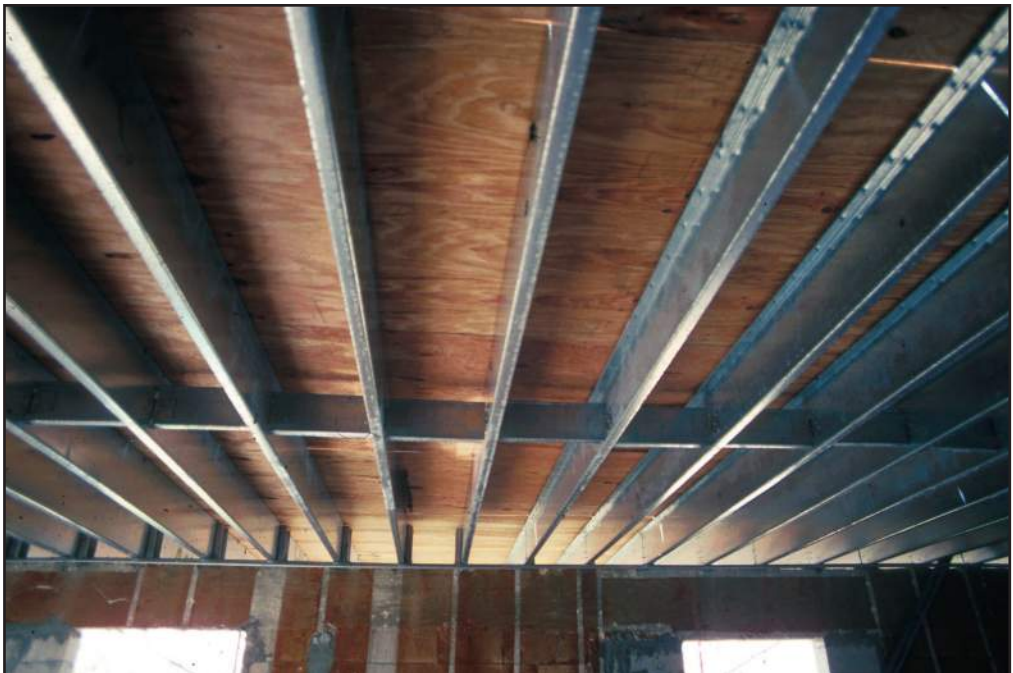
Figure 56

One advantage of metal framing is its relatively light weight. An additional advantage is that the screws used to attach metal-frame components provide strong connections.

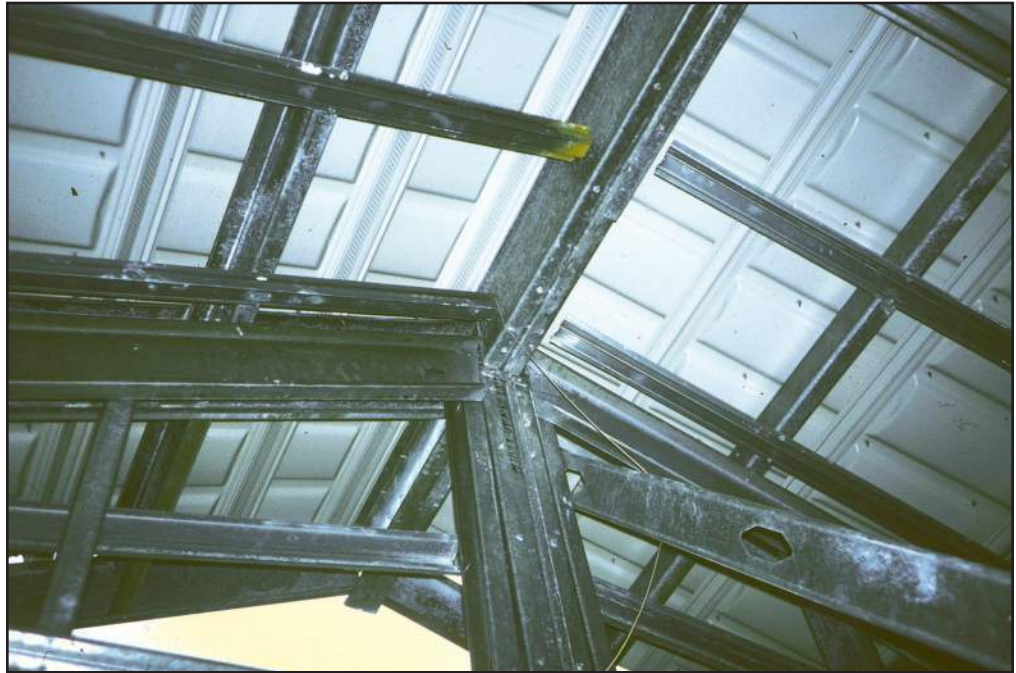
**Figure 57**

The project progresses with wiring and other utility work. As in each of the other house elevation projects, all current building code requirements must be met.

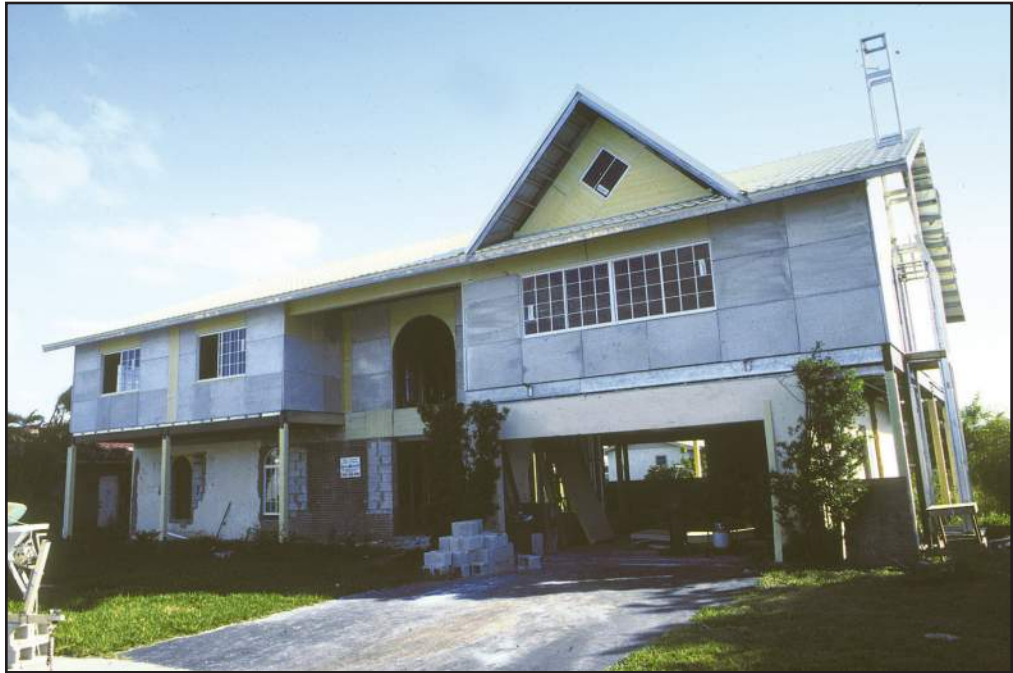
Figure 59

The exterior
walls consist of
prefabricated
concrete panels.
Innovative techniques
such as those
employed in this
project are helping
homeowners who
need practical and
economical methods
of repairing and
protecting their
houses.

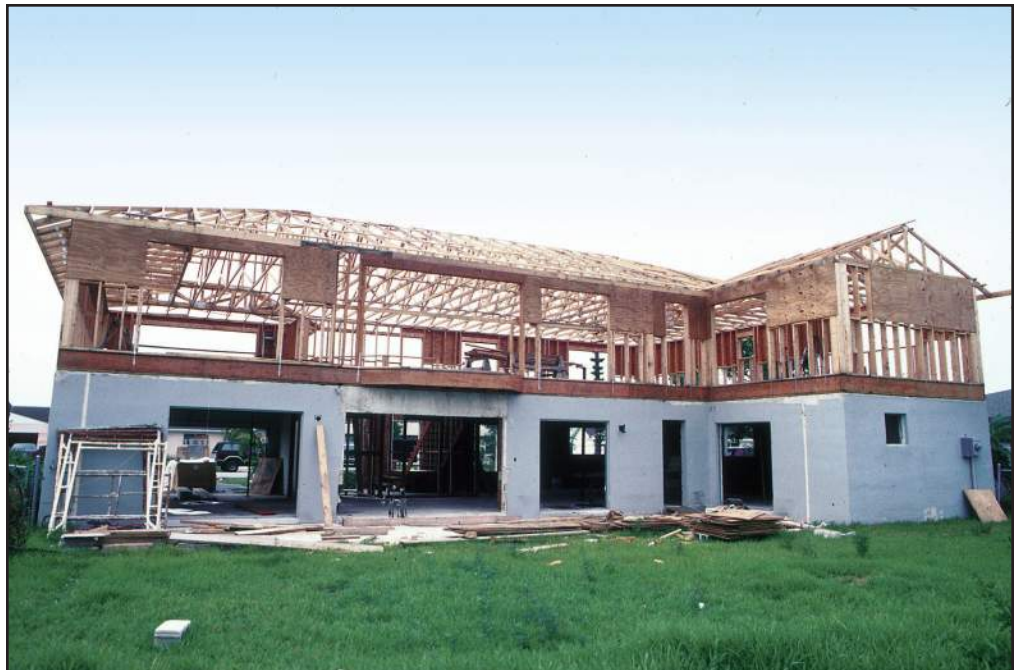
Figure 62
After the wood framing was completed, the roof and exterior wall sheathing were added.

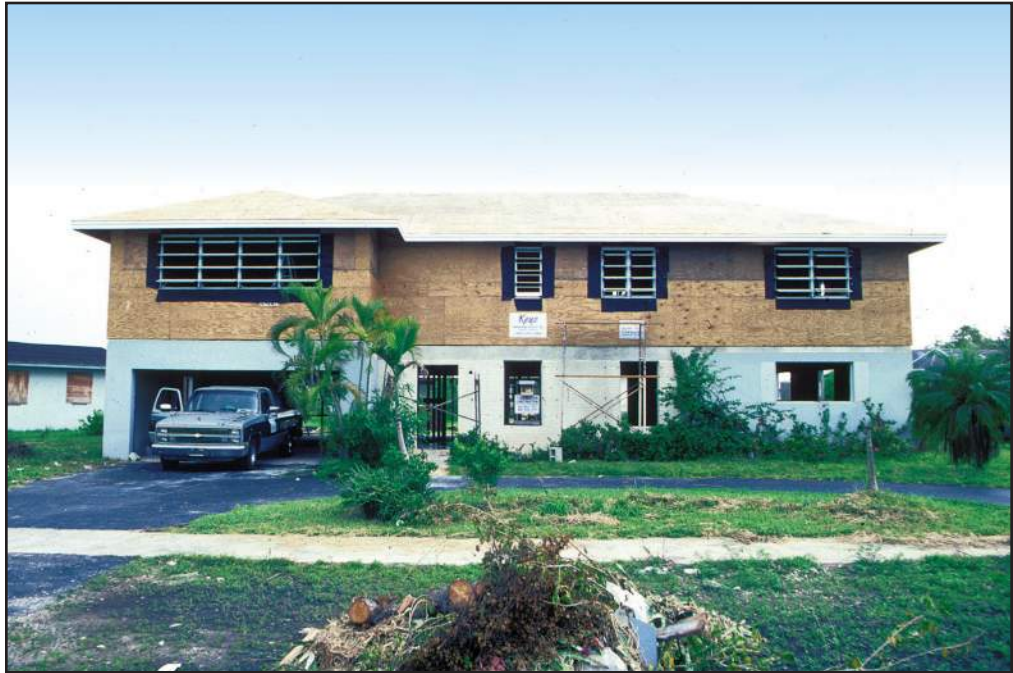
Figure 63
The new second-story walls are securely connected to the original first-floor walls with galvanized metal hurricane straps.

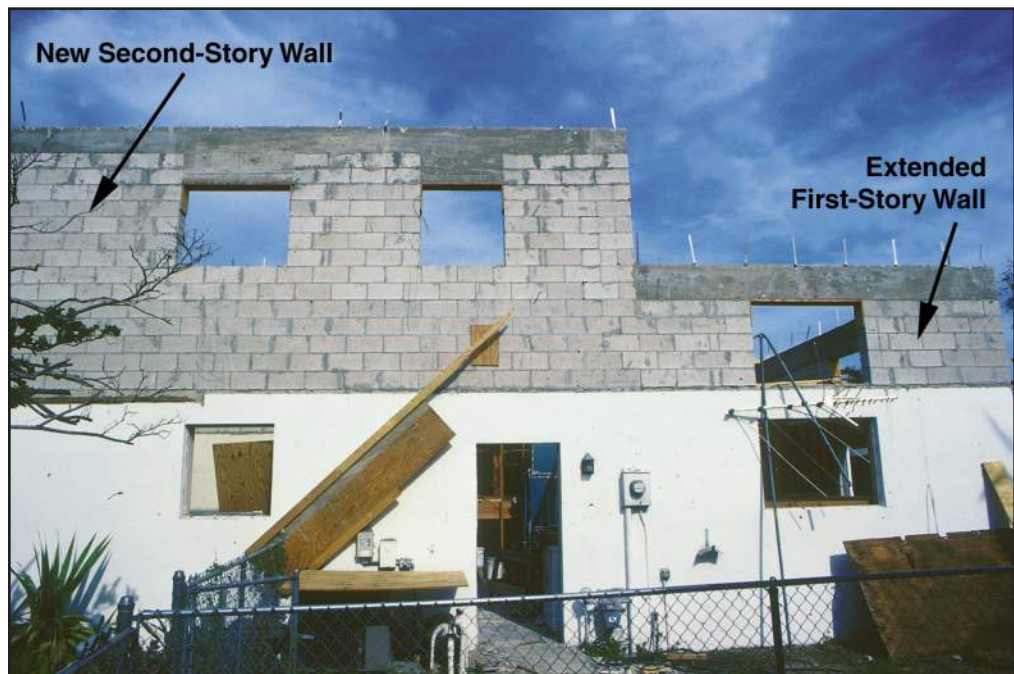
Figure 65

After the house was gutted, the walls were extended upward with reinforced concrete block. In this view from behind the house, the rear wall of the new second story can be seen on the left and the extended first-story wall on the right. Note the new raised window opening in the extended wall, just above the original opening.

Many owners of substantially damaged houses in the areas affected by Hurricane Andrew took advantage of the opportunities afforded by their elevation projects to make additional improvements. For example, the owner of the next house (Figures 65–72) used a combination of Techniques 1 and 2. In addition to extending the walls of the house upward and raising the lowest floor above the BFE, he built a new second-story addition over the garage. The addition was not a necessary part of the elevation process, but it does provide additional living space well above the flood level.

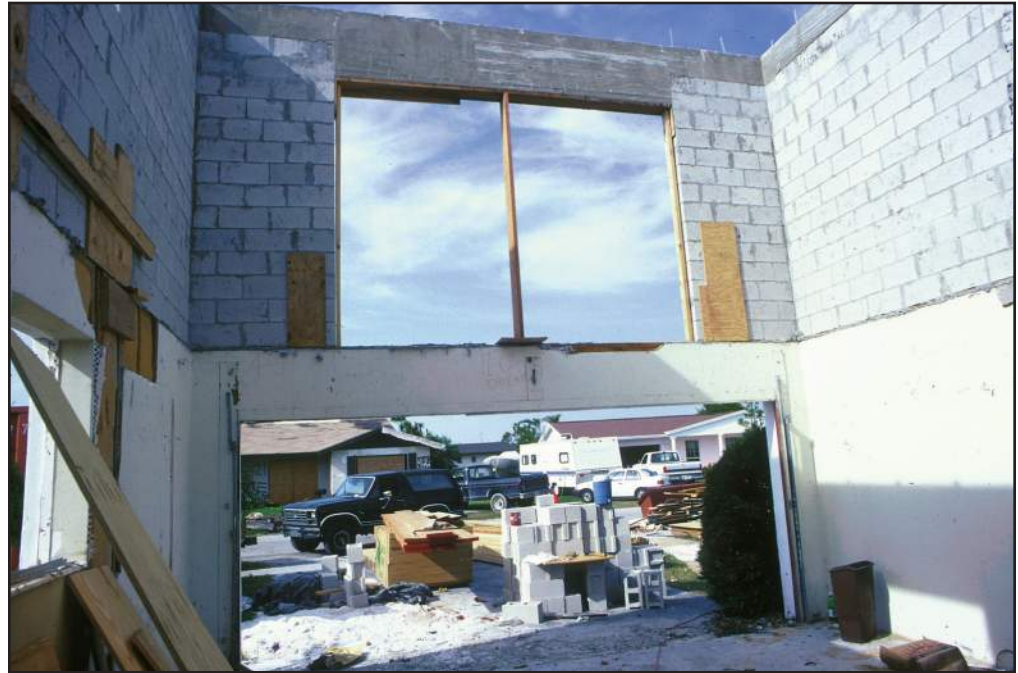
Figure 66
The new second-story walls as seen from inside the garage.

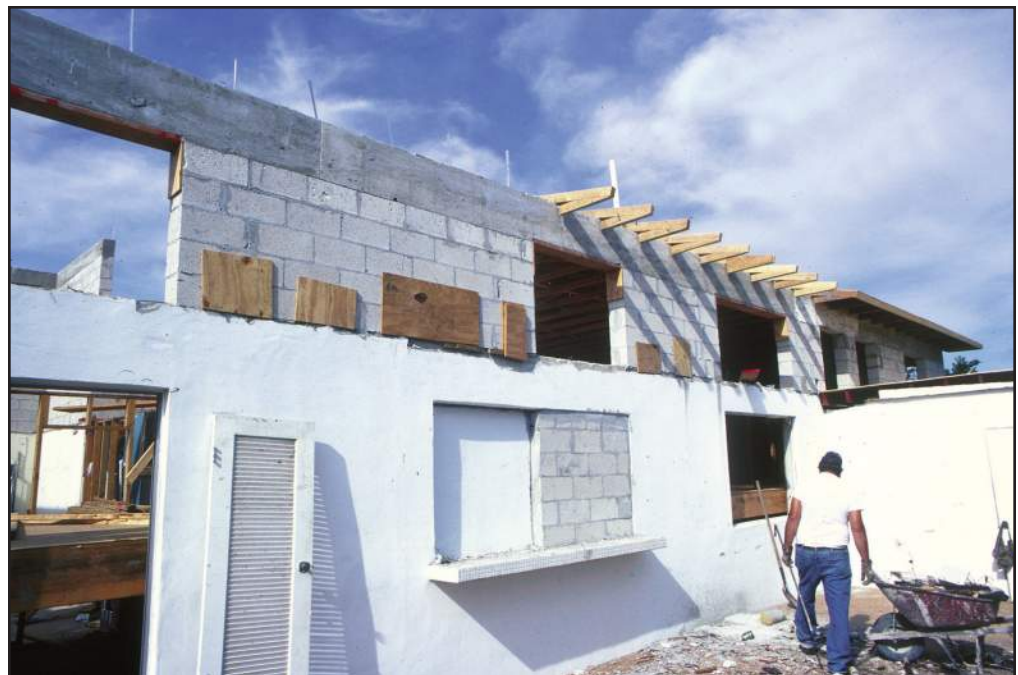
Figure 67
The extended first-story walls.

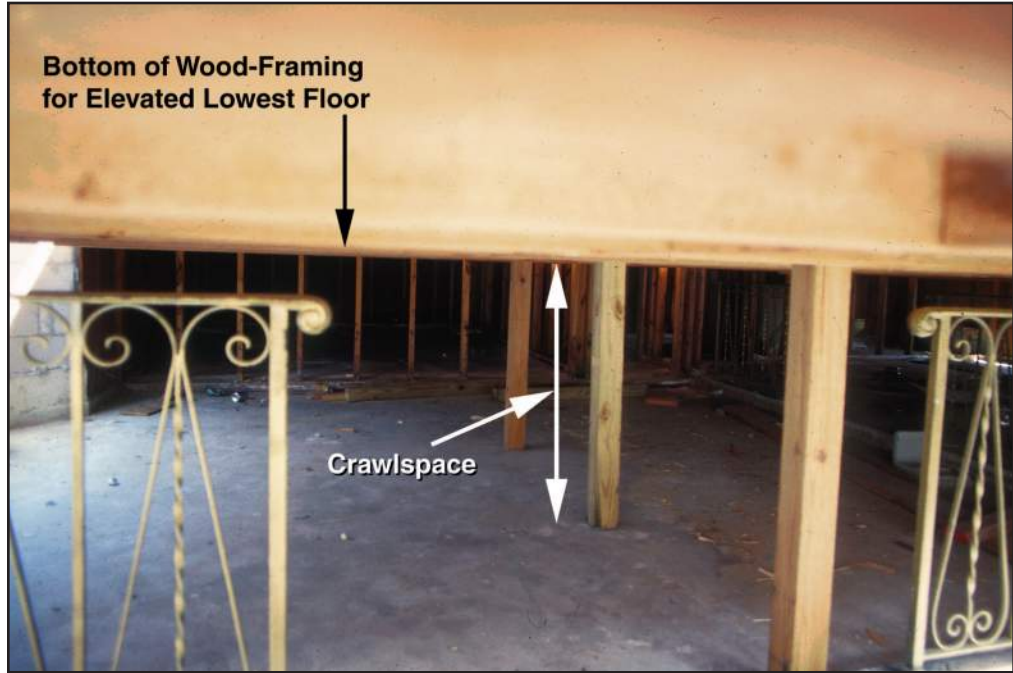
Figure 68

Rather than install a new concrete slab on compacted fill, the owner of this house chose to build a new wood-frame floor above the old concrete slab. This method creates a crawlspace below the new floor.

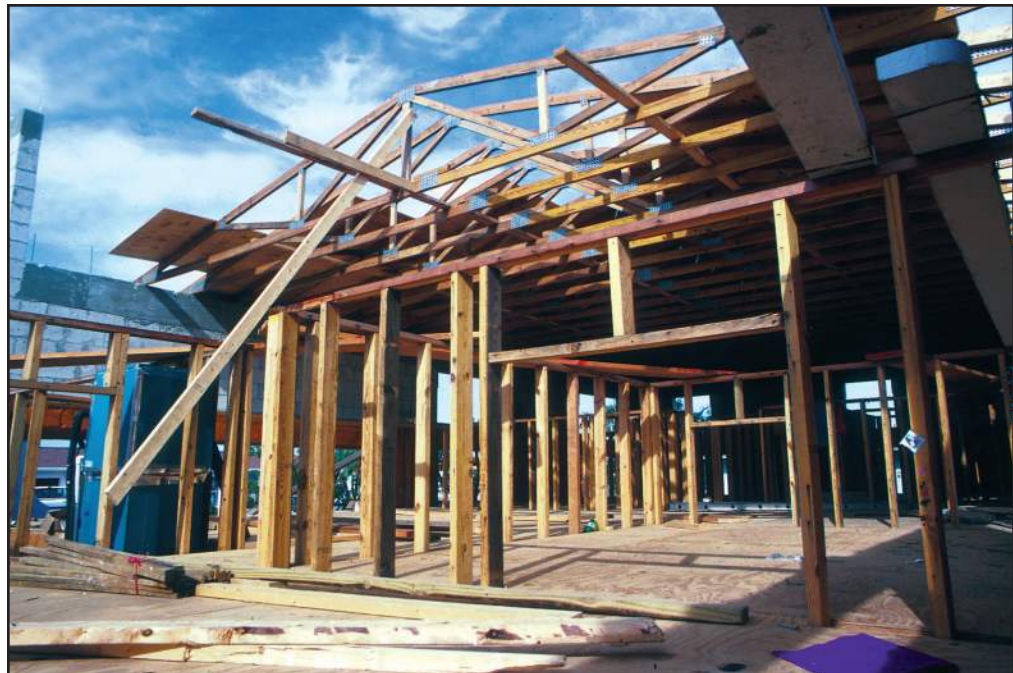
Figure 69

Wood framing is used for the new second story.

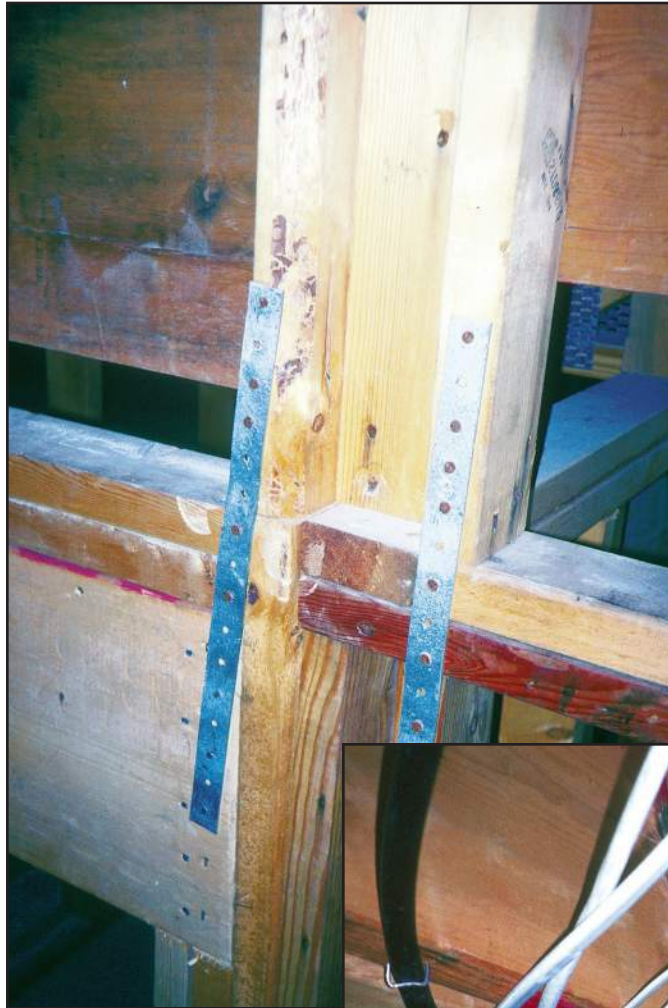
Figure 70

Metal hurricane straps are used to tie the structural members together and create a continuous load path from the roof to the foundation.

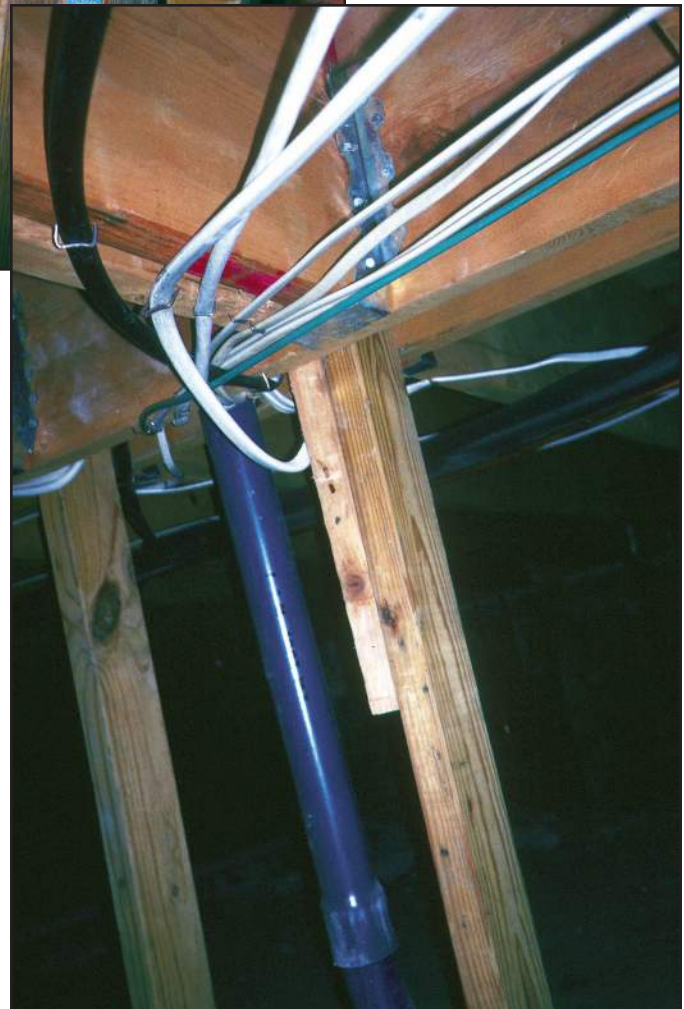
**Figure 71**

All plumbing and electrical renovation work must be performed according to state and local code requirements.

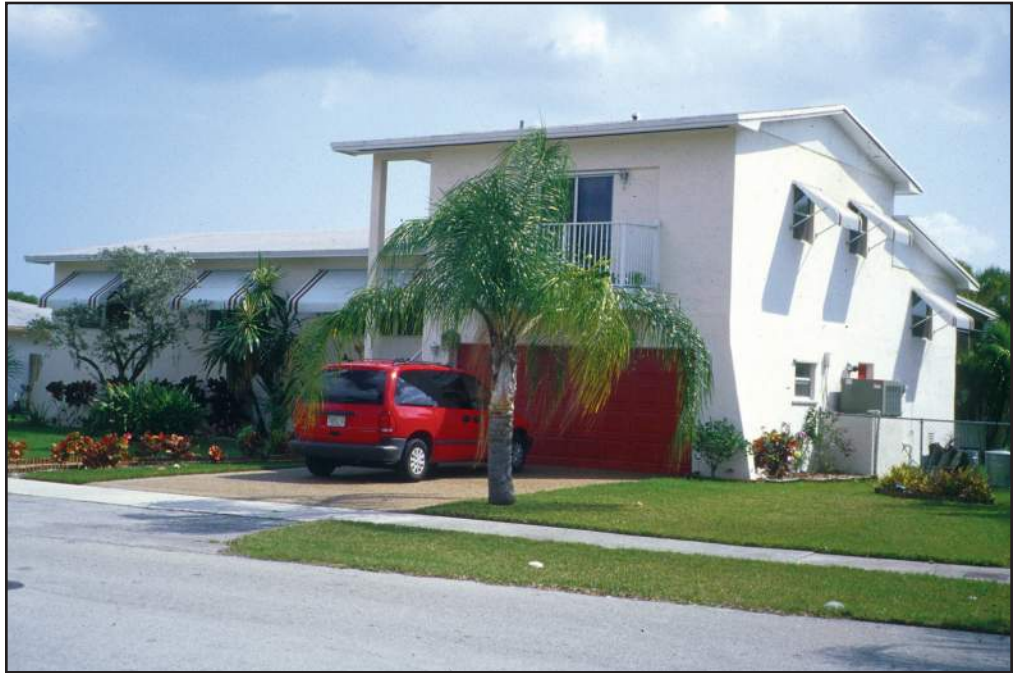
Figure 72
The completed house is compliant with local floodplain management requirements, is more resistant to flood damage, and provides additional living area above the flood level.

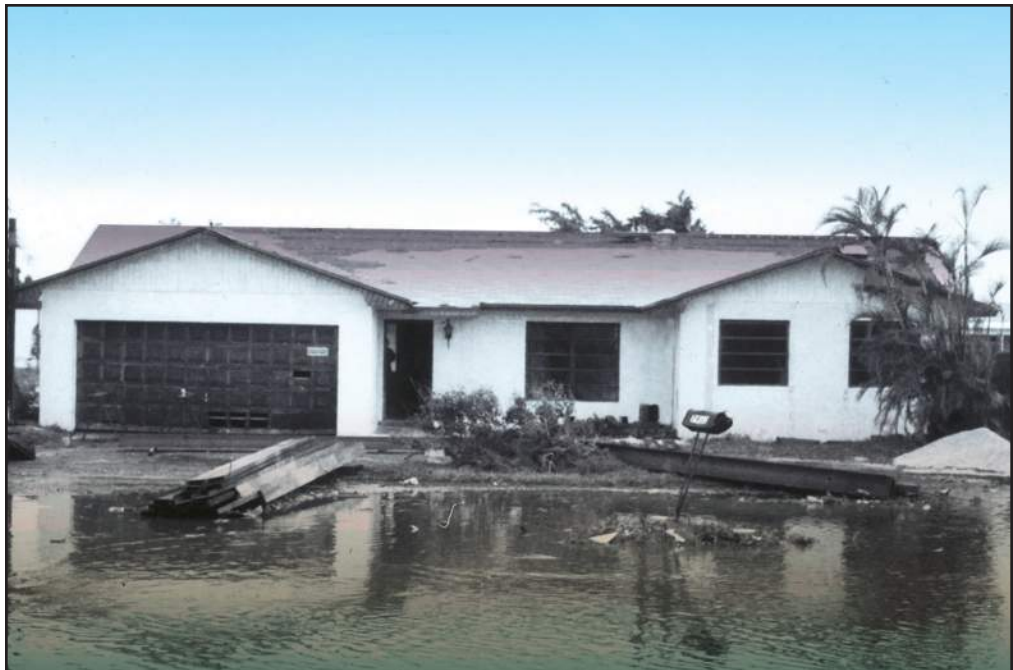
Figure 73
Like the houses shown previously, this one-story house, with its concrete block walls, concrete slab foundation, and attached garage, is typical of the houses in the area affected by Hurricane Andrew.

Unlike Techniques 1 and 2, which build up from the existing foundation and walls, Technique 3 lifts the entire house with hydraulic jacks and builds a new foundation below it (Figures 73–85).

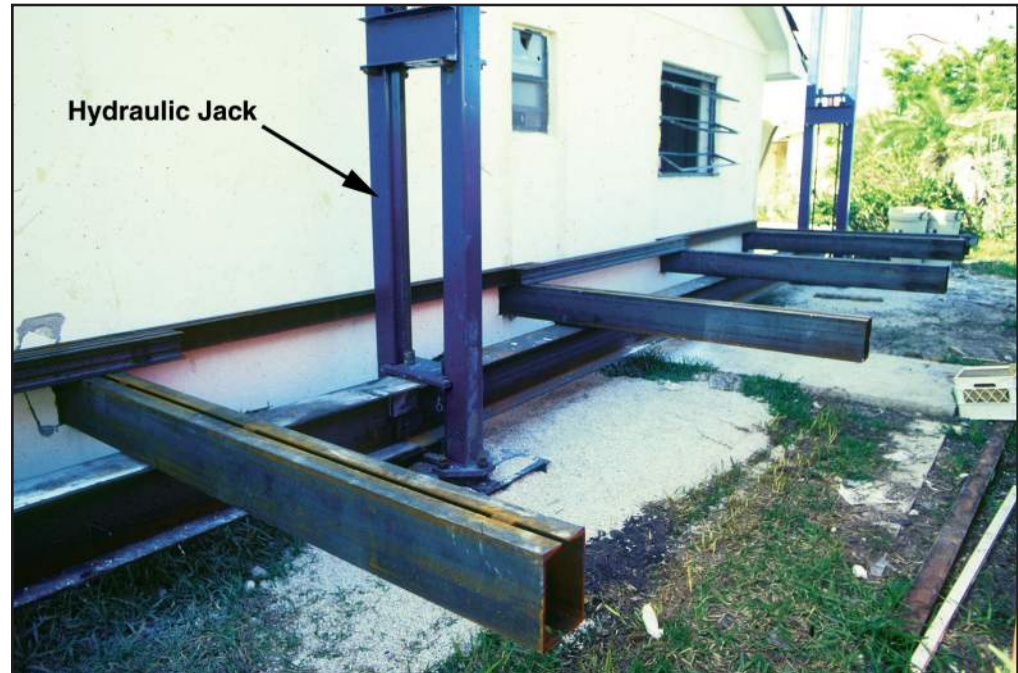
Figure 74

In this variation of Technique 3, steel beams are inserted through the walls of the house rather than under the slab. The beams span the length and width of the house and cross one another inside to create a grid. Outside the house, the beams rest on larger beams that will be raised with hydraulic jacks.

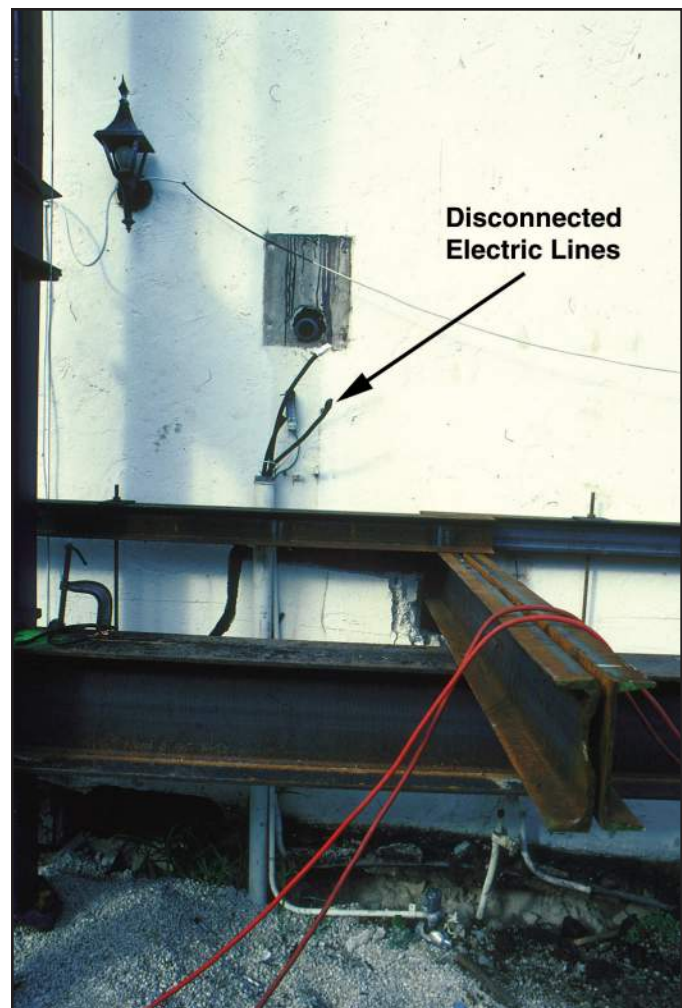
**Figure 75**

Electrical lines and other utilities were disconnected early in the project.

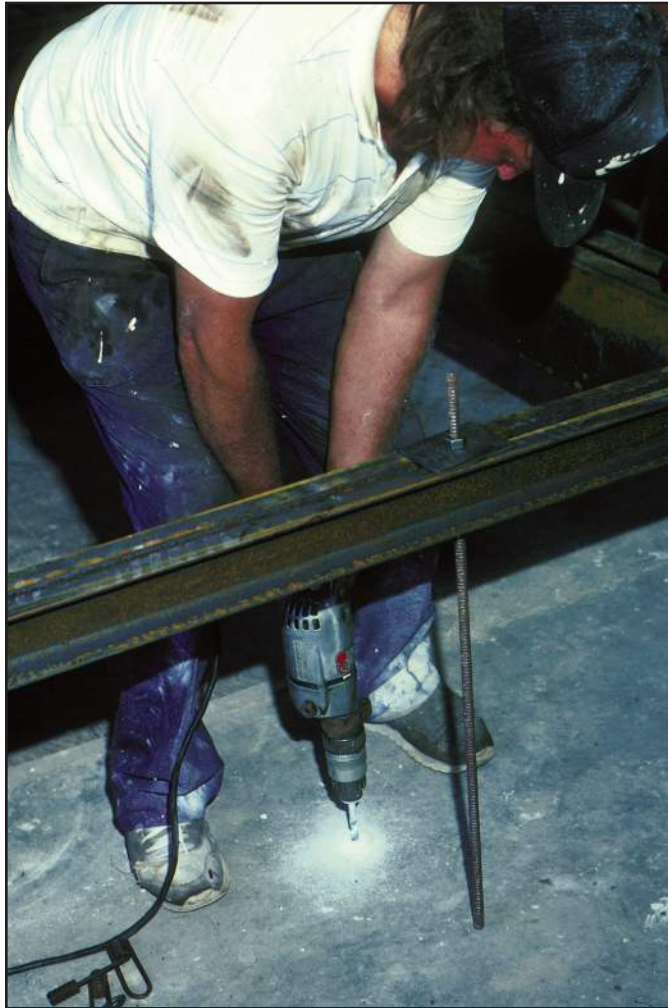
Figure 76
Inside the house,
workers drill holes in
the concrete slab ...

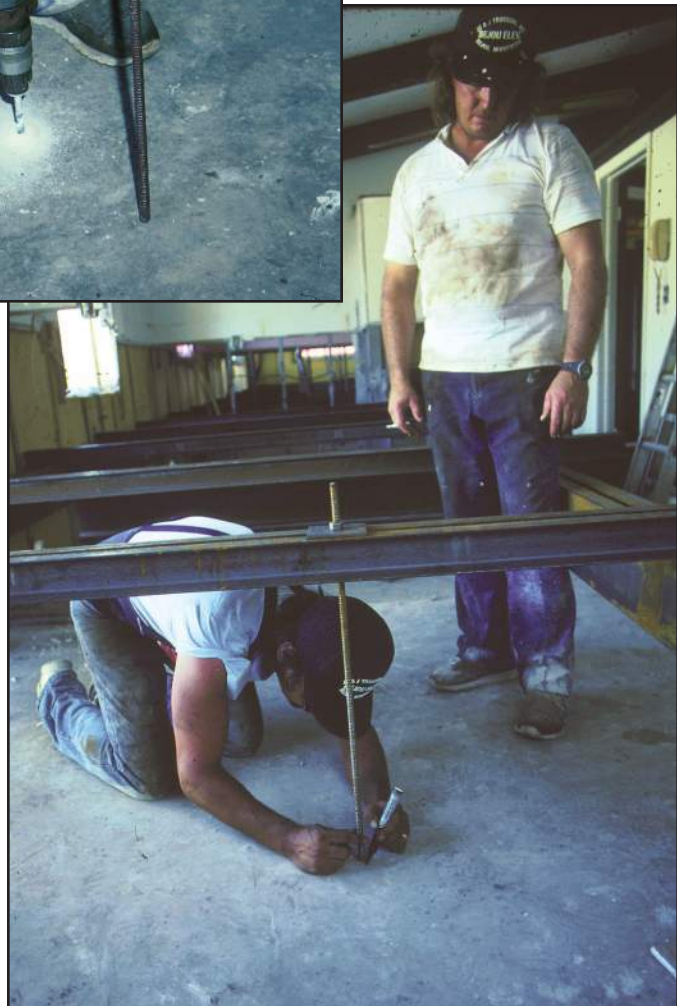
Figure 77
... install anchors ...

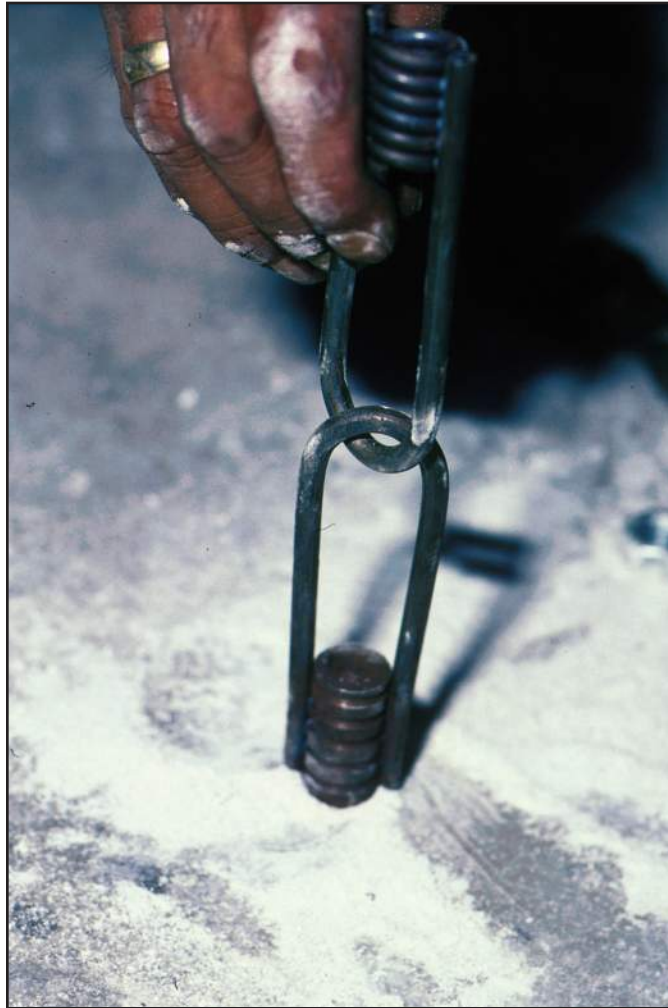
Figure 78
... and use hangers
to attach the anchors
to the grid of steel
beams.
