Above the Flood: Elevating Your Floodprone House

FEMA 347/ May 2000

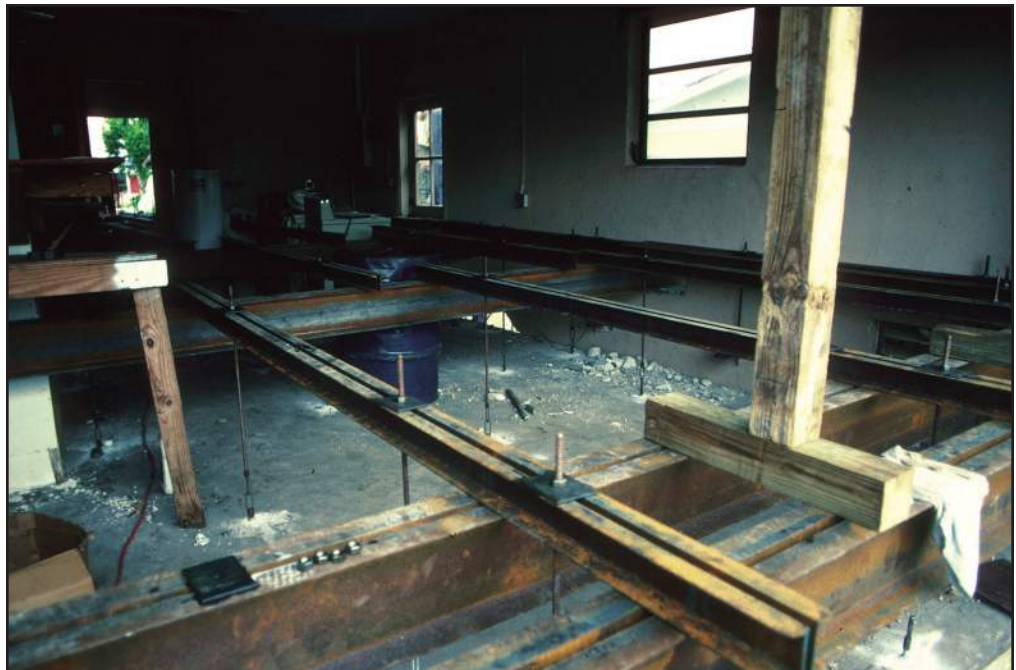
Figure 79
The anchors and
hangers connect the
slab securely to the
beams, enabling the
beams to raise the
slab along with the
rest of the house.

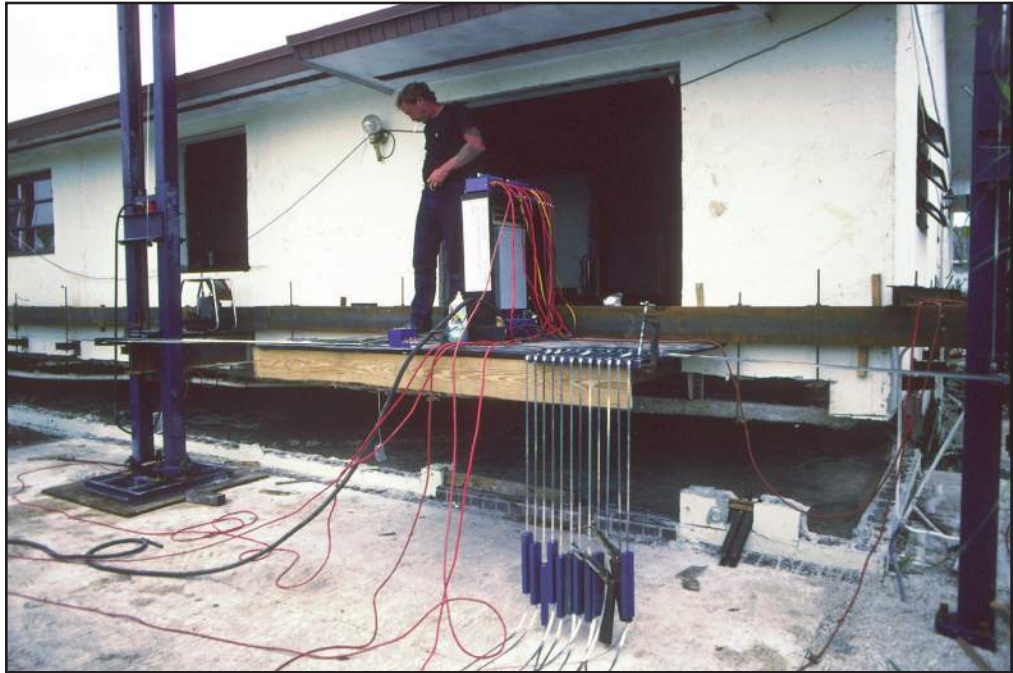
Figure 80

Lifting the house, while simple in theory, is complicated by the need to ensure an equal amount of lift at each jack throughout the process. Too much or too little lift at even one jack can cause the slab and walls to crack. The elevation contractor for this project used a sophisticated jacking system that provided the required level of control.

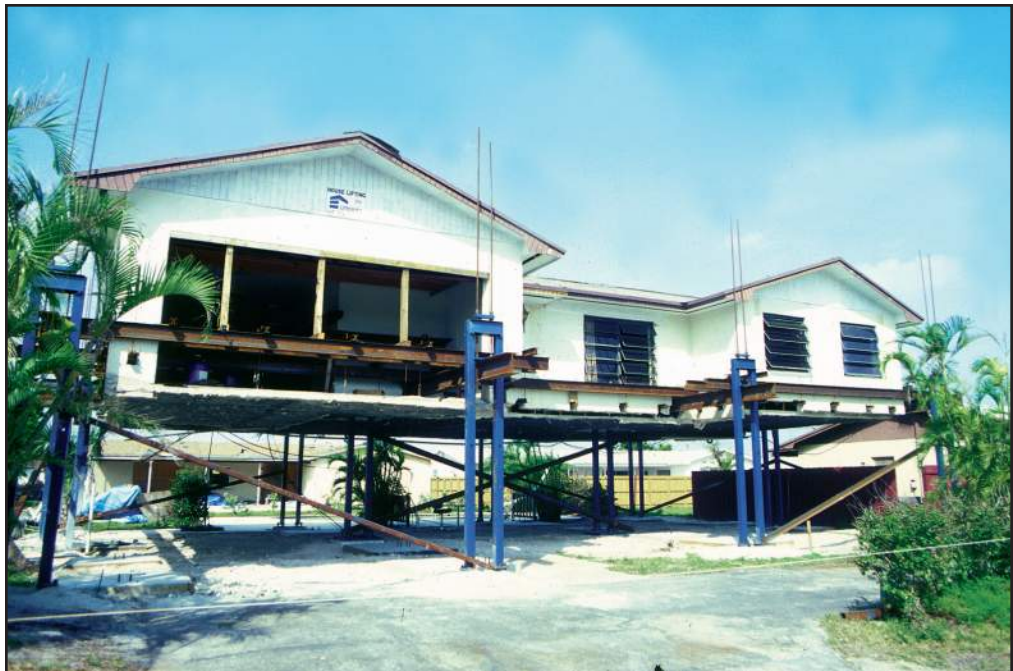
Figure 81

The house and slab were raised one full story.

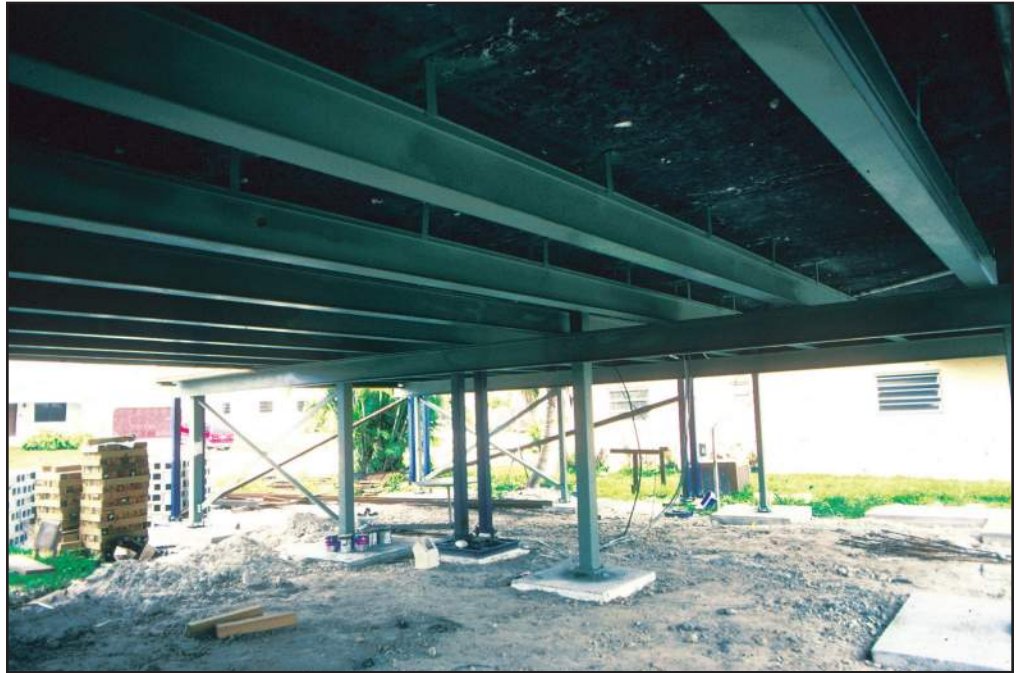
Figure 82

While the jacks and beams supported the house, new steel foundation members were installed below.

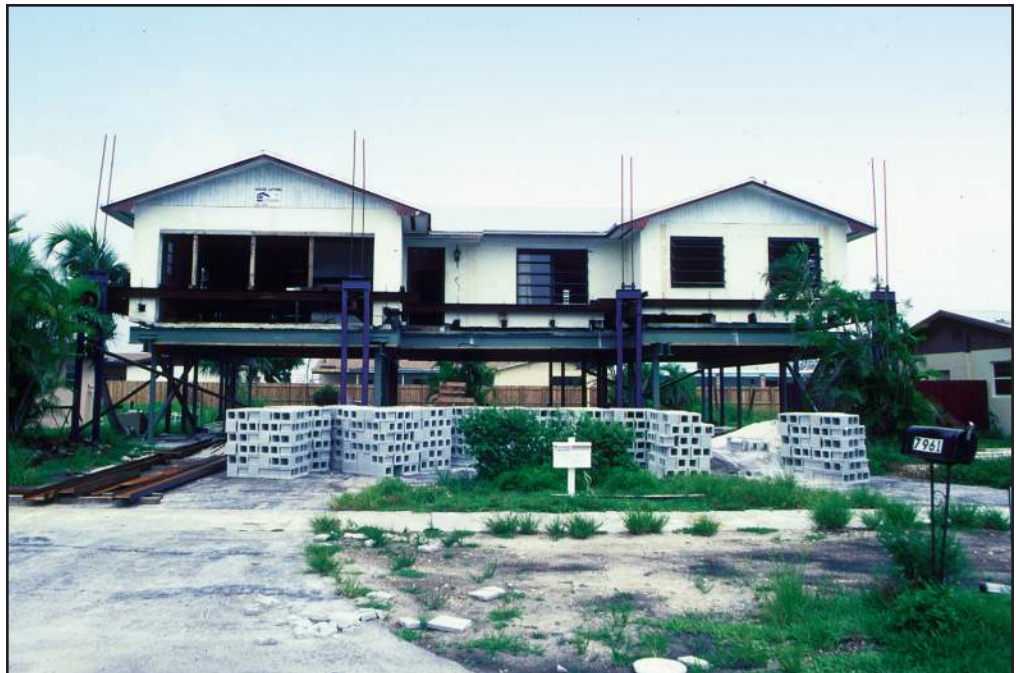
**Figure 83**

Concrete blocks were brought to the site ...

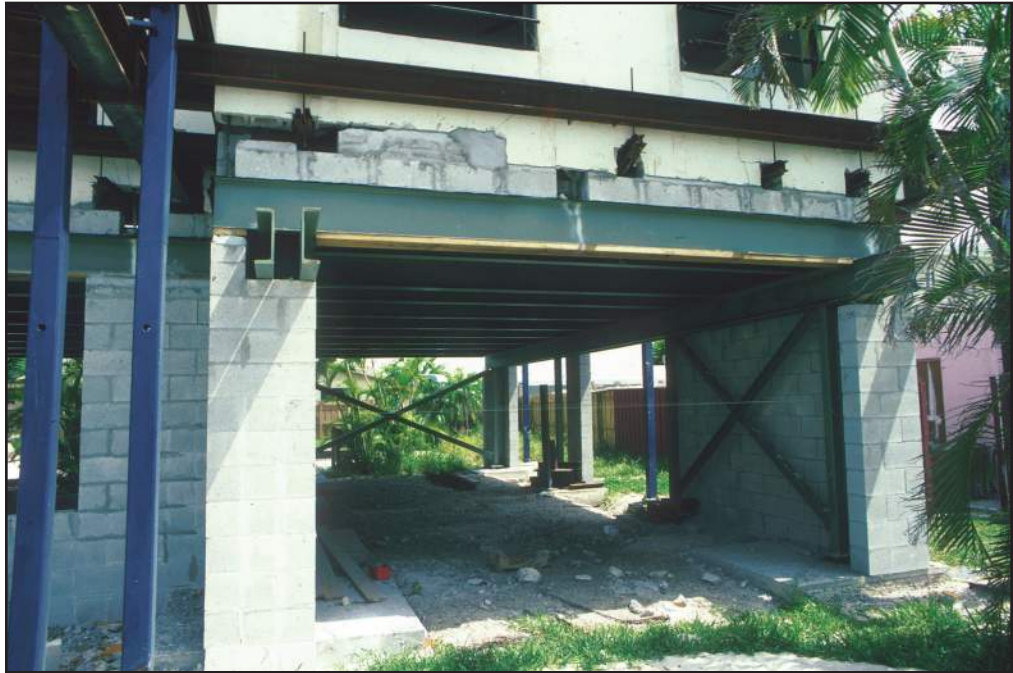
Figure 84

... and used to build the lower-level walls.

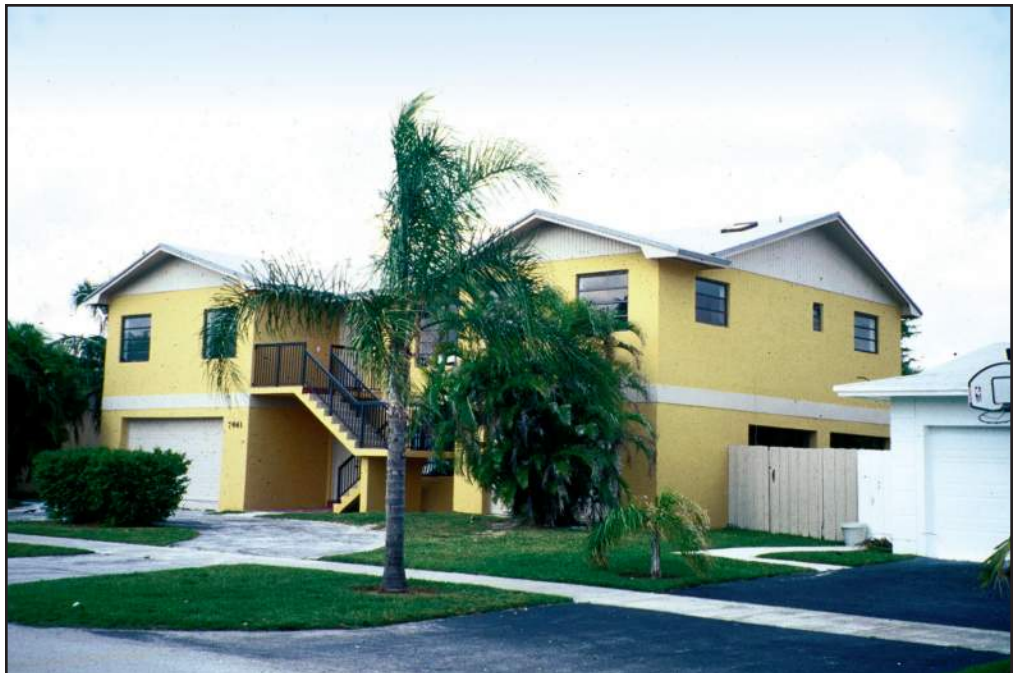
Figure 85

The completed house, with lower-level space for parking and storage and upper-level living space, looks as if it were originally designed and built as a two-story structure.
