Project: GOLDEN GATE BEAUTIFICATION, M.S.T.U.

Landscape Architect Report: January 2021

Location: Sunshine Blvd.

Report No.: 3 (FY-21)

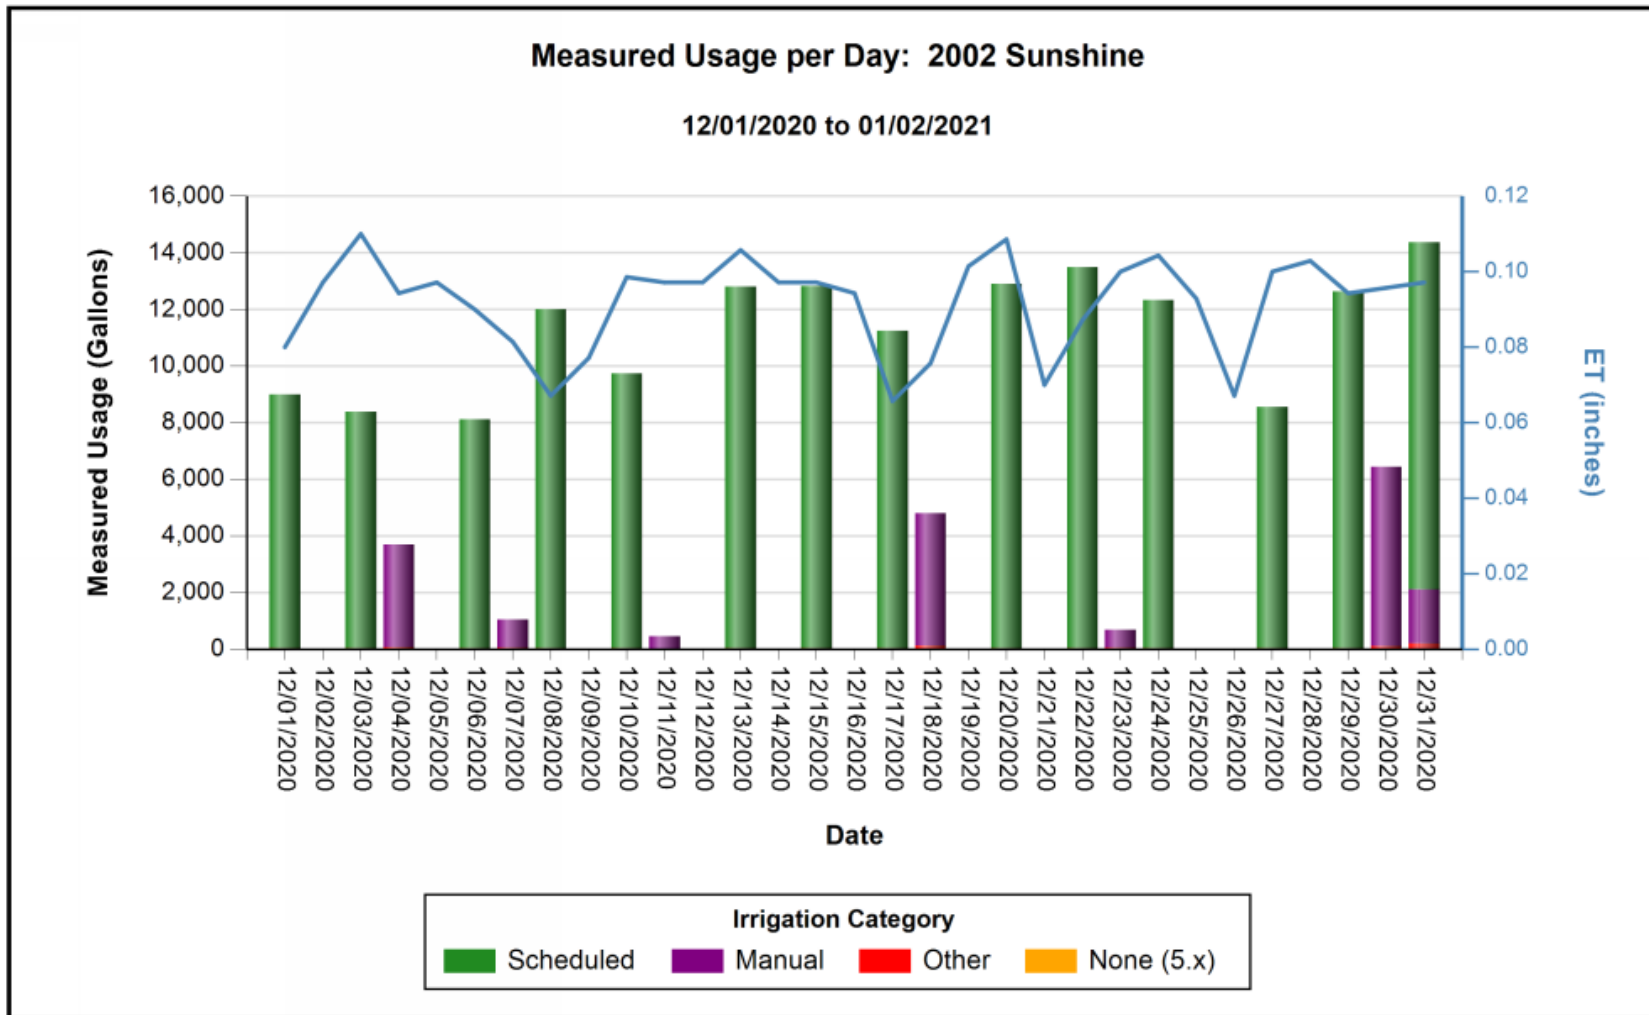
**Single Controller
 Measured Usage History Report**

Collier County
 Site: Golden Gate MTSU
 09013515 - 2002 Sunshine
