2022 CLAM BAY WATER QUALITY ANALYSIS

Water Quality Analysis for Evaluation of
Limit with Numeric Nutrient Criteria

SECTIONS 4/5/9/32/32, TOWNSHIPS 48/49 SOUTH,
RANGE 25 EAST
COLLIER COUNTY, FLORIDA

Initial: September 18, 2023
Updated: November 28, 2023

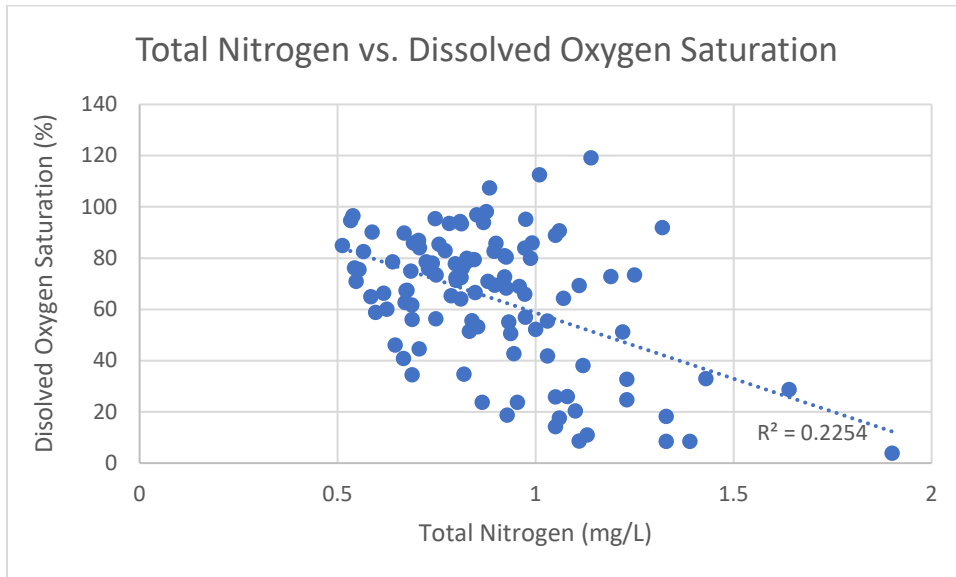
Figure 7. Negative relationship between Total Nitrogen and Dissolved Oxygen Saturation over the period of January 2022 through December 2022 in Clam Bay.

Nutrient Data (TP and TN) were graphed against DO and Chlorophyll-a to determine if a relationship exists between the two in Clam Bay. The resulting Figures below are consistent with Stantec’s findings in the 2021 report.

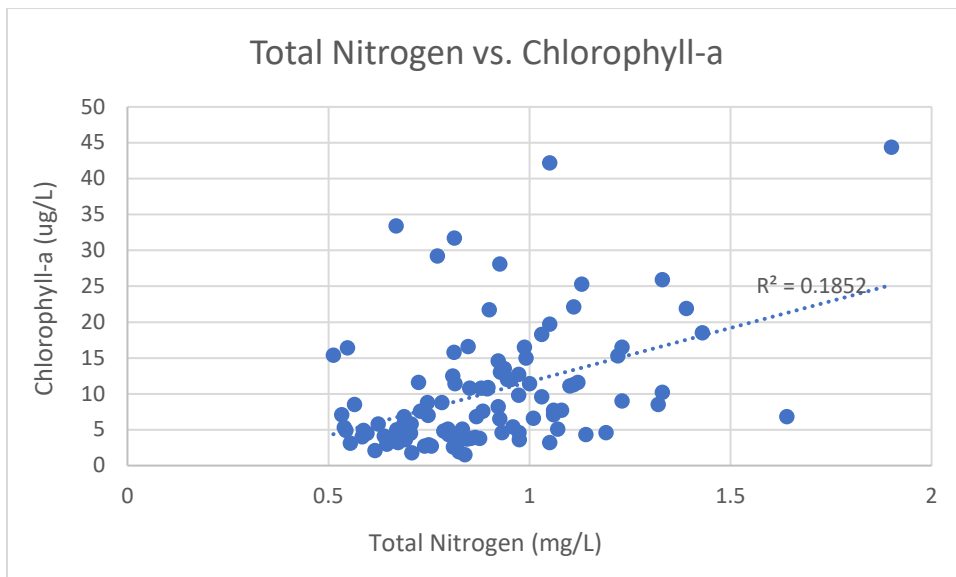
Figure 8. Positive relationship between Total Nitrogen and Chlorophyll-a over the period of January 2022 through December 2022 in Clam Bay.

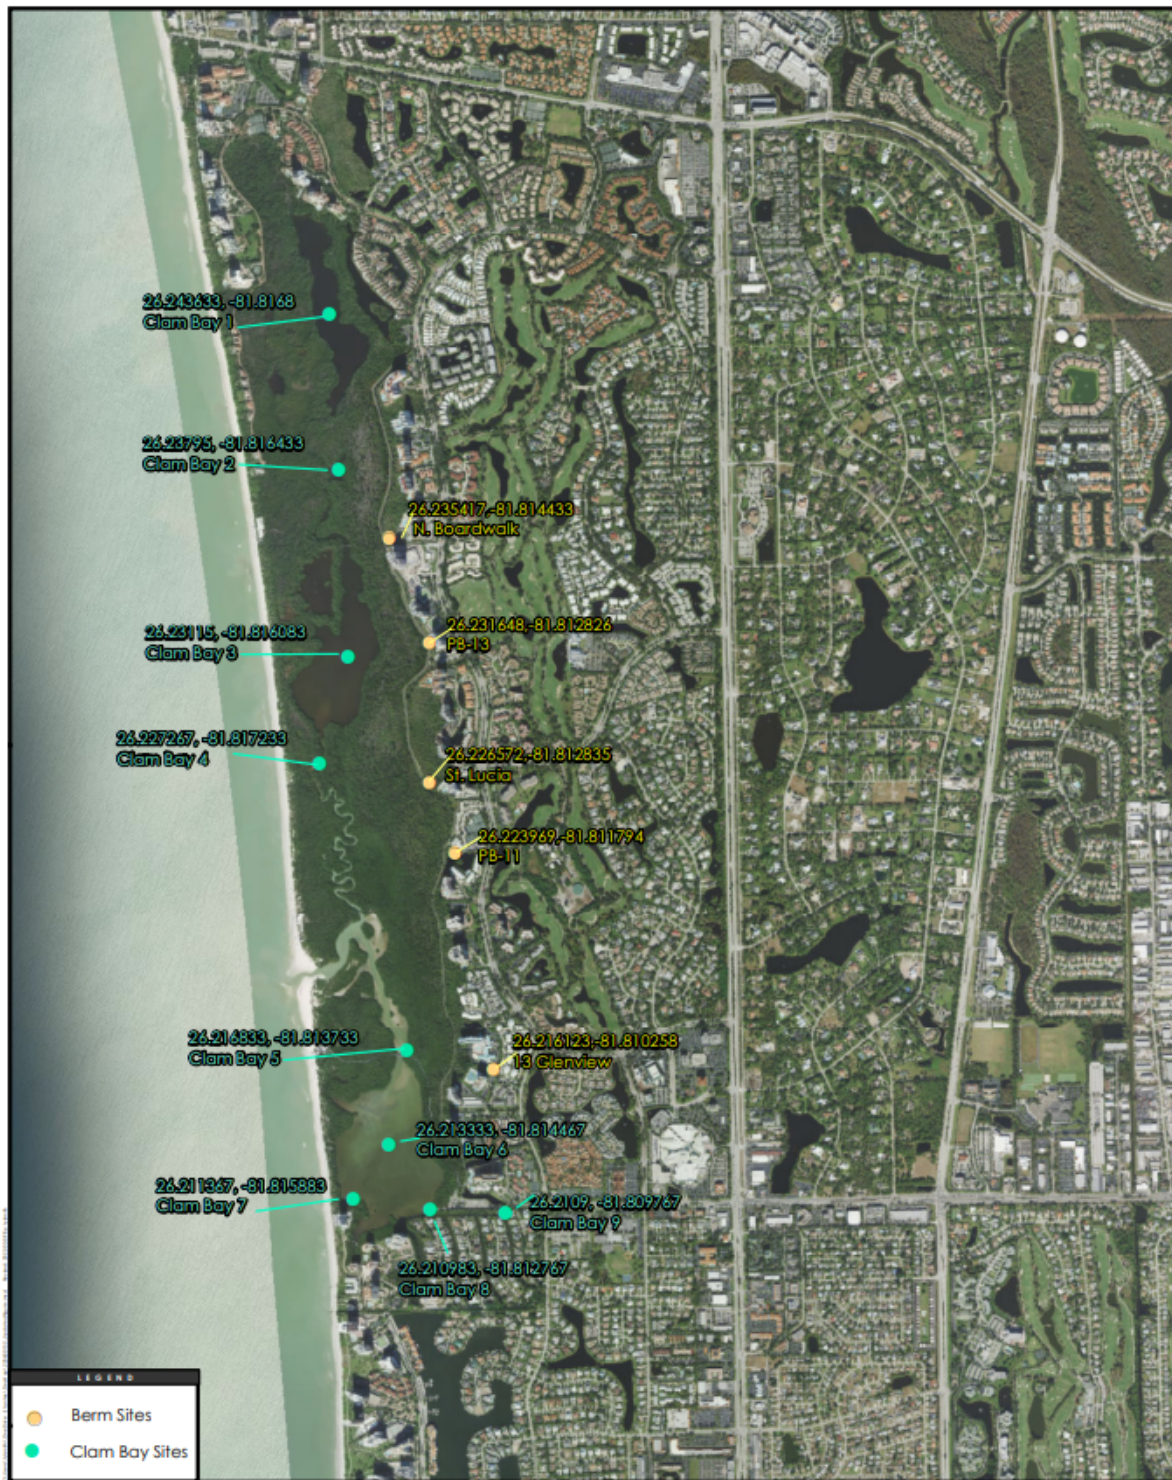
Figure 1: Water quality Sample locations for Clam Bay and Berm Water Quality Monitoring
