Date: March 17, 2009
 Inspection: Pine Air Lakes
 Inspected by: Mark Lindsay, Denise Weaver
 Begin: Naples Blvd.

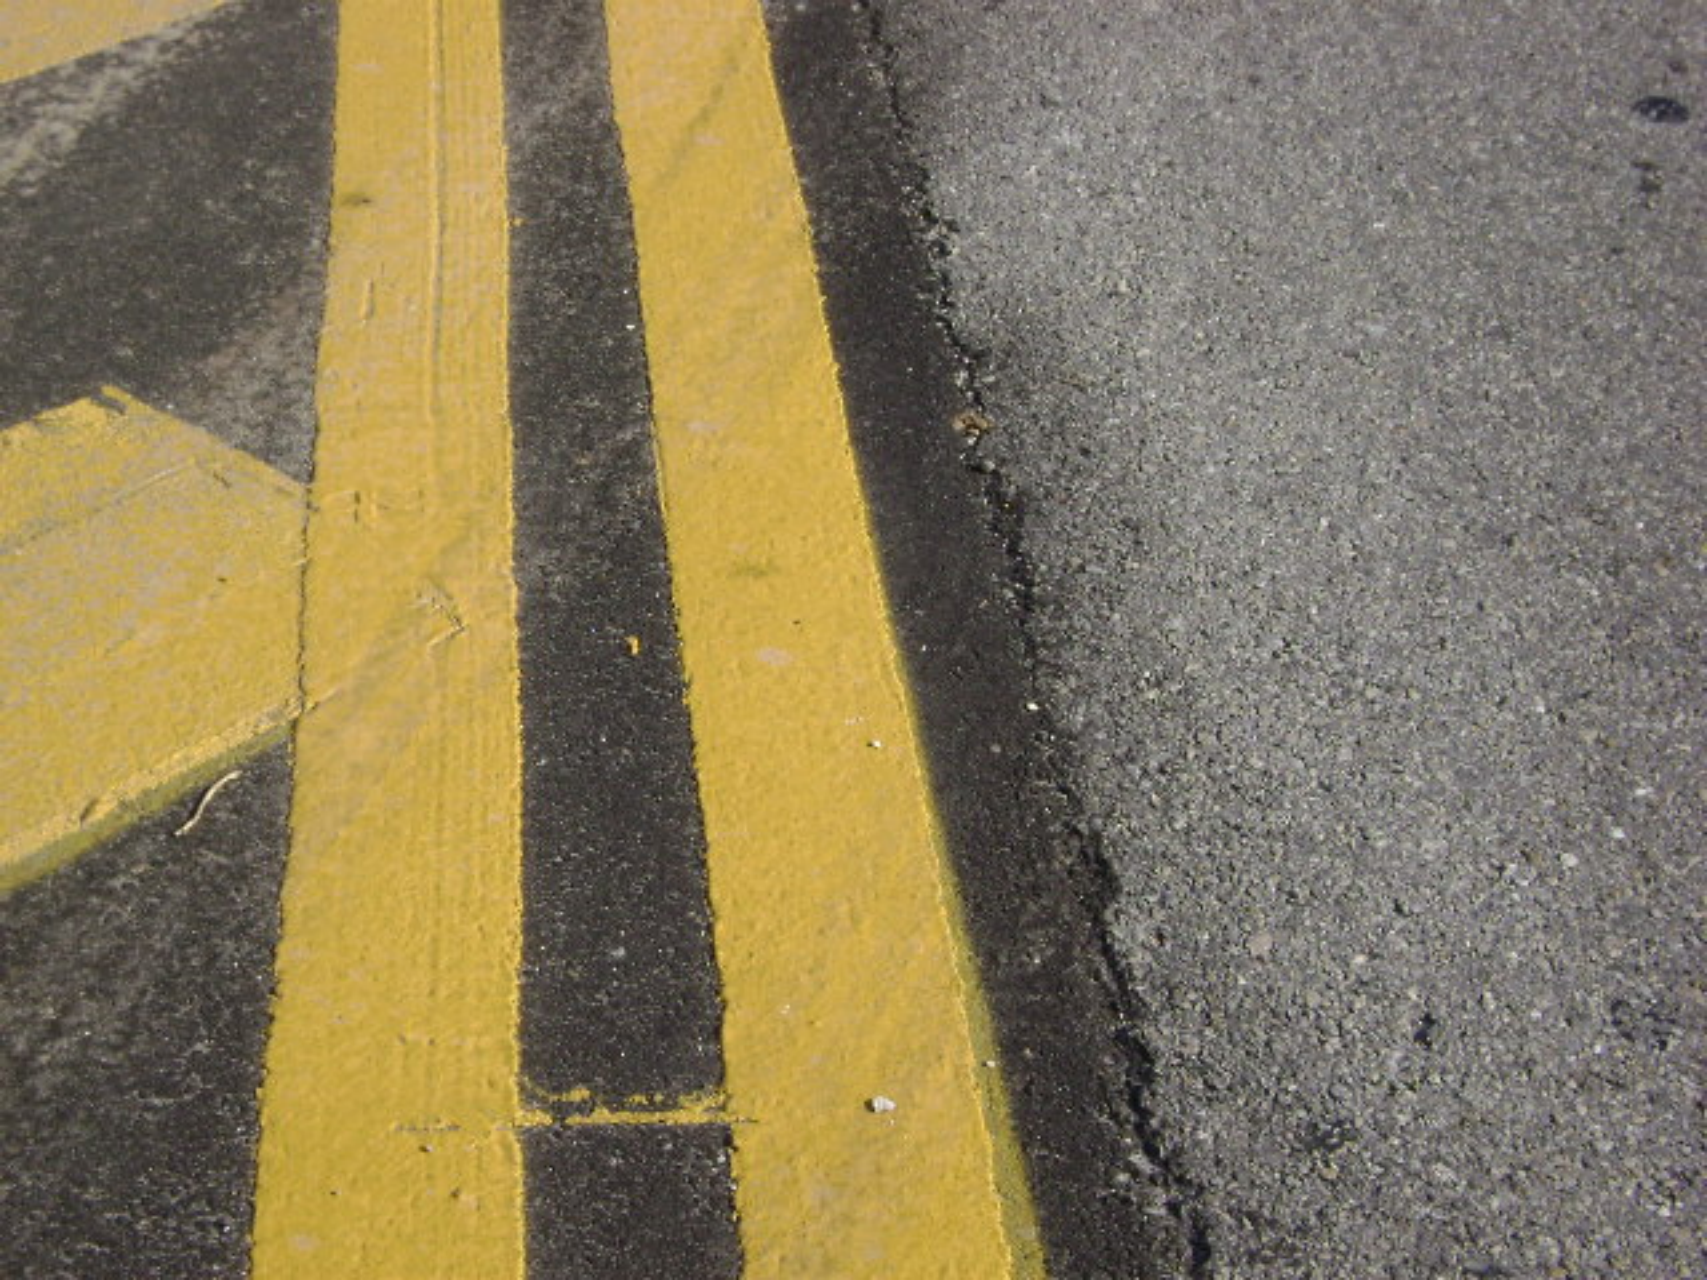
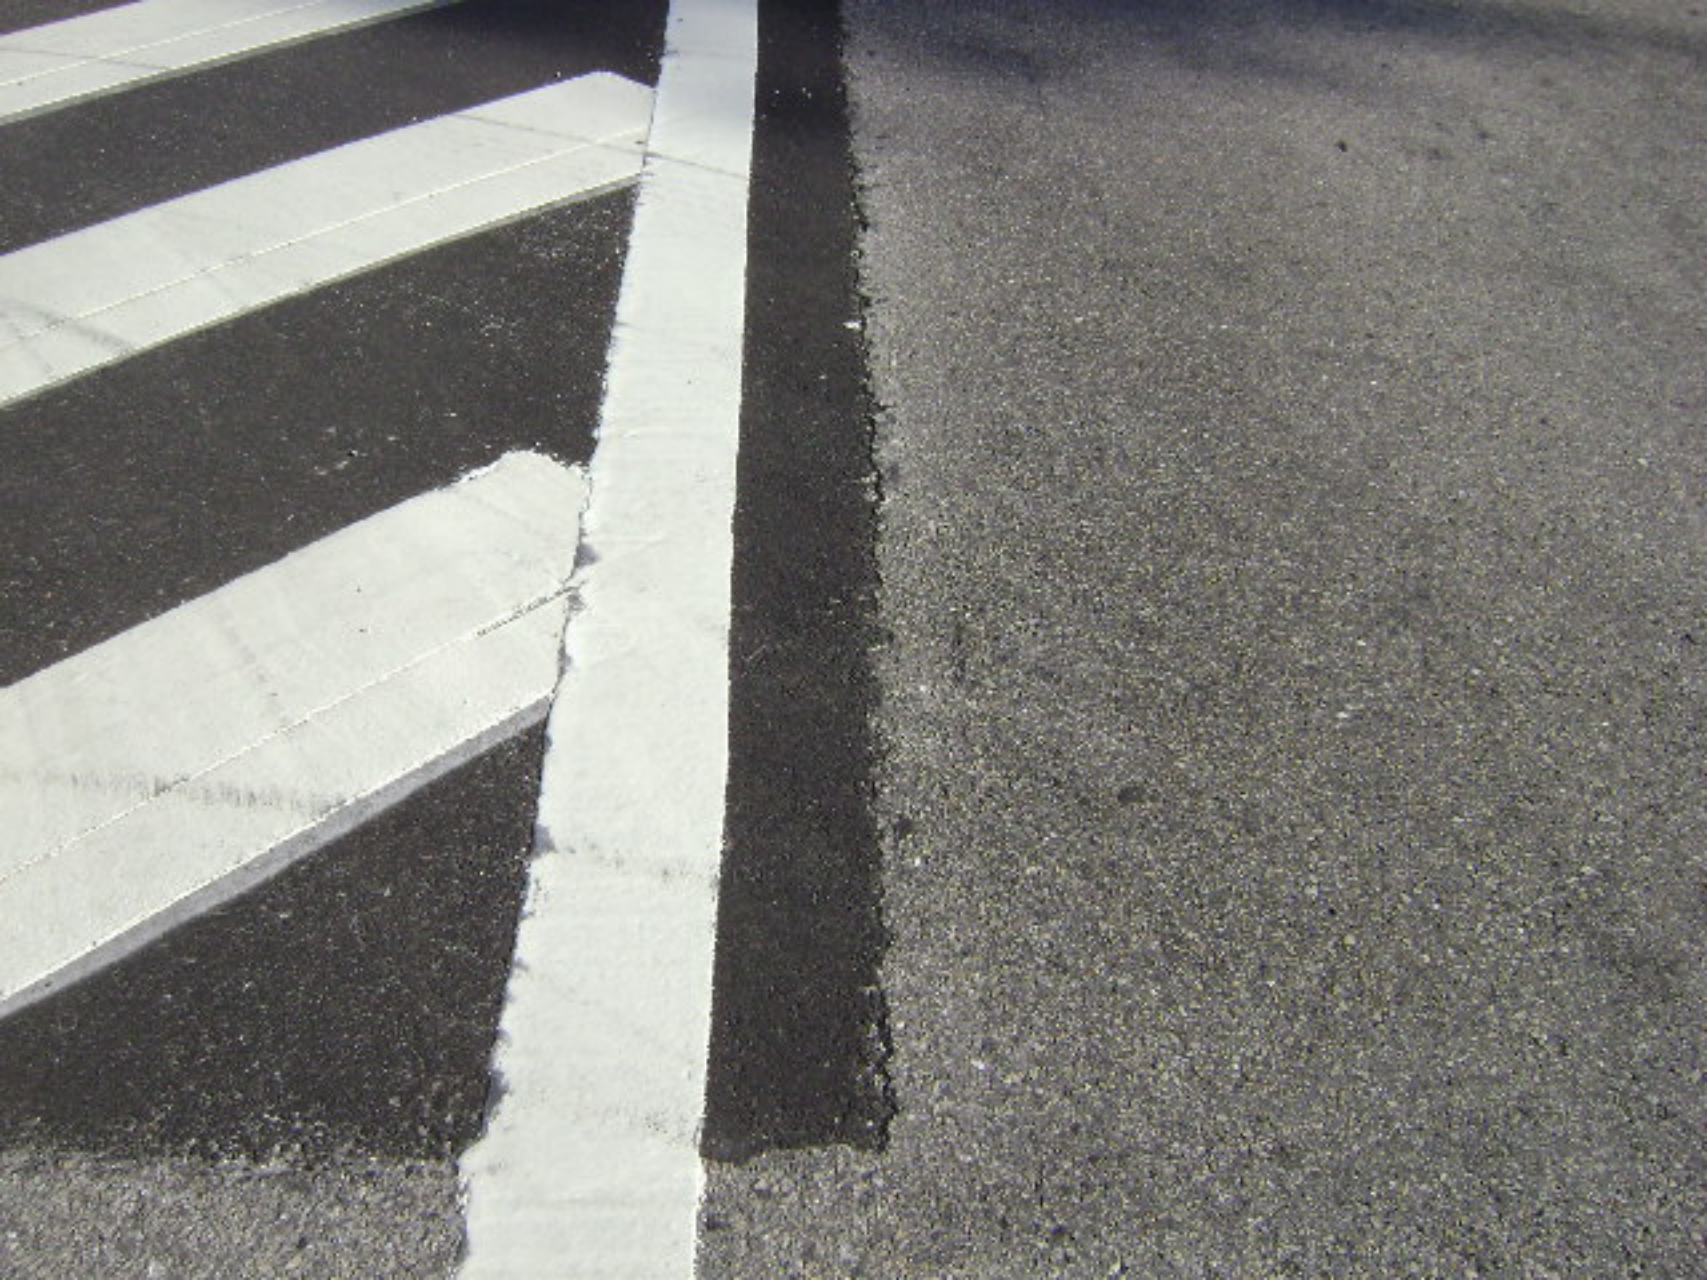
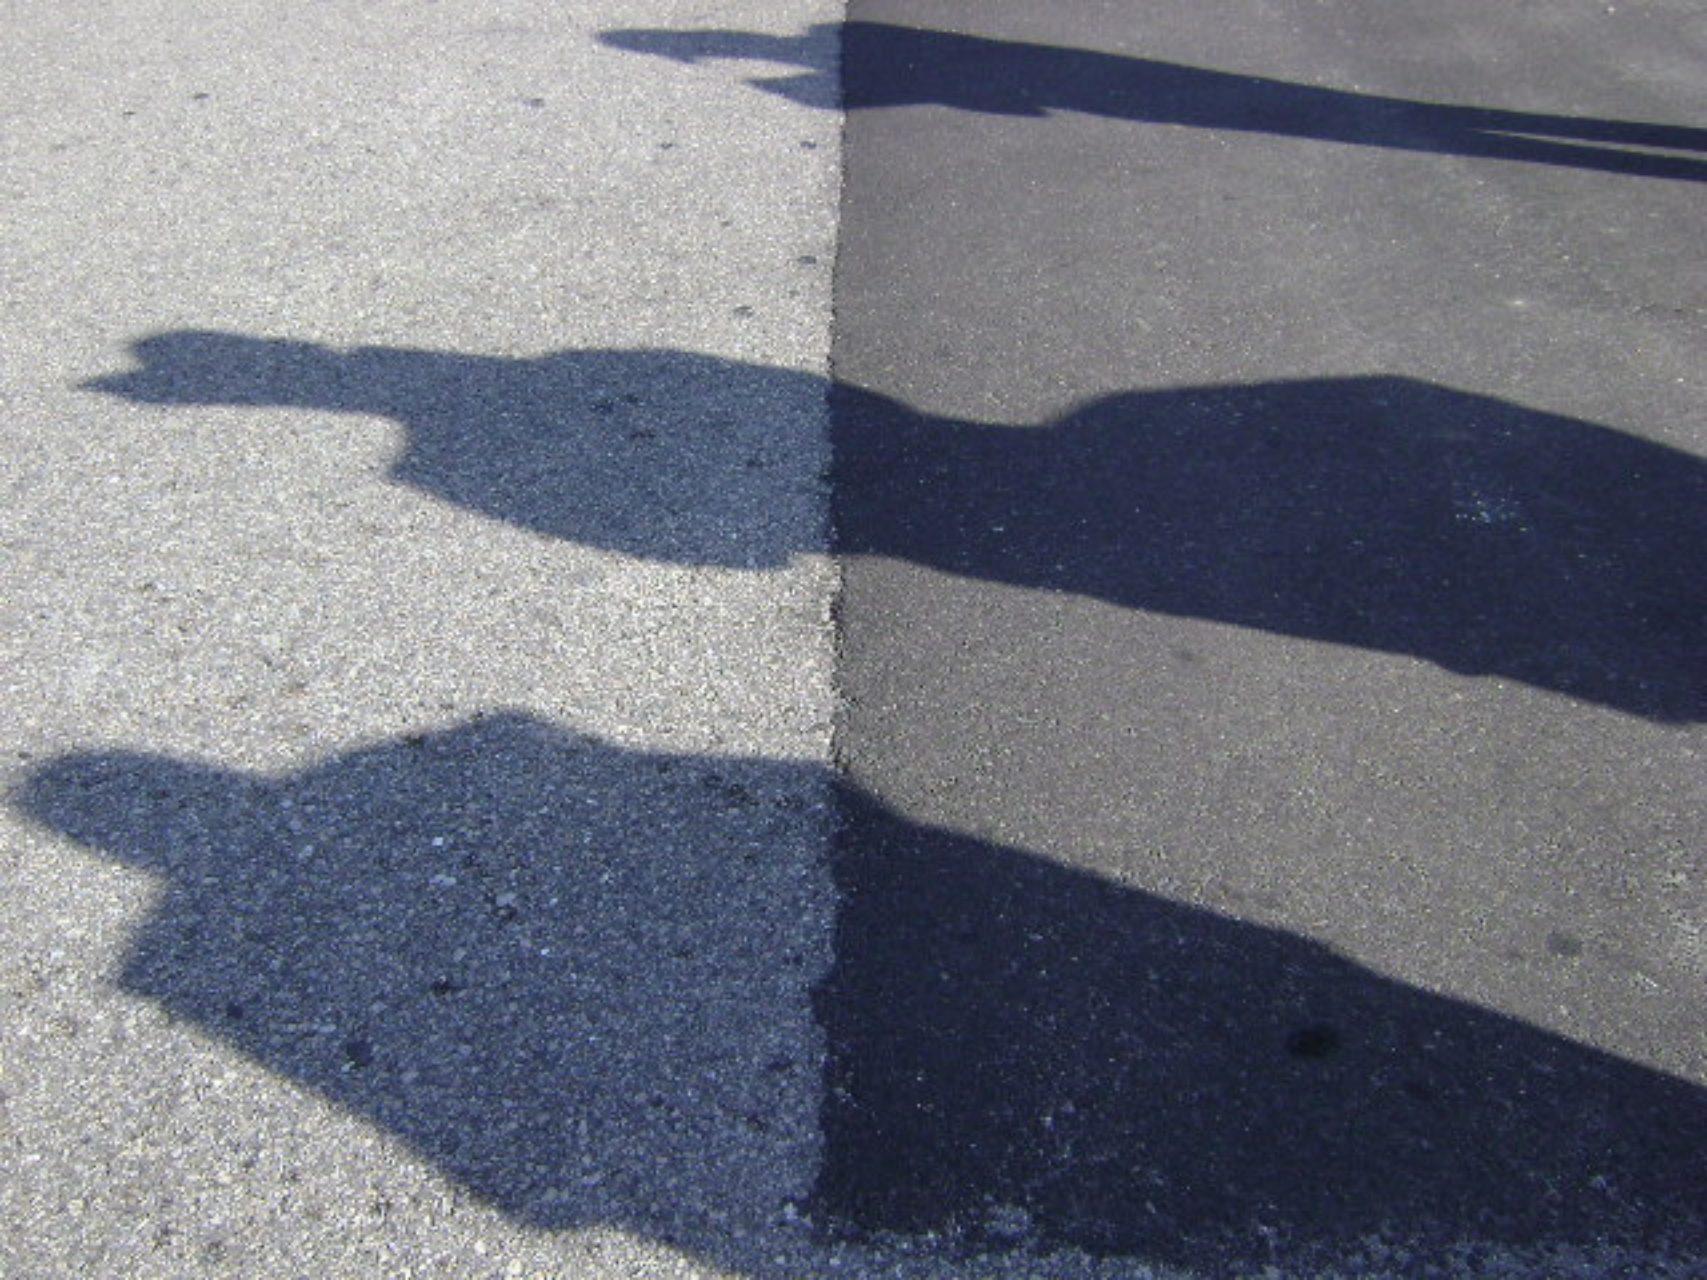
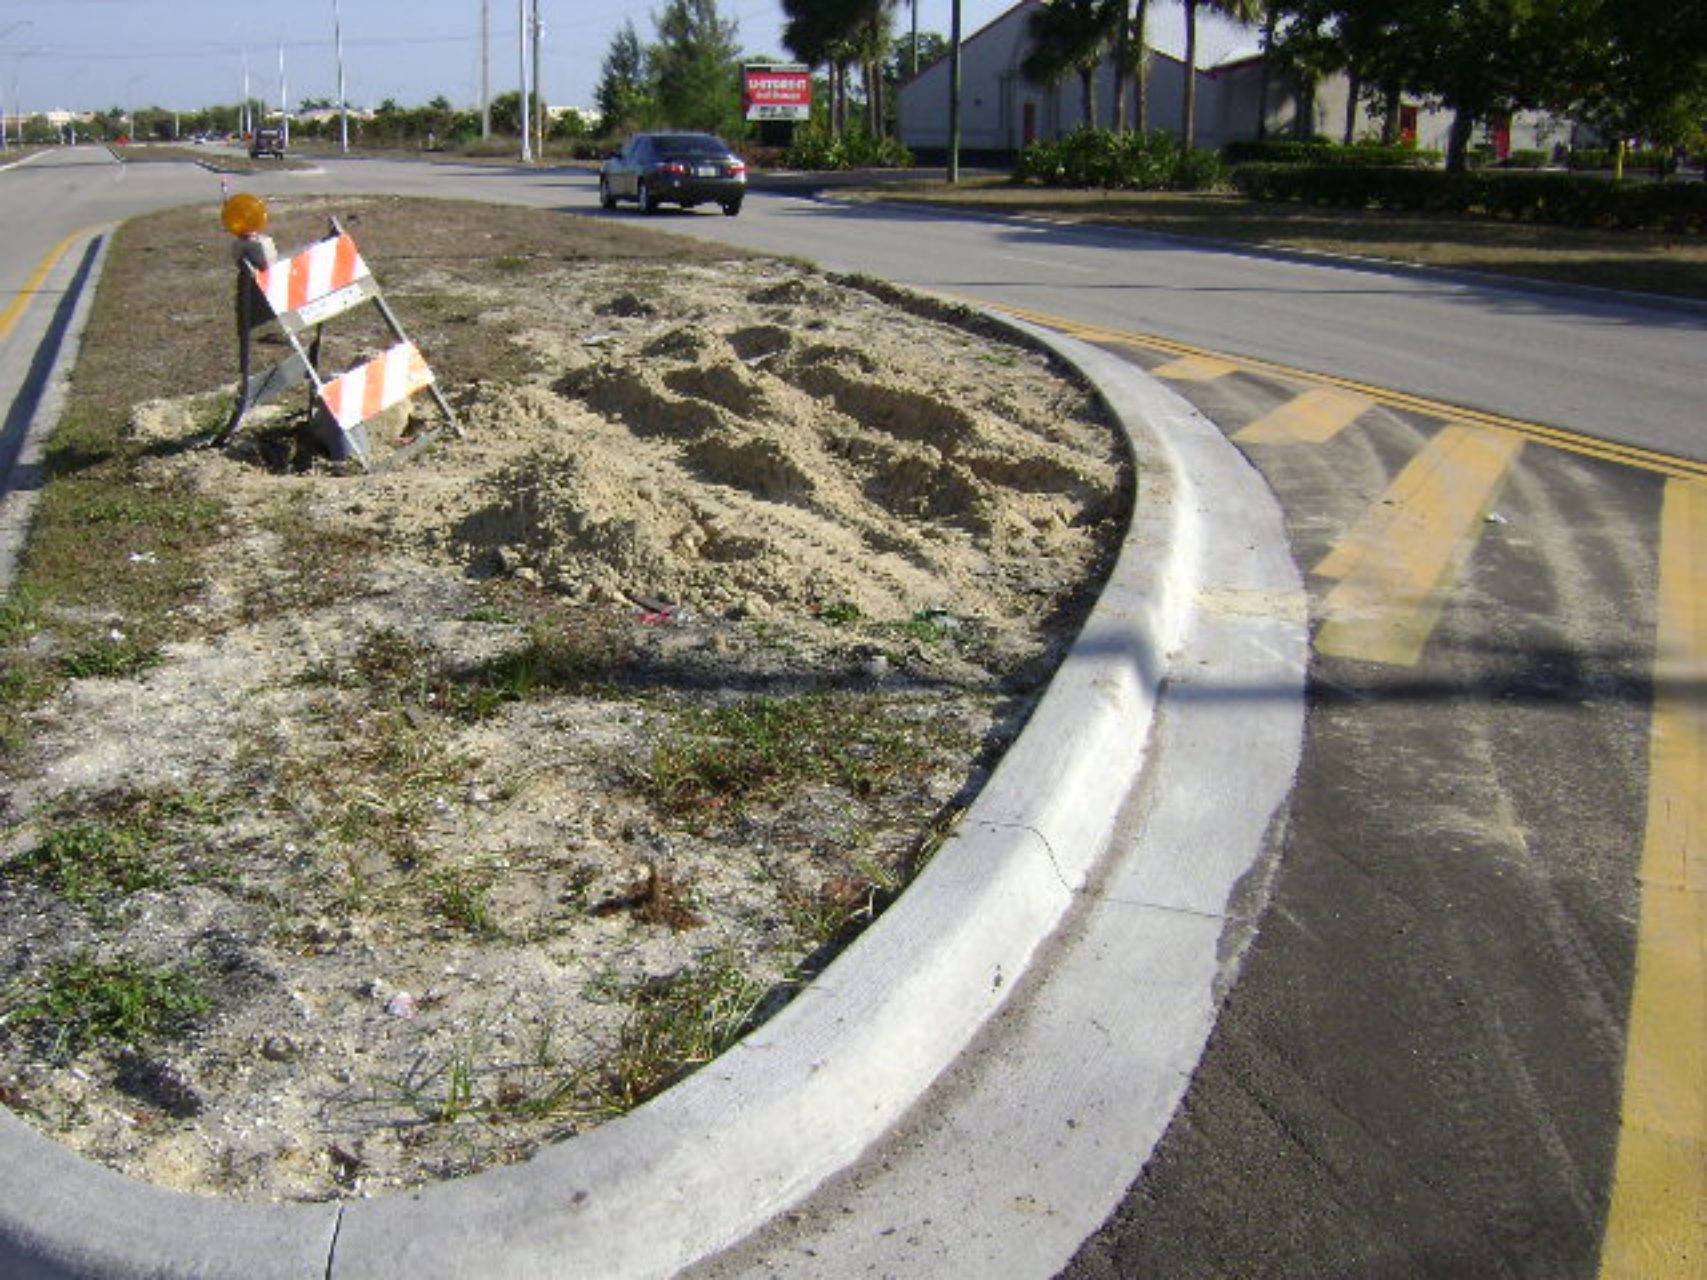
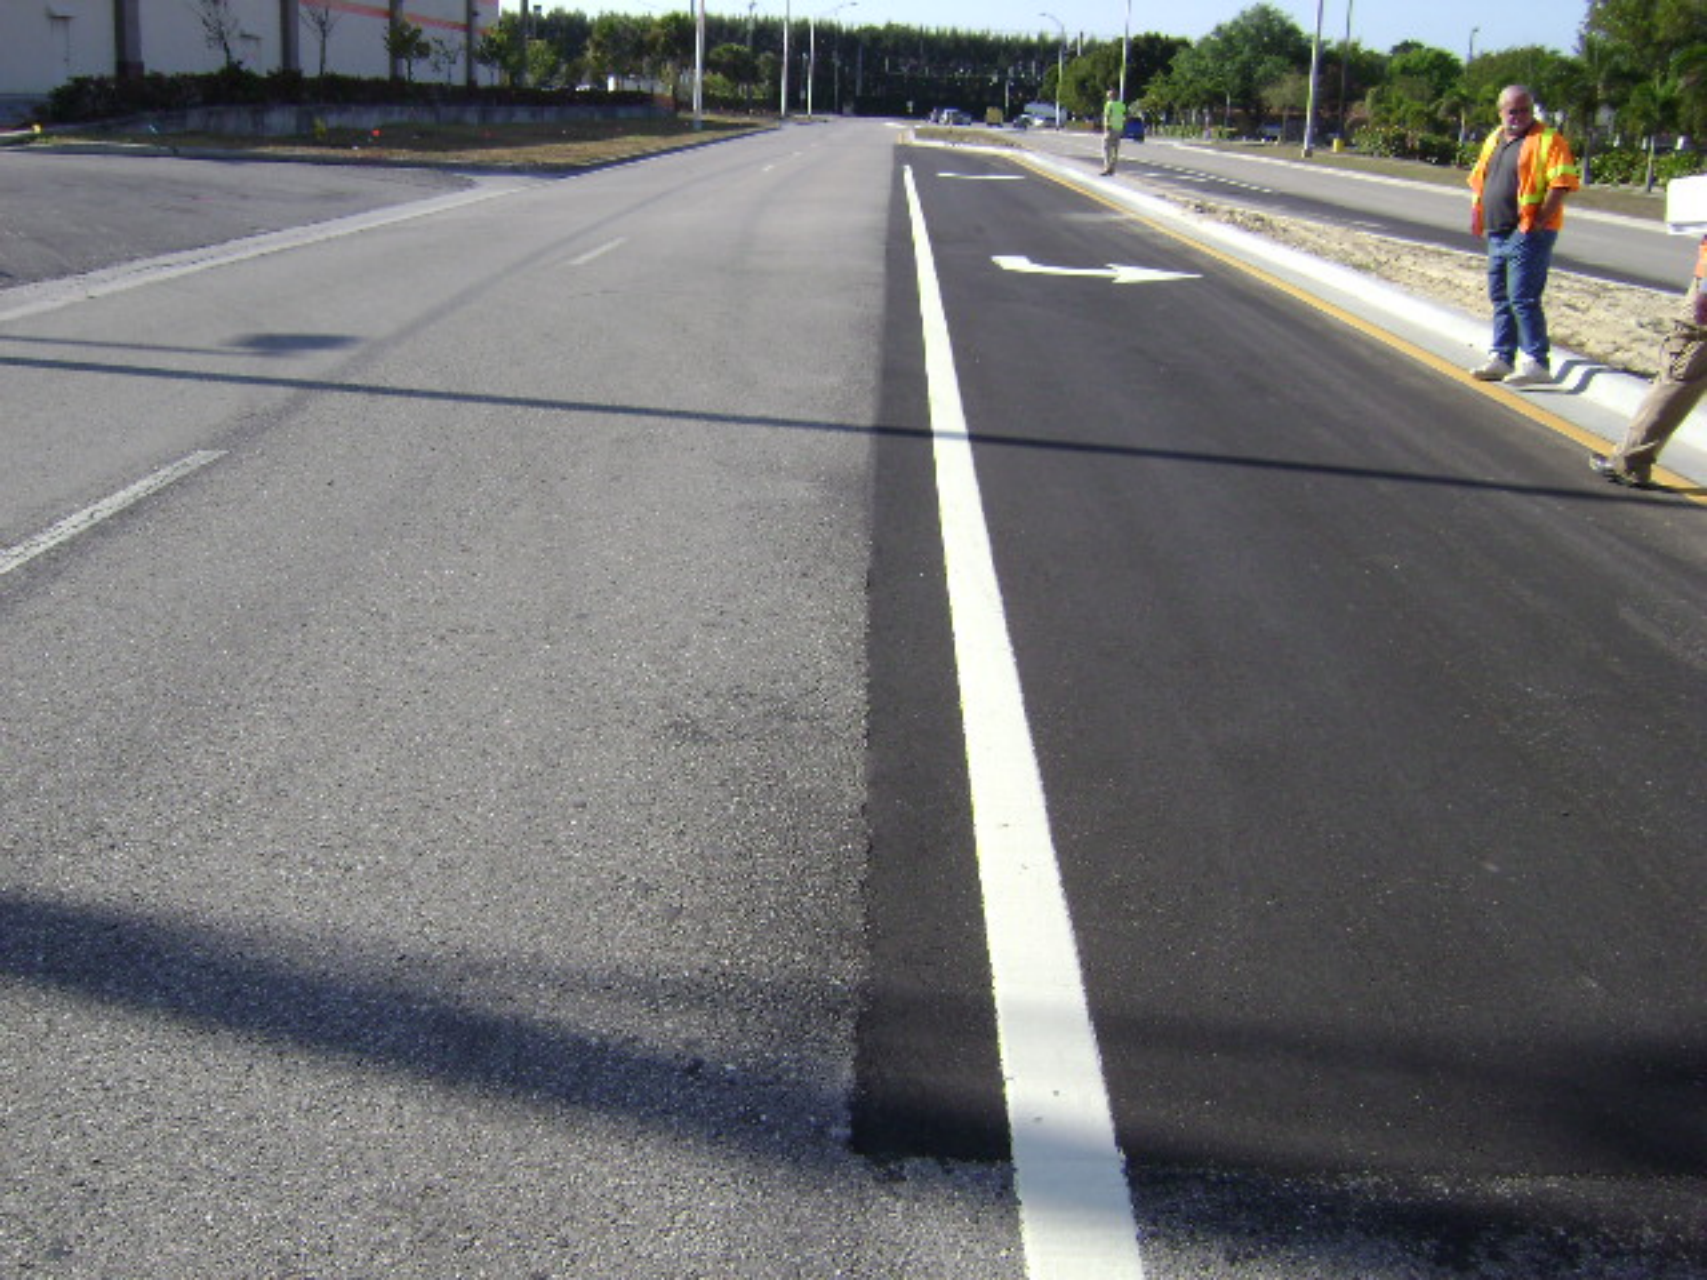
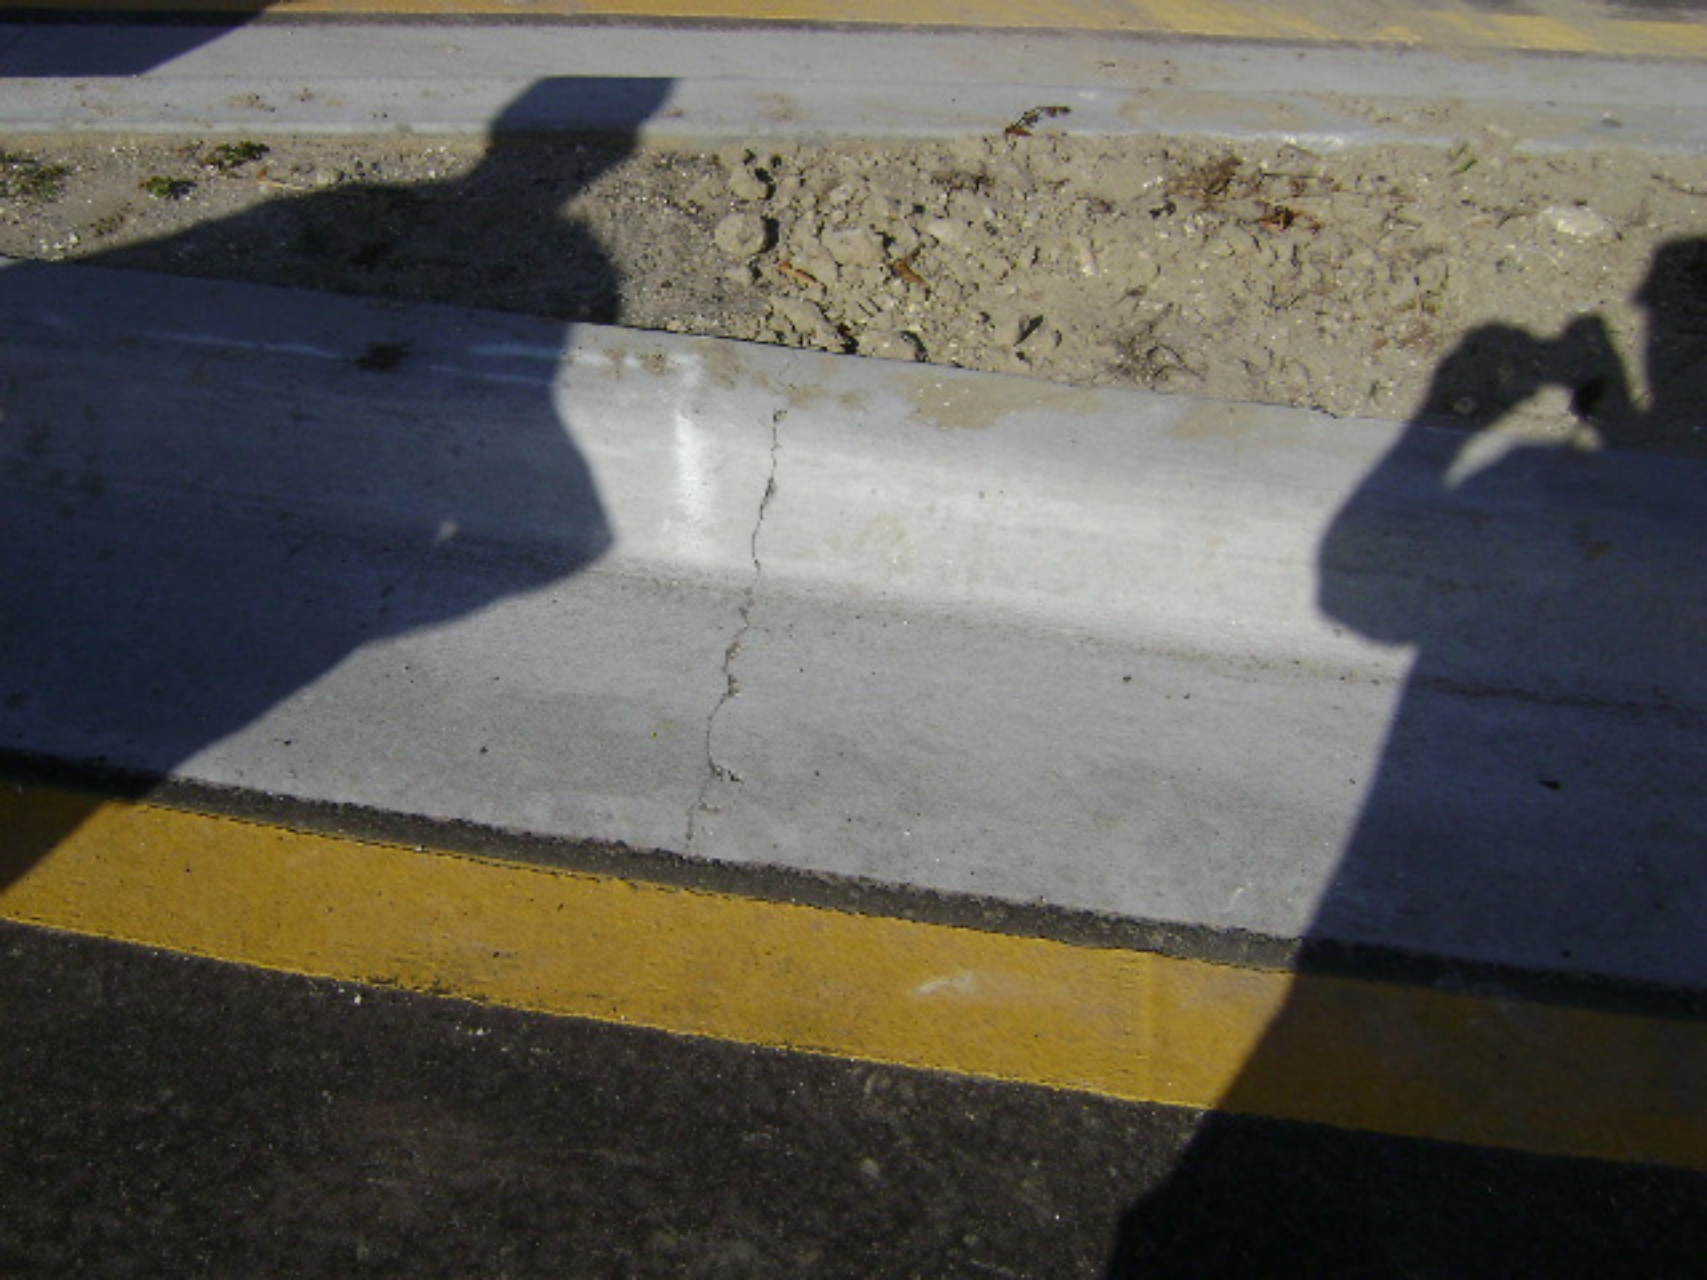
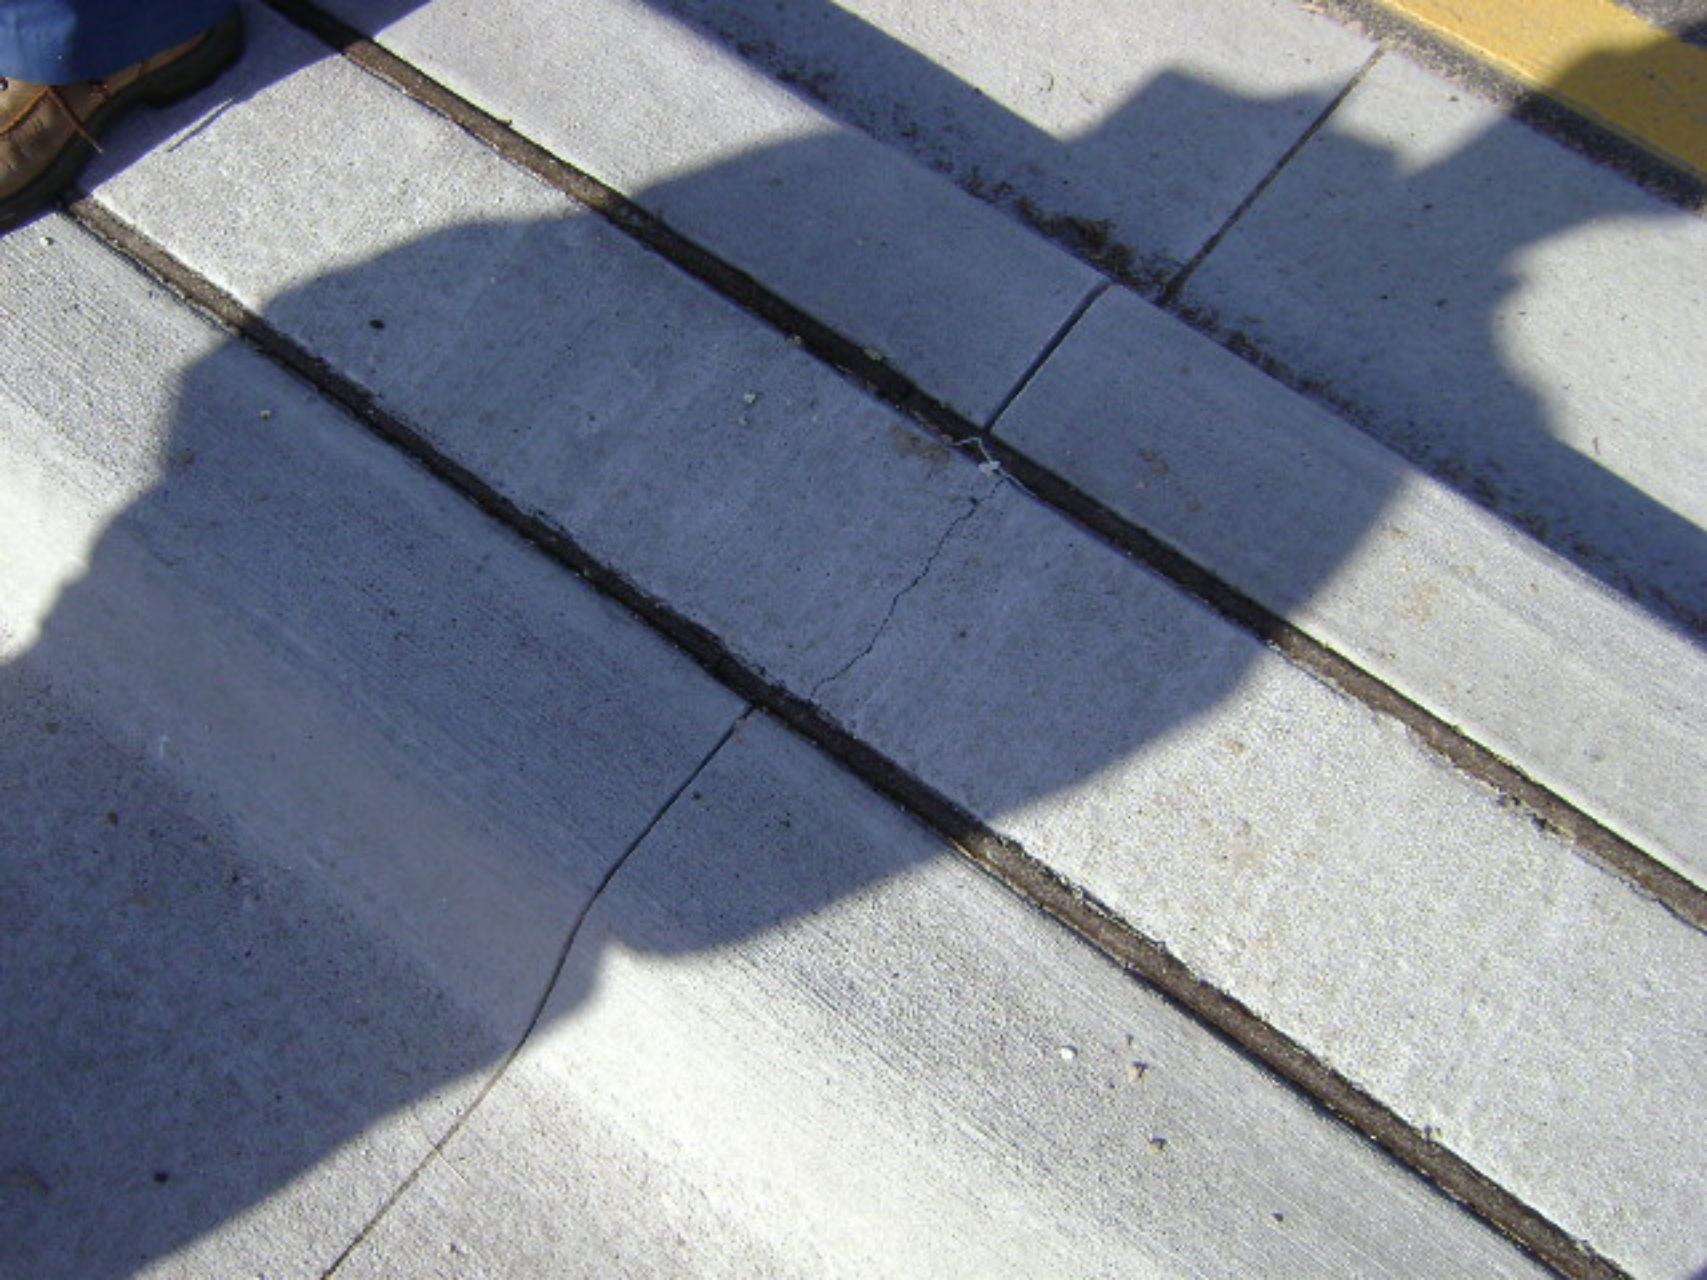
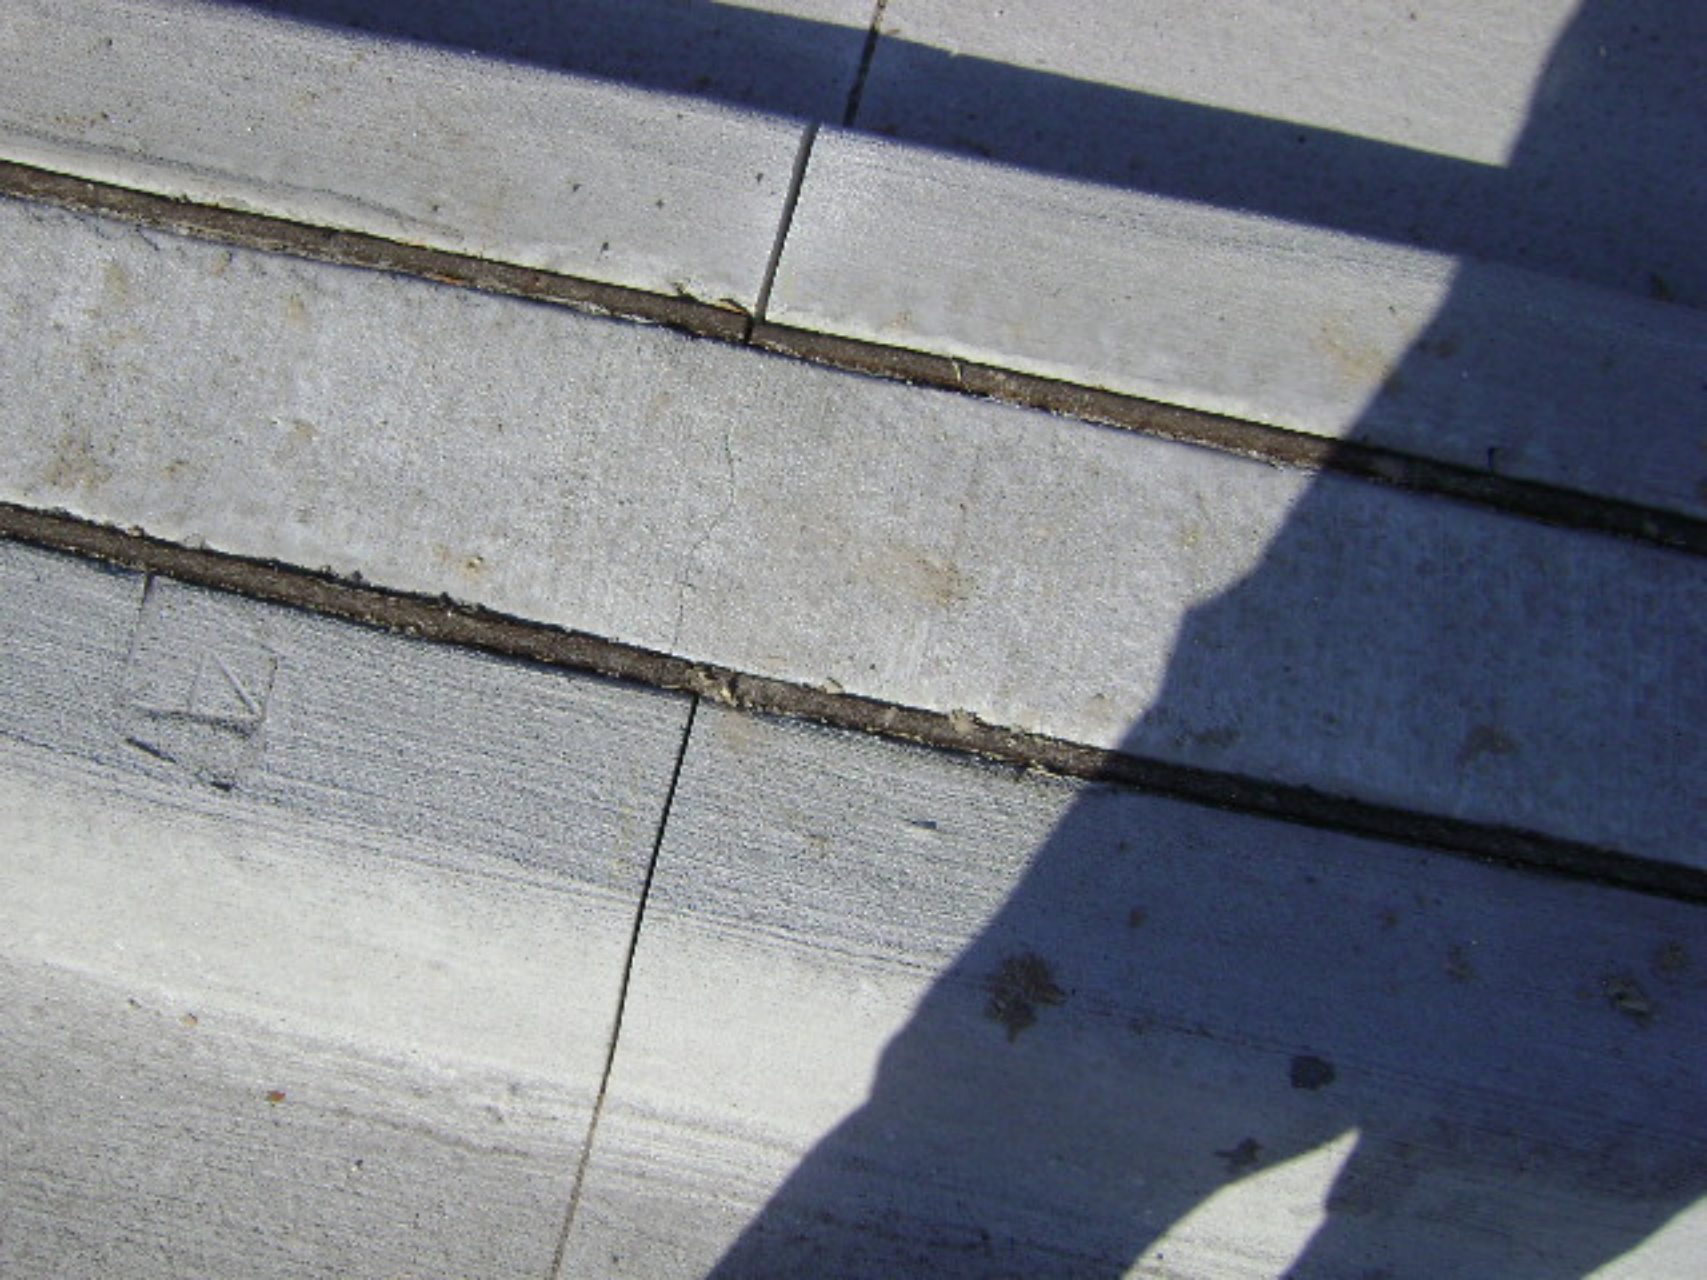
Location	Deficiency	Picture#
Naples Blvd. at Pine Ridge intersection-turn lanes north of Home Depot	- Asphalt not pinched over, various locations / Needs to be sealed - Curbing in good condition / If damaged due to irrigation line construction, the contractor (Stahlman) will be responsible for repairs	3567-69 3570
Naples Blvd.-turn lanes at Home Depot	- Asphalt not pinched over, various locations / Needs to be sealed - Cracked curbing / Replace in 4' min. sections - Cracked curbing / Replace in 4' min. sections, add expansion joint (various locations) - Curbing in good condition / If damaged due to irrigation line construction, the contractor (Stahlman) will be responsible for repairs - Painted striping will be rechecked at 1 yr. warranty	3571 3572 3573-76 3577 3583
Pork chop at Home Depot	- Additional striping, delineators & signage (No Left Turn) is required by Design Standards	3578
Naples Blvd.-median at Home Depot	- Curbing in good condition / If damaged due to irrigation line construction, the contractor (Stahlman) will be responsible for repairs	3579

Pine Ridge Rd. at Naples Blvd. intersection -eastbound turn lanes	- Needs 3 expansion joints for 10' spans - Add chain to inlet	3580-81 3582
Naples Blvd. at Airport Rd. intersection	- Slight depression (3/8" for 100' +/-) will be rechecked at final & 1 yr. warranty / May require mill and resurface - Cracked curbing / Replace in 4' min. sections, add expansion joint (various locations) - Asphalt not pinched over, various locations / Needs to be sealed	3584 3585 3586
Airport Rd. at Naples Blvd. intersection	- Curbing needs to be sealed	3587

- All median landscaping will be contractor's responsibility
- CEI will periodically recheck curbing to ensure no further damage due to irrigation subcontractor's negligence
