**Project:** GOLDEN GATE BEAUTIFICATION, M.S.T.U.  
**Project Manager:** Darryl Richards, r.l.a., P.S.D. – P.T.N.E. Dept.  
**Consultant:** McGee & Associates  
**Contractor:** Hannula Landscaping & Irrigation  
**Report Period:** FY 14-15, January 2015

**Location:** Coronado Pkwy. and Hunter Blvd.  
**Consultant's Representative:** Michael A. McGee, rla, isa  
**Contractor's Representative:** Dale Hannula  
**Report No.:** Four - FY 14-15

GOLDEN GATE BEAUTIFICATION, M.S.T.U.      **Location:** Coronado Pkwy. & Hunter Blvd.      **Report Period:** FY 14-15, January 2015      **Report No.:** Four

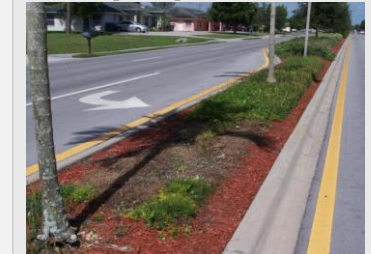
**Comment [MAM1]:**

X	11	Hand remove grassy type weeds in Mimosa on west end of median and treat Dollar weeds.(photo)	M&A: 5/12/14 Continue hand removal until weeds are gone. M&A: 7/8/14 Grass and broadleaf type weeds still exist in Mimosa. Please have your pest control subcontractor continue to explore some over the top herbicides for the weeds. M&A: 8-13-14 Over the top herbicide to treat dollar weeds also killed Minosa. Spray dead area with contact herbicide to remove weeds and then provide count to replace with 1 gal. size plants. M&A: 9-10-14 Prune Mimosa behind back of curbing.
		X	16	At address 5291: Eight dead Coontie/Zamia need to be replaced. Please provide replacement plants at 3 gal. container size 16" ht./spr. One dwarf Bougainvillea 'Helen Johnson' plant is missing. Replant with 3 gal size.	Hannula 1/10/14: Estimate #14-0006 submitted. Staff approved 1/13/14.
		X	18	At address 5254: Five dead Coontie/Zamia need to be replaced. Please provide replacement plants at 3 gal. container size 16" ht./spr.	Hannula 1/10/14: Estimate #14-0006 submitted. Staff approved 1/13/14.

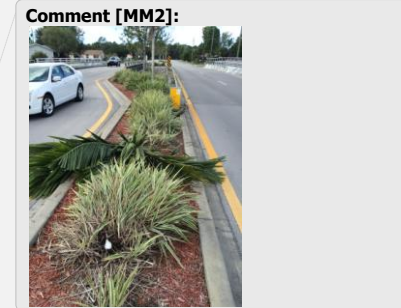
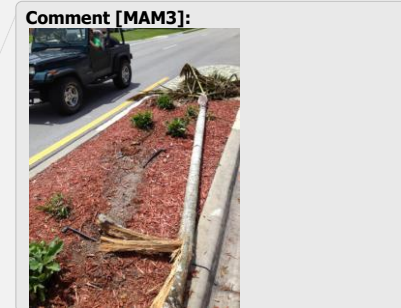
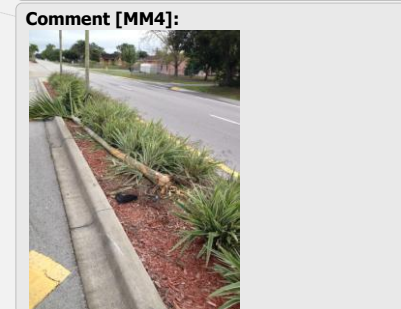
<b>Median #12</b>		X	5	Auto accident (1) Alexander palm needs to be replaced.(photo)	Provide estimate for replacement.
<b>Median #13</b>		X		Increase watering on Society Garlic plants.	
		X	3	(4) missing Society garlic plants.	Provide estimate for replacements at 1 gal. size.
<b>Median #14</b>		X		Spray Flax lily plants for insects. Oleander scale observed.	
		X		Increase watering on Flax lily plants.	
		X		Alexander palm destroyed due to auto accident. (photo)	
<b>R/W Areas</b>					
<b>Hunter Blvd.</b>					
<b>Median 1 thru 12</b>		X		Reposition and restake tree bubblers. Bubblers in narrow medians need to have the bubblers positioned on the centerline of the median, which is the highest point of the median.	
<b>Median #1</b>		X	14	Lantana being replaced with Juniper parsoni as part of previous flood damage.	Hannula: Revised estimate #13-3405 submitted on 12/20/13, M&A: Estimate pending Committee approval. M&A: 10-16-14 It is recommended to replant this median with Juniper as planned. It was not washed over during the street flooding. Update estimate for replanting.

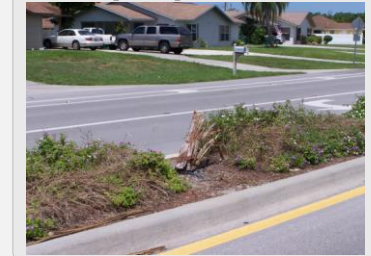
**Comment [MAM7]:**

X	21	At address 5261: One replacement Ms Alice Bougainvillea plant has rolled out of its root ball and needs to be replaced with a 7 gal. size plant. (photo)	Hannula 1/10/14; Estimate #14-0007 submitted 01/10/14. Staff approved 1/13/14.
<b>Median #9</b>		X	16	See COMMENTS column. At address 5481: Review Lantana on west end for replacements. 8 – plants need to be replaced. 4 – white, 4 – Lavender. 3 – gal. or 8” basket size if available.	M&A: 12 -12 1-13 If the Lantana plantings are to be replaced then it is recommended the median be replanted with Big Rose Crown of thorn.

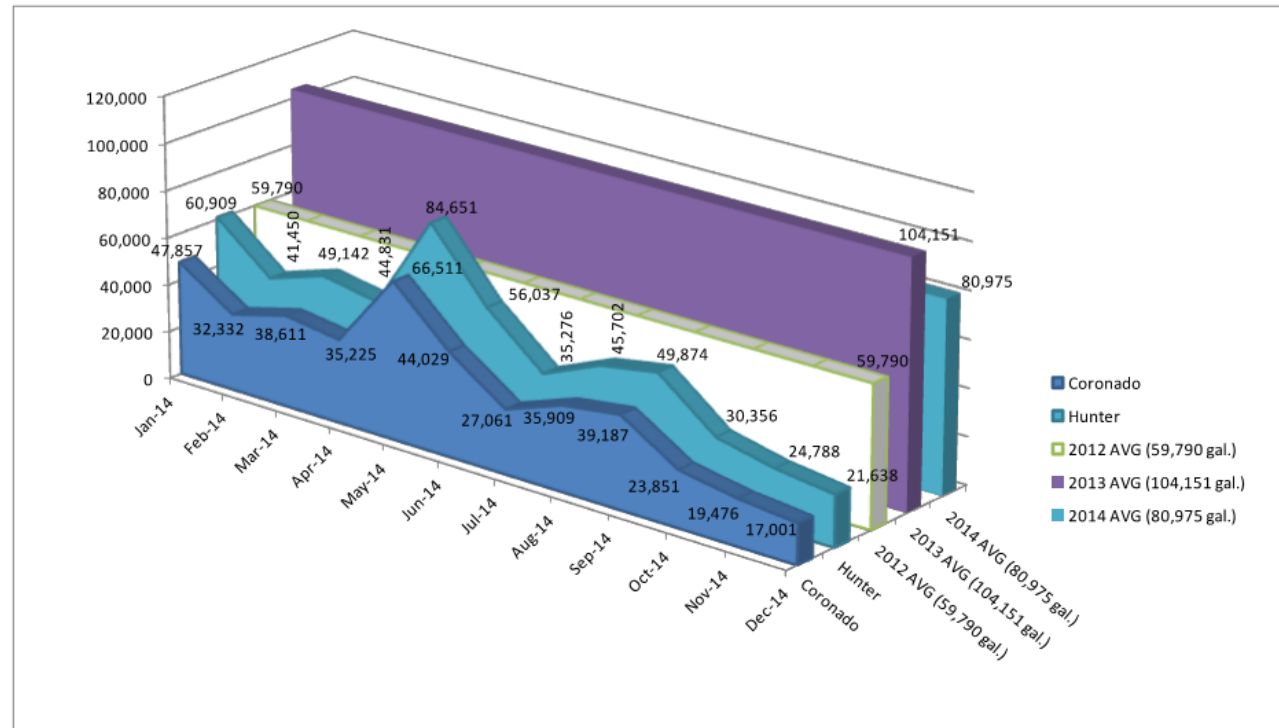
## GG MSTU Coronado - Hunter, Well Annual Water Use for 2014

Recommended: Supplemental watering rate of .5 or less inches per week. One half inch per week equals 24,846 gallons per week or 99,384 gallons per month.

2012 total water use: 717,484 gallons or 14.44 inches of supplemental water pumped.

2013 total water use: 1,249,815 gallons or 25.15 inches of supplemental water pumped.

2014 total water use: 971,704 gallons or 19.66 inches of supplemental water pumped.

X	X	2	If the Bermad pulse counter is working then request from Darryl’s office to contact the County Irrigation Project Manager to set the maximum flow per week at 25,000 gallons at which time an alarm will be sent to Hannula Landscaping.

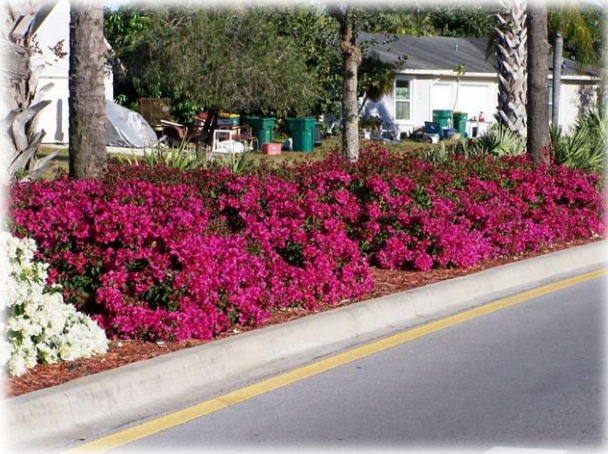
My compliments to the maintenance personnel for the color of the Bougainvillea shrubs which has been occurring since December and continues today.

Hunter Blvd.-Dwarf Bougainvillea 'Helen Johnson'

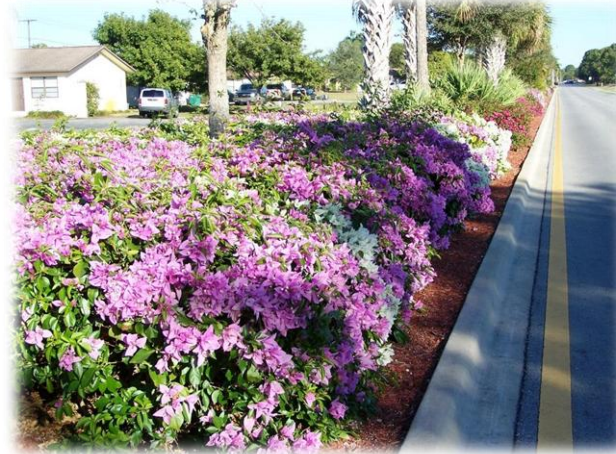
Coronado Parkway- Bougainvillea 'Silhouette & Ms. Alice'

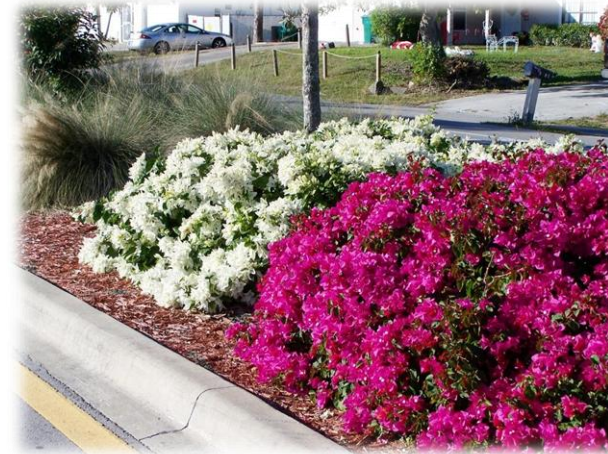
Hunter Blvd. – Bougainvillea 'Helen Johnson' & Ms. Alice'
