**Project:** GOLDEN GATE BEAUTIFICATION, M.S.T.U.

**Location:** Sunshine Blvd.

**Report Period:** FY 16-17, July 2017

**Report No.:** Nine

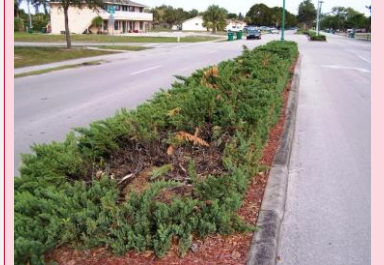
Commented [MM1]:

<b>Median #1</b>			X	2	Prune dead and/or brown foliage out of Juniper plants at all locations.	M&A: North end Juniper remove dead plants and/or foliage.
			X	6	There exist considerable areas within the turf invested with weeds and/or dead spots.	
			X	18	On the north end about 60 L.F. of Juniper has been damaged. It appears to have been run over. Prune out damaged and dead foliage. (Photo)	
			X	21	<del>Plumbago is water stressed.</del> Recommend adding two sprinkler heads on risers and with rebar supports in the center of the bed. Sprinklers should have 4' by 15' center strip nozzles.	
			X	31	Two Juniper plants have been damaged and need to be replaced with 3 gal. size.	
<b>Median #2</b>			X	6	Prune dead and/or brown foliage out of Juniper plants all locations	
			X	7	Address 2112: Replant (13) dwarf Bougainvillea 'Helen Johnson' 3 gal. size at location where water service repair occurred.	
			X	14	At address 2236: Dead turf area on east side of median apparently due to irrigation coverage issue. (5' x 40')

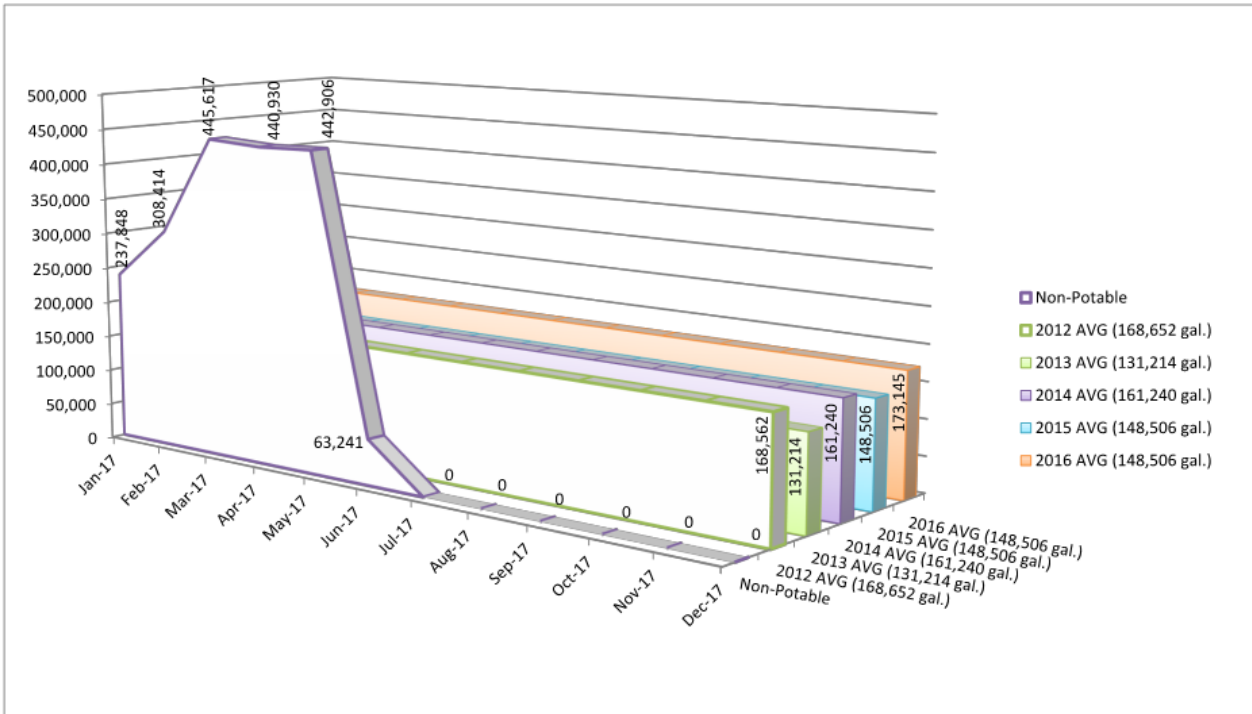
## GG MSTU Sunshine Blvd. Well Annual Water Use for 2017

Recommended: Supplemental watering rate of .75 to 1 inch per week. One inch per week equals 39,917 gallons per week or 159,668 gallons per month.

2012 total water use: 2,022,743 gallons or 50.67 inches of supplemental water pumped

2013 total water use: 1,574,562 gallons or 39.45 inches of supplemental water pumped

2014 total water use: 1,954,877 gallons or 48.97 inches of supplemental water pumped

2015 total water use: 1,782,067 gallons or 44.64 inches of supplemental water pumped

2016 total water use: 2,077,734 gallons or 52.05 inches of supplemental water pumped
