GOLDEN GATE BEAUTIFICATION, M.S.T.U.

Location: Golden Gate Pkwy.

Report Period: FY 18-19, January 2019

Report No.: Four

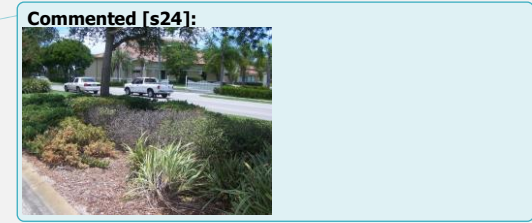
| LOCATION/WORK AREA | AC | S | C | R | MAINTENANCE SERVICES OBSERVATIONS & RECOMMENDATIONS | RESPONSE or COMMENTS |
|--|---|---|---|---|---|--|
| | | X | X | 3 | Auto accident in east end bed Juniper at pump station. Remove damaged and prune out dead. (8+/-) plants involved (photo) | |
