EXHIBIT 16

MAINTANENCE ACCESS ROAD/SEAWALL (B.1)

SHEET 1 of 1 DATUM NGVD 29 (NGVD = NAVD + 1.266')

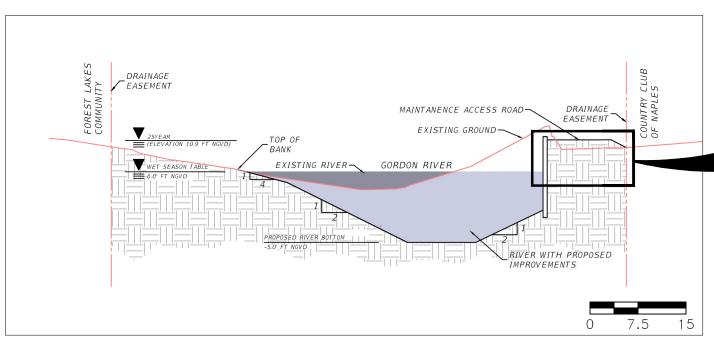
SECTION VIEW A-A

TO WEEP HOLE 10' O.C.

10'-8"

11.0 NOV Based on 25 Year Existing Stage

COMPACTED FILL 98%

*VERIFY PERIMETER SITE CONDITIONS UPON FINAL DESIGN
