Clam Pass Physical and Tidal Monitoring Report 2021 and Post Construction Summary 2022

August, 2022

Prepared for
Pelican Bay Services Division

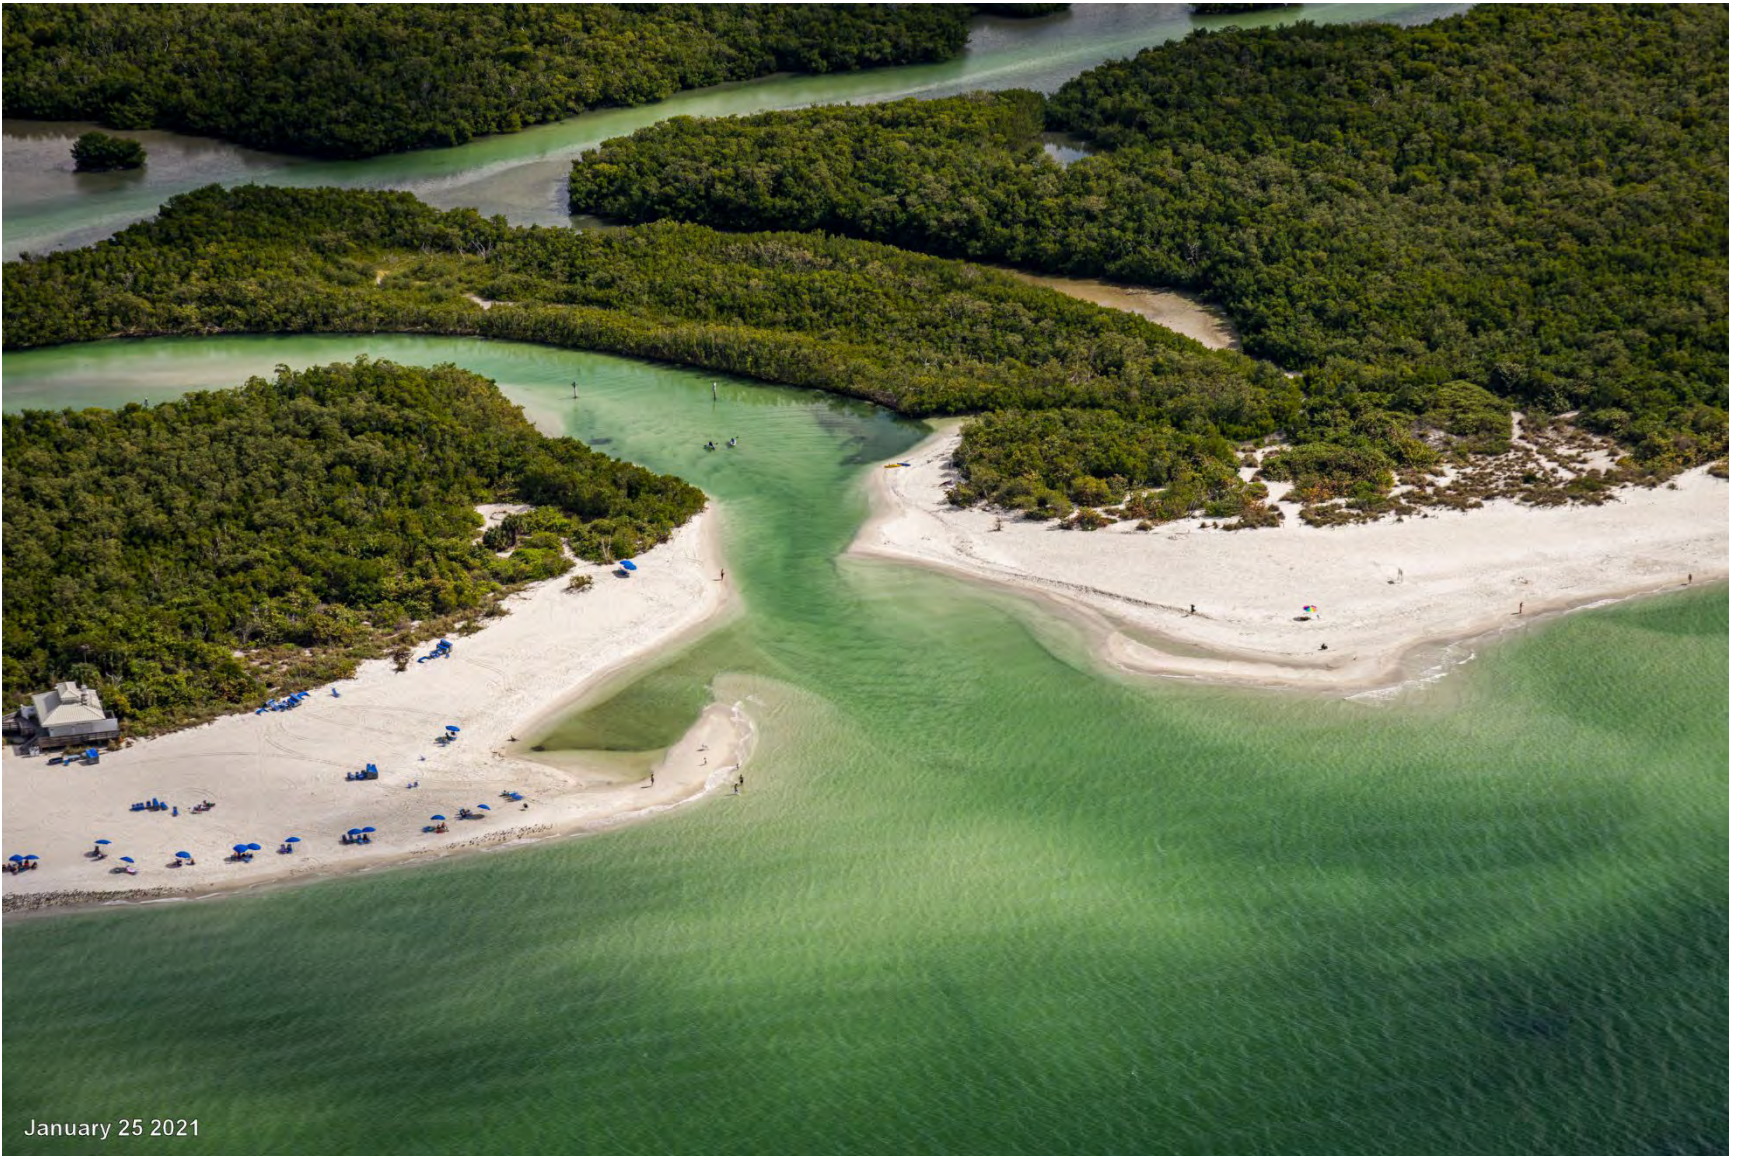
January 25 2021

Figure A1 - Clam Pass Aerial Photograph (Photo Taken by Aerial Innovations)

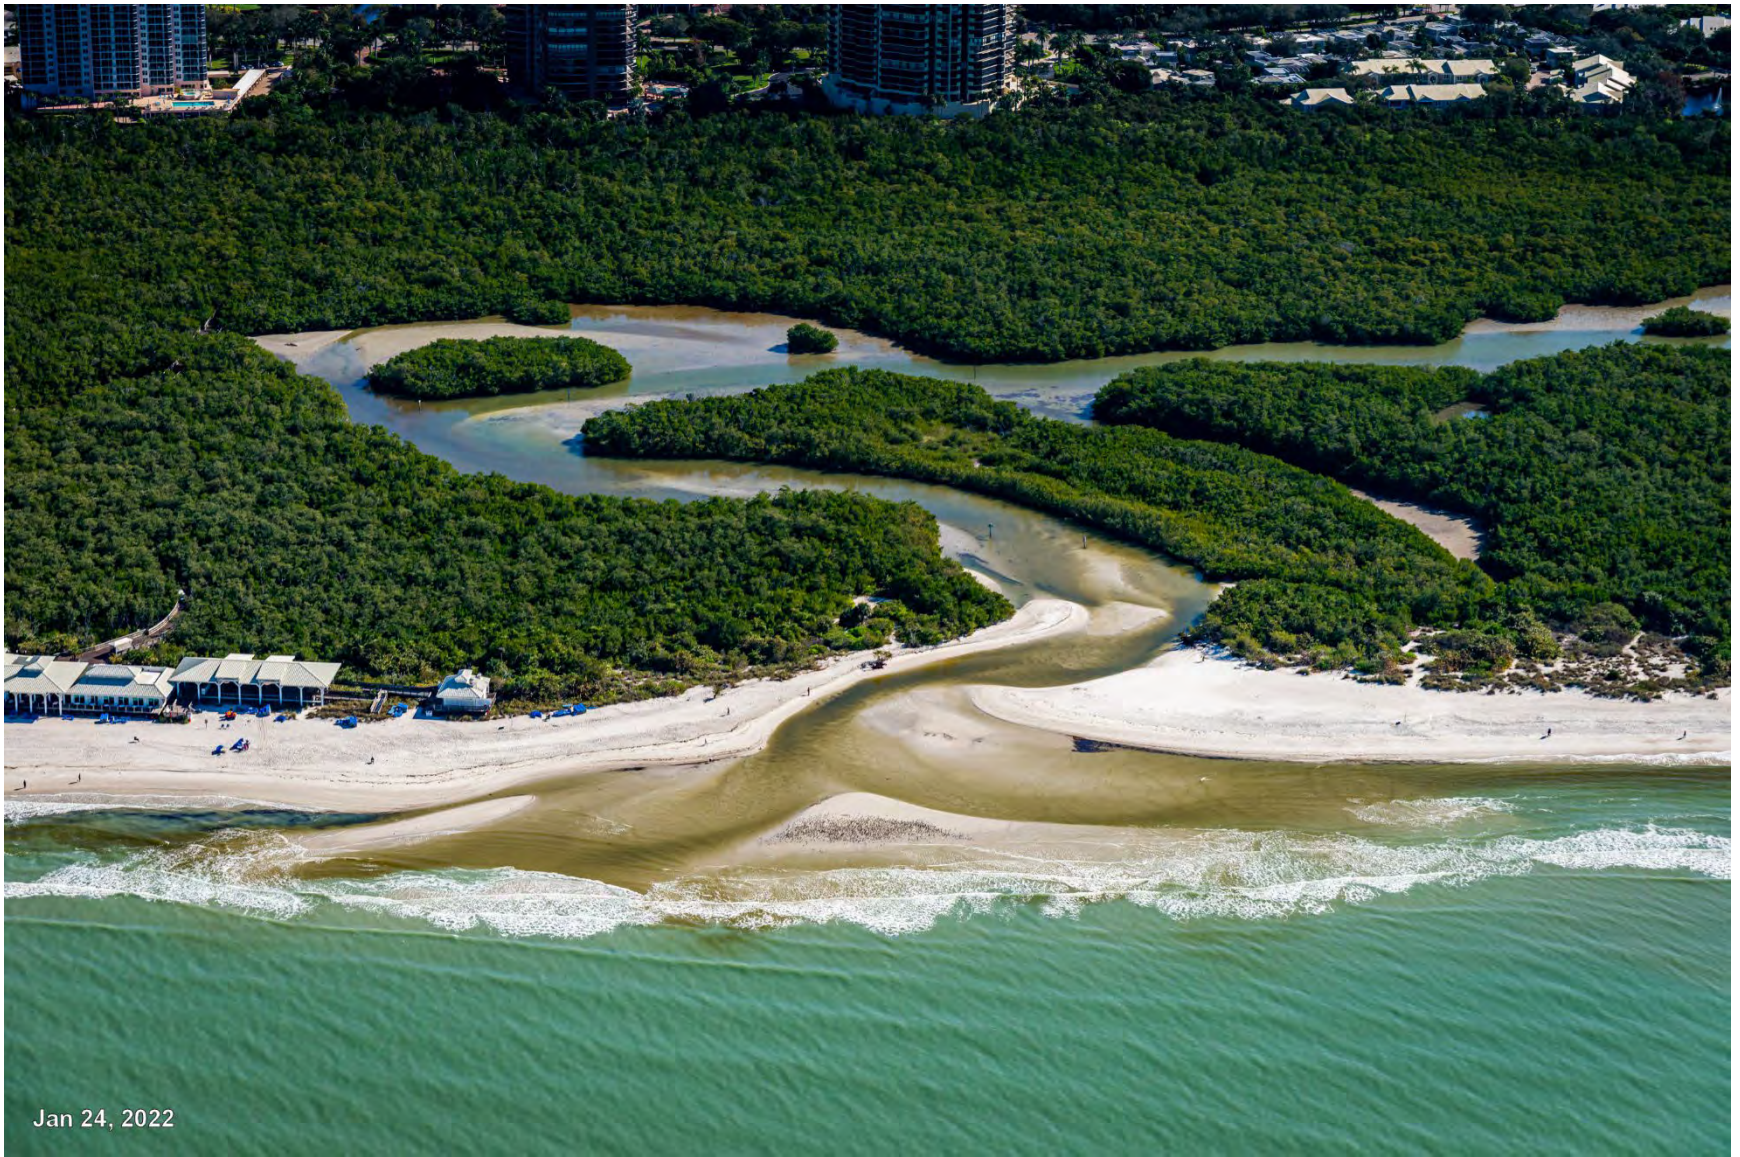
Jan 24, 2022

Figure A13 - Clam Pass Aerial Photograph (Photo Taken by Aerial Innovations)

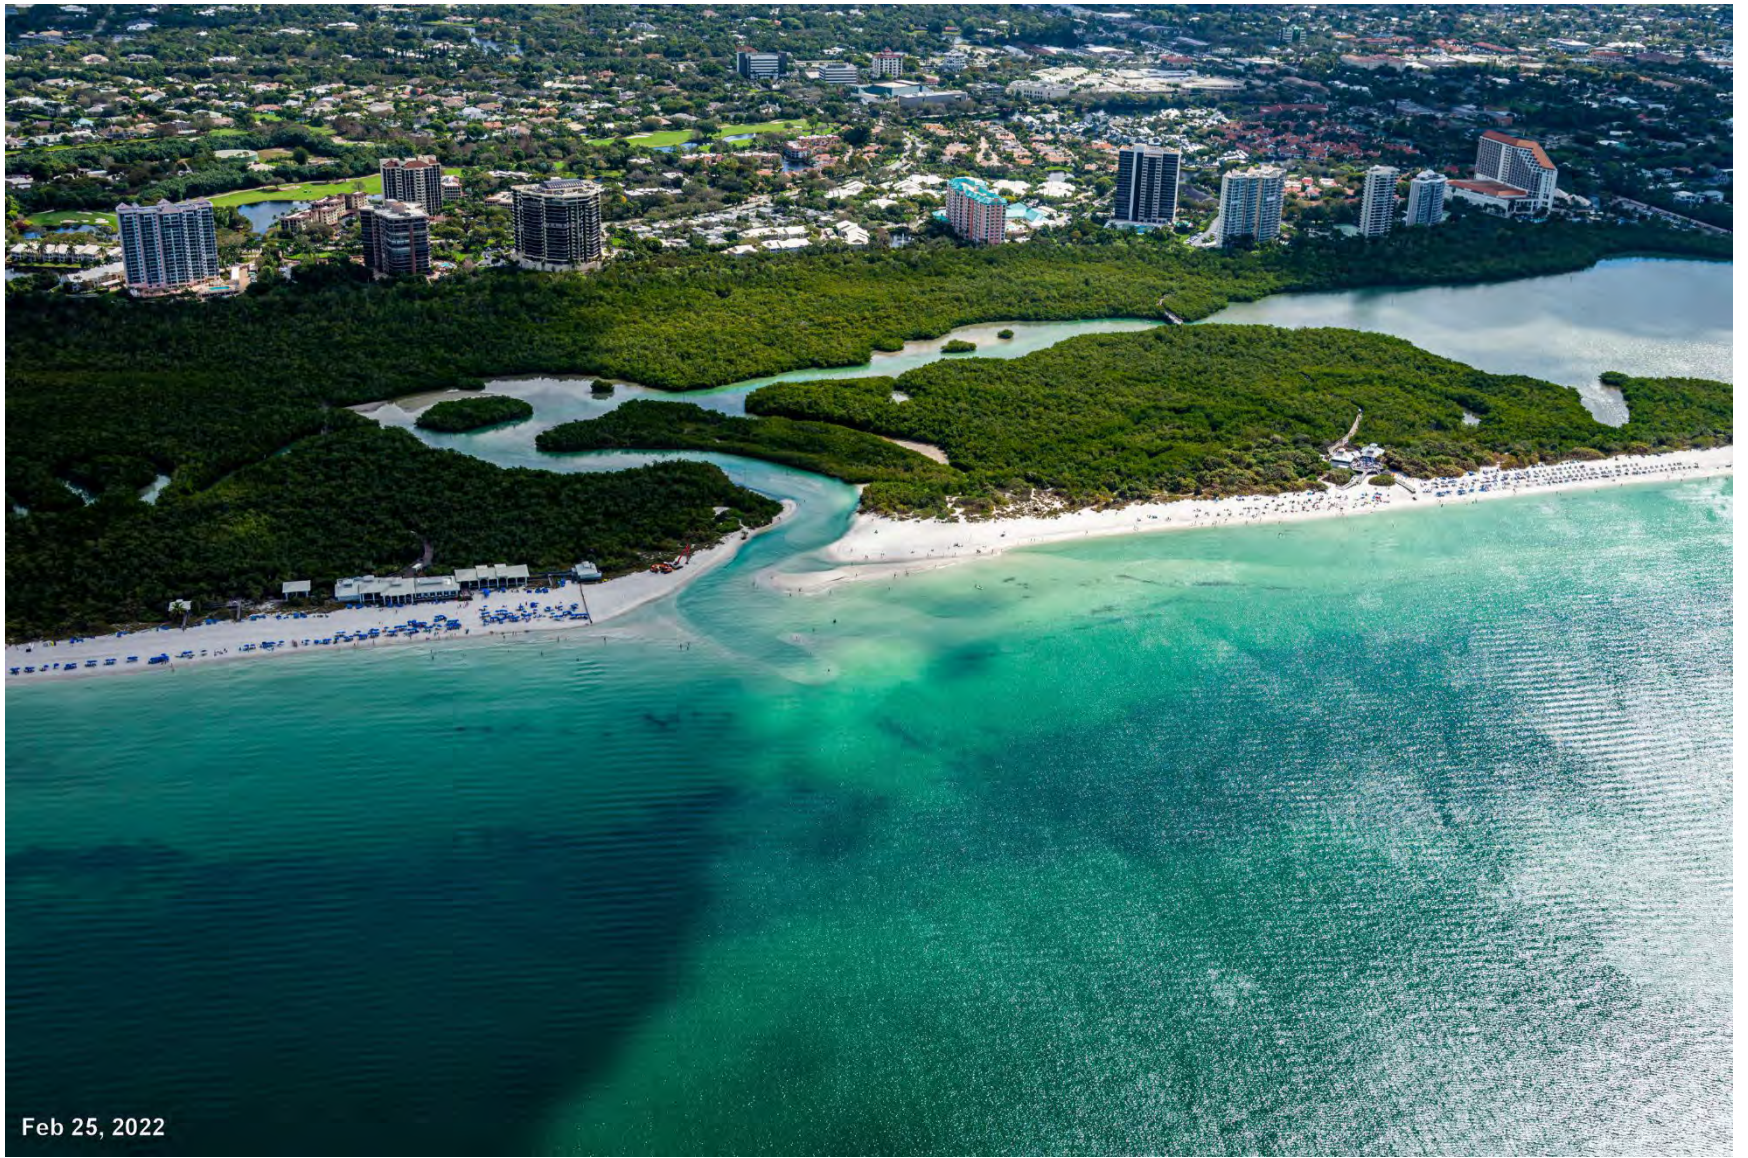
Feb 25, 2022

Figure A14 - Clam Pass Aerial Photograph (Photo Taken by Aerial Innovations)
